# SHW Serious Incident (SI) – Final Notice

| <b>Incident Short Description:</b> | Lug failure when lifting precast concrete drainage lid |

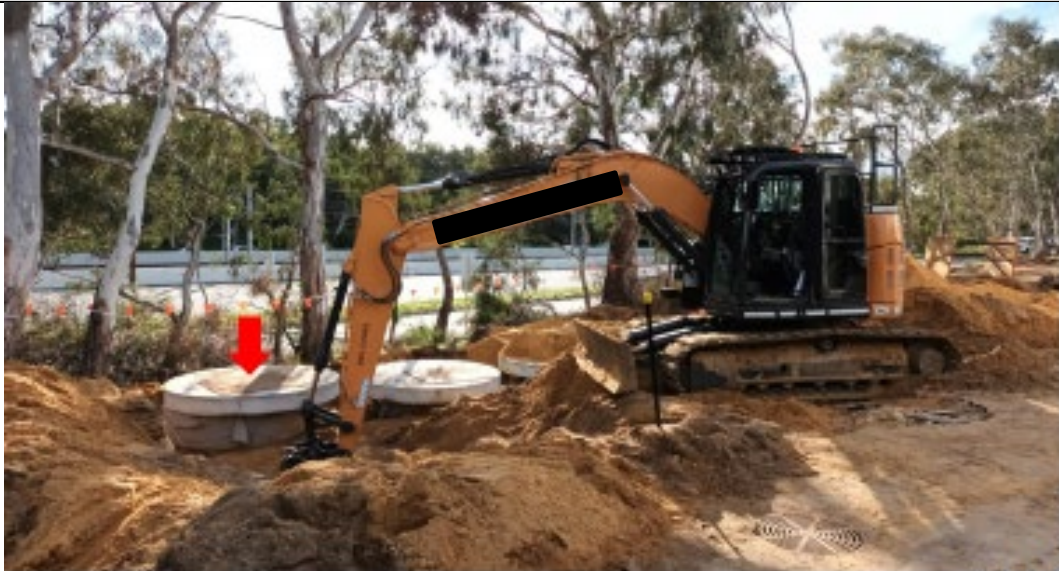
**Image 1: Location of Drainage Lid**

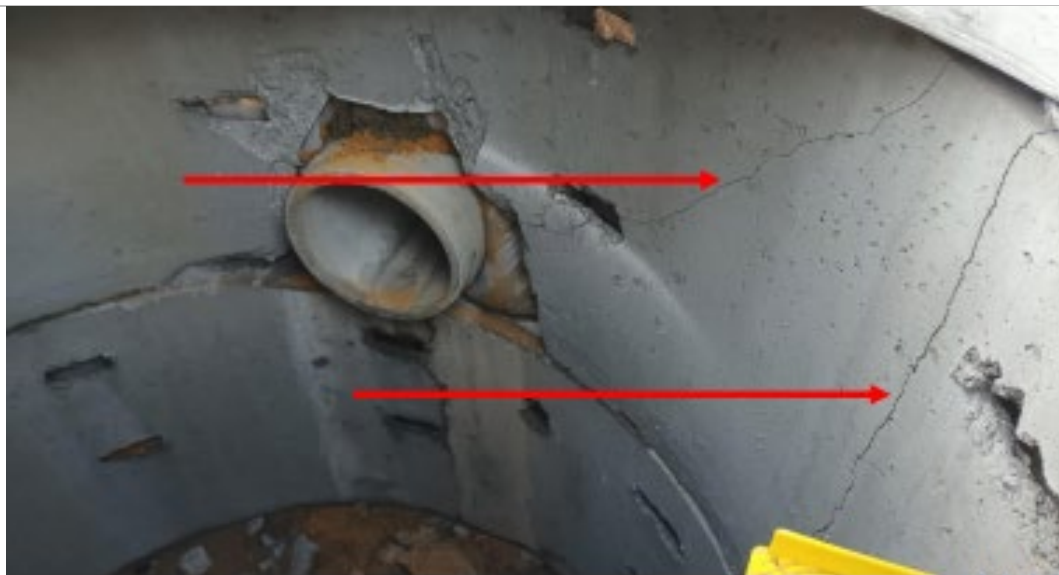
As the lid was being lowered onto the liner, at approximately 500mm above the liner, one of the lifting lugs has stretched to breaking point and snapped off resulting in the lid dropping directly onto one edge of the liner. The drop then shock-loaded the second lug which also snapped off. The lid came to rest on top of the liner it was being installed on; crack damage to the liner also resulted.

**Image 2: Damage to Drainage Liner**

- Job preparation / planning: utilise other lifting methods such as an Integrated Tool Carrier with a fork attachment or truck and Hiab to pick and place precast products to the direct area of installation as close as possible. This shall then reduce the use of the pre-cast lifting lugs and possible shock loading from tramming across uneven ground.
- Manufacturer's safe lifting and certification requirements to be conveyed to involved lifting personnel, transport companies and all personnel that handle pre-cast products.
- Safe Work Method Statement to be updated to reflect manufacturer's lifting requirements that are to be complied with at all times.
- Supervision to ensure Safe Work Method Statements have approved lift study or manufacturers safe lifting guide certification paperwork attached and are complied with in field.
- Removal and replace damaged Pre-Cast lid and liner.

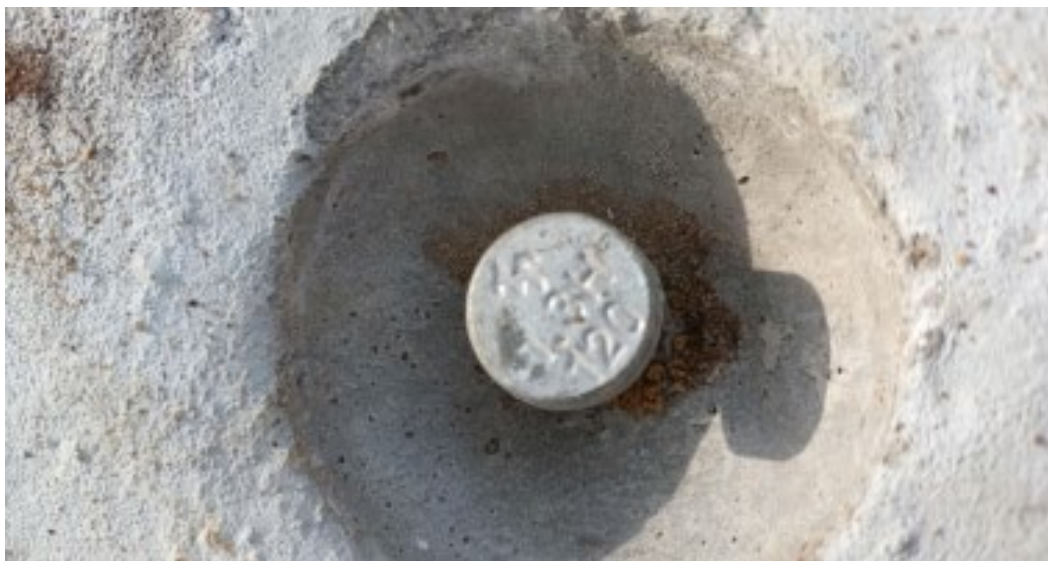
A two leg 8mm lifting chain sling rigged at maximum of 60 degrees was utilised with 2.0t swift lifts attached to only two of the four 1.3t SWL precast lifting lug points.

**Image 3: 1.3t Swift Lift Lifting Point**

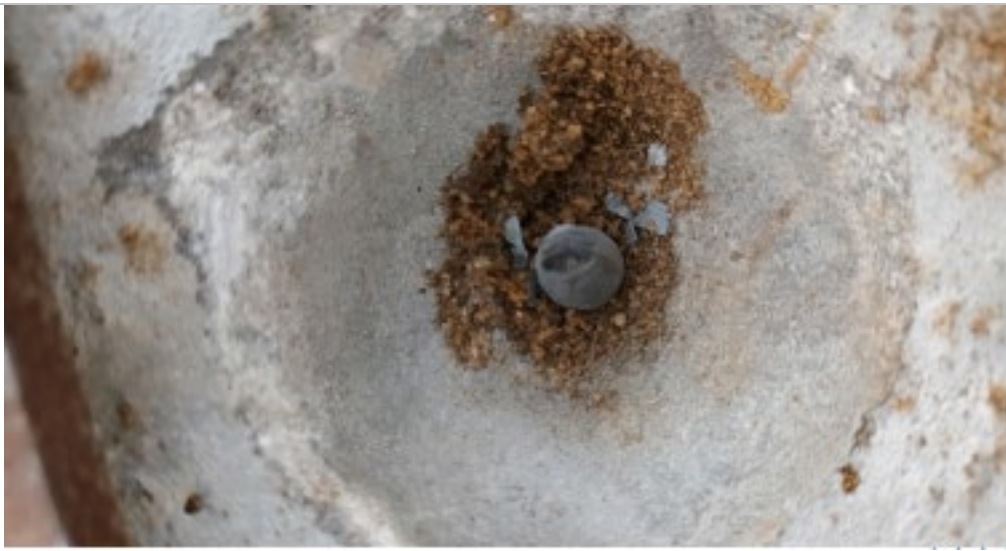
The precast concrete lids were required to be moved by the 14.5t excavator over uneven ground, with this possibly resulting in overloading of the installed precast lifting lugs.

**Image 4: Broken Swift Lift Lifting Point**

- Incorrect lifting technique was utilised i.e. two chains instead of the required four; documentation can be provided to operators prior to any lifting of pre-cast products.
- Stress loading of the pre-cast lifting points occurred due to tramming precast products across uneven ground.
- Manufacturer's recommendations provide for the use of all four pre-cast lifting points installed in concrete precast products; four-leg chain sling shall be used to undertake the lift safely as per manufacturer's recommendations.
