# SHW Serious Incident (SI) – Final Notice

| <b>Incident Short Description:</b> | Contractor Light Vehicle Conducts U-Turn into Path of Oncoming Member of Public Vehicle |

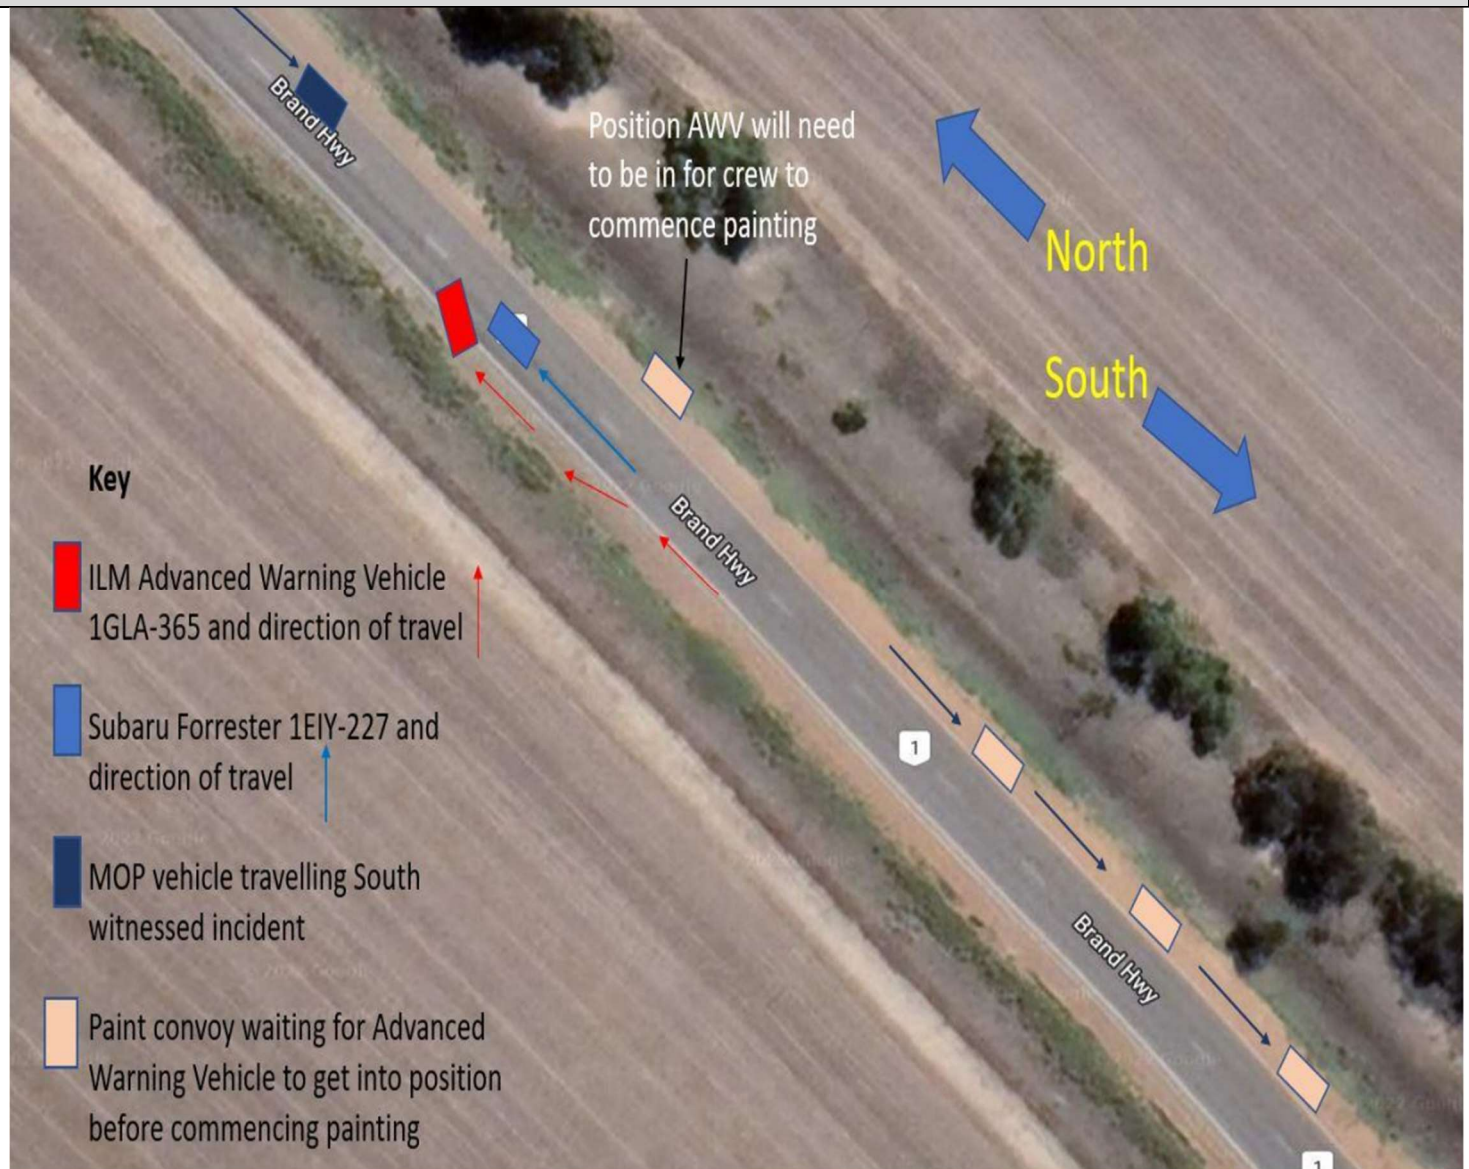
The operator of the AWV pulled out of the convoy and completed a U-turn to head North so they could reposition correctly. Once reaching the required distance the operator pulled to the left-hand verge of the road and at approximately 2:50 PM commenced a second U-Turn to cross back over the highway to face Southbound. During this U-Turn manoeuvre the AWV crossed into the path of an oncoming Northbound Member of Public (MOP) vehicle.

**Position of vehicles at the time of the incident**

| <ul style="list-style-type: none"> <li>• Procedure (Vehicle Movement Plan) for completing U-turns to be developed, implemented, and communicated. This will detail how and when a U-Turn can be completed, including use of spotters and two-way communication. It will also call for side roads to be used if they are close enough and verge edges to be wide enough for vehicles to position themselves perpendicular to the road.</li> <li>• When travelling to site vehicle convoy is to travel in the order, they are to commence work in, this will be communicated in a Vehicle Movement Plan.</li> <li>• Install rear-facing cameras on vehicles with restricted vision.</li> <li>• Review the work planning process to see if there is an opportunity to pre-plan potential turn around points for addressing in the VMP.</li> <li>• Update SWMS and risk assessment to identify and mitigate the risks of vehicles doing a U-turn.</li> <li>• Review purchasing process to look at options for built in safety devices/technology.</li> </ul> | |

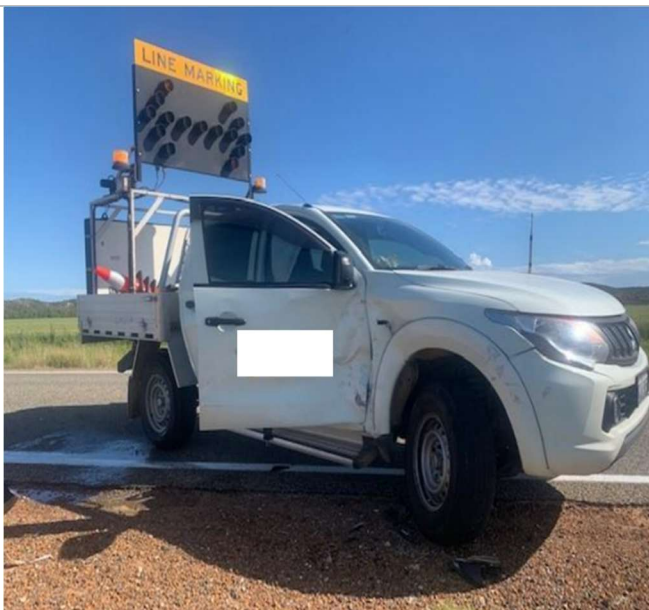
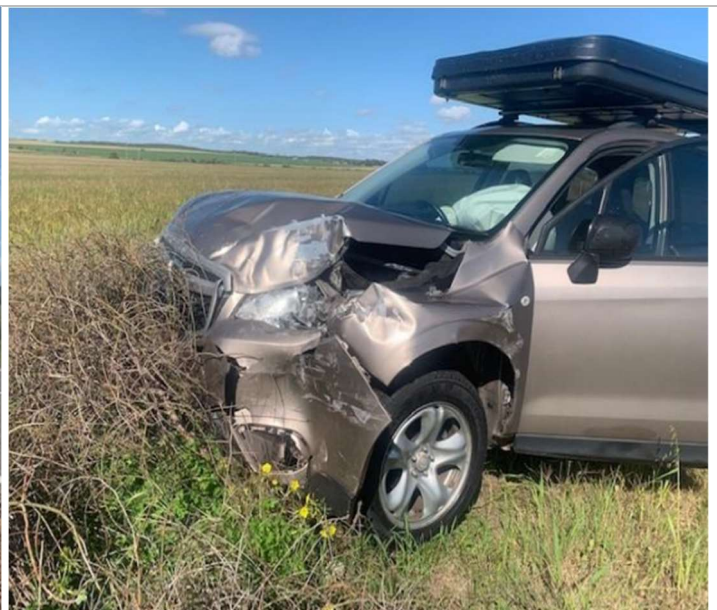
The front left-hand side of the Northbound MOP vehicle contacted the right-hand side front guard and door of the AWV causing both vehicles to travel East across the road and come to a stop. Both drivers exited their respective vehicles, with only minor muscle pain sustained by the AWV operator.

**Damage to AWV and MOP Vehicle**

| <ul style="list-style-type: none"> <li>• AWW was in the incorrect position when the convoy pulled up. Convoy to travel in order of work positioning not identified.</li> <li>• Risk management processes did not consider a Vehicle Movement Plan (VMP) for the operation.</li> <li>• Process for completing U-Turn not in place (no VMP).</li> <li>• Spotters and/or two-way communication not used.</li> <li>• Width of the shoulder is not wide enough for a light vehicle to be able to position itself to be able to see both lanes of traffic clearly.</li> <li>• Driver of AWW failed to identify oncoming traffic.</li> <li>• Restricted vision with Variable Message Board (VMB) on back of AWW.</li> <li>• Contractor purchasing process does not look at the options available for safety devices.</li> </ul> | |
