# SHW Serious Incident (SI) – Final Notice

| <b>Incident Short Description:</b> | Tele-Handler Overloaded |

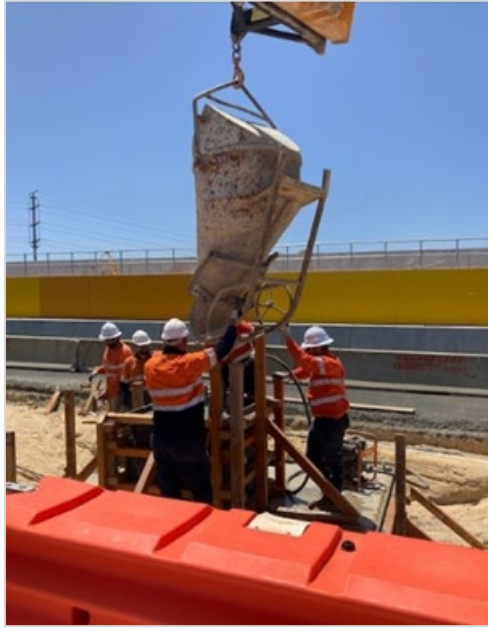
***500L kibble suspended from tele-handler. Workers in close proximity of kibble.***

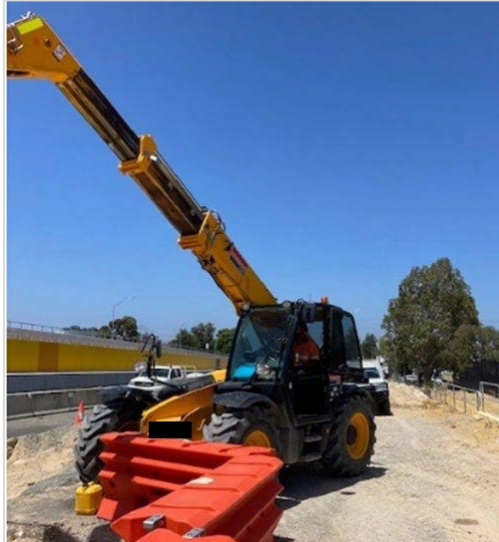
At 10:55am whilst extending the tele-handler boom, the load alarm orange & red lights commenced flashing and the audible beeper sounded. The Operator then overrode the alarm function, continued to extend the machine boom until he noticed the rear of the machine rising as the machine started to rock forward. The Operator promptly retracted the boom, concrete loading was adjusted, and the pour was completed.

***Wheels approximately 300mm off the ground.***

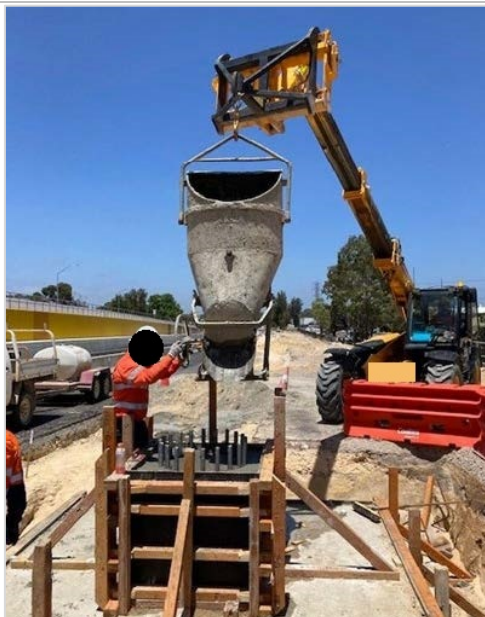
***Gross weight (full capacity) = 1080 kg approximately***

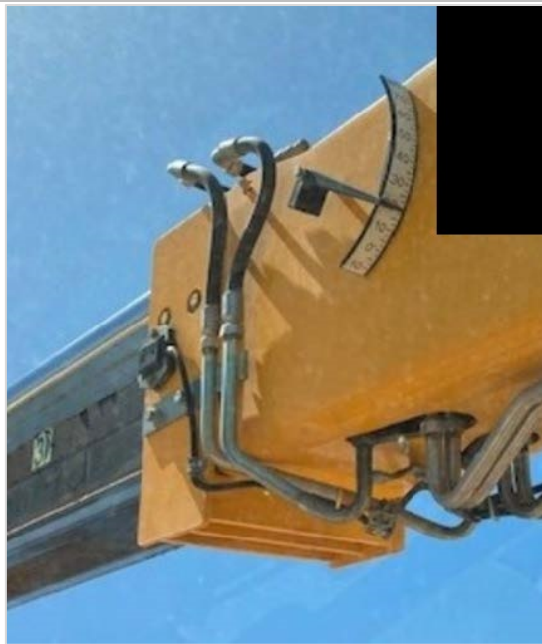
**Boom angle = 20 degrees**

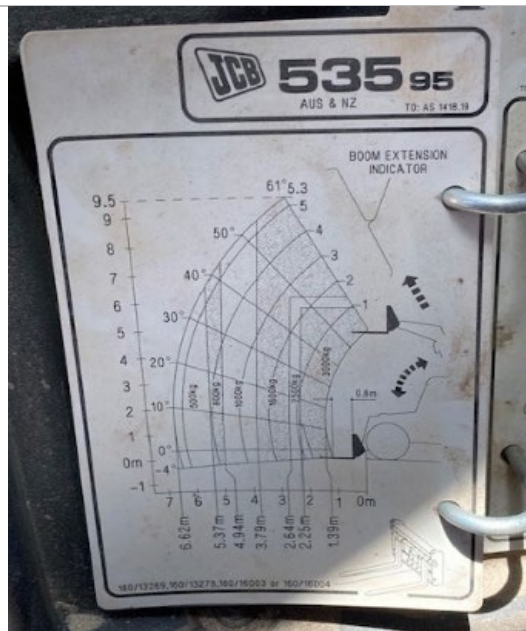
**Load (1080kg) ÷ Capacity (850kg) x 100 = Utilisation 127%**

- The immediate cause of the near miss was the tele-handler was operated beyond the design lifting capacity when warning alarms were ignored, and the override function was used to extend the boom.
  - Note: The override function is provided to allow the operator to override a hydraulic lock out function and retract the boom.
- Additional contributing factors include:
  - Operator relied on the machine's load warning system for operation.
  - Fundamental lift study planning was not carried out - i.e. the load chart was not used to calculate utilisation percentage.
  - Workers may have been experiencing time pressures imposed by the project.

- Develop and implement a 'Lift Card'. The lift card is a front-line planning tool for the calculation and recording of plant utilisation percentage using the applicable mobile plant lift chart.
- Identify personnel holding required competency certificates and licences for operation of mobile plant as a crane. Ensure only authorised personnel operate mobile plant.
- Disciplinary action to be taken for breach of duty of care.
- Develop a Safety Alert to share the learning opportunities across the business.
- Coaching of key personnel in relation to effective planning of works.

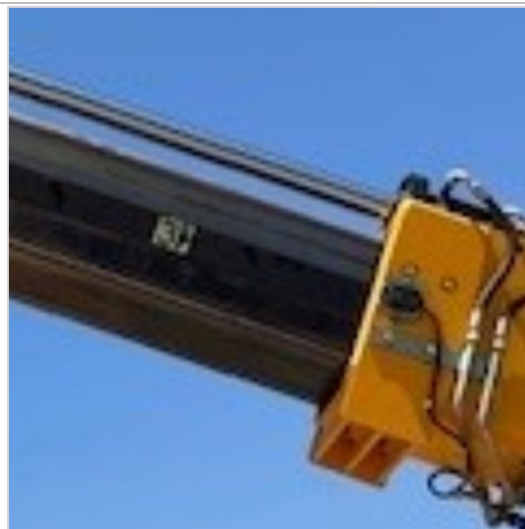
**Boom extension = 3.7m**
