# SHW Serious Incident (SI) – Final Notice

| <b>Incident Short Description:</b> | The Driver of a Traffic Control Vehicle experienced a microsleep, resulting in the vehicle crossing the opposing lane and striking a tree. |

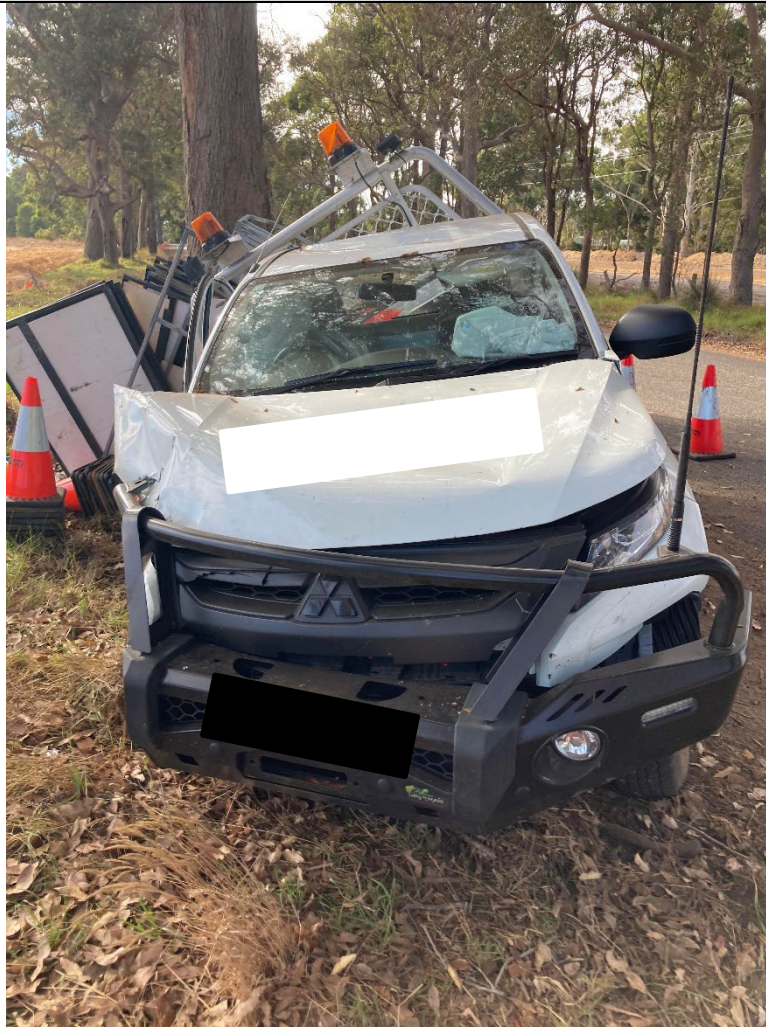
***Front view of damage to Traffic Control Vehicle***

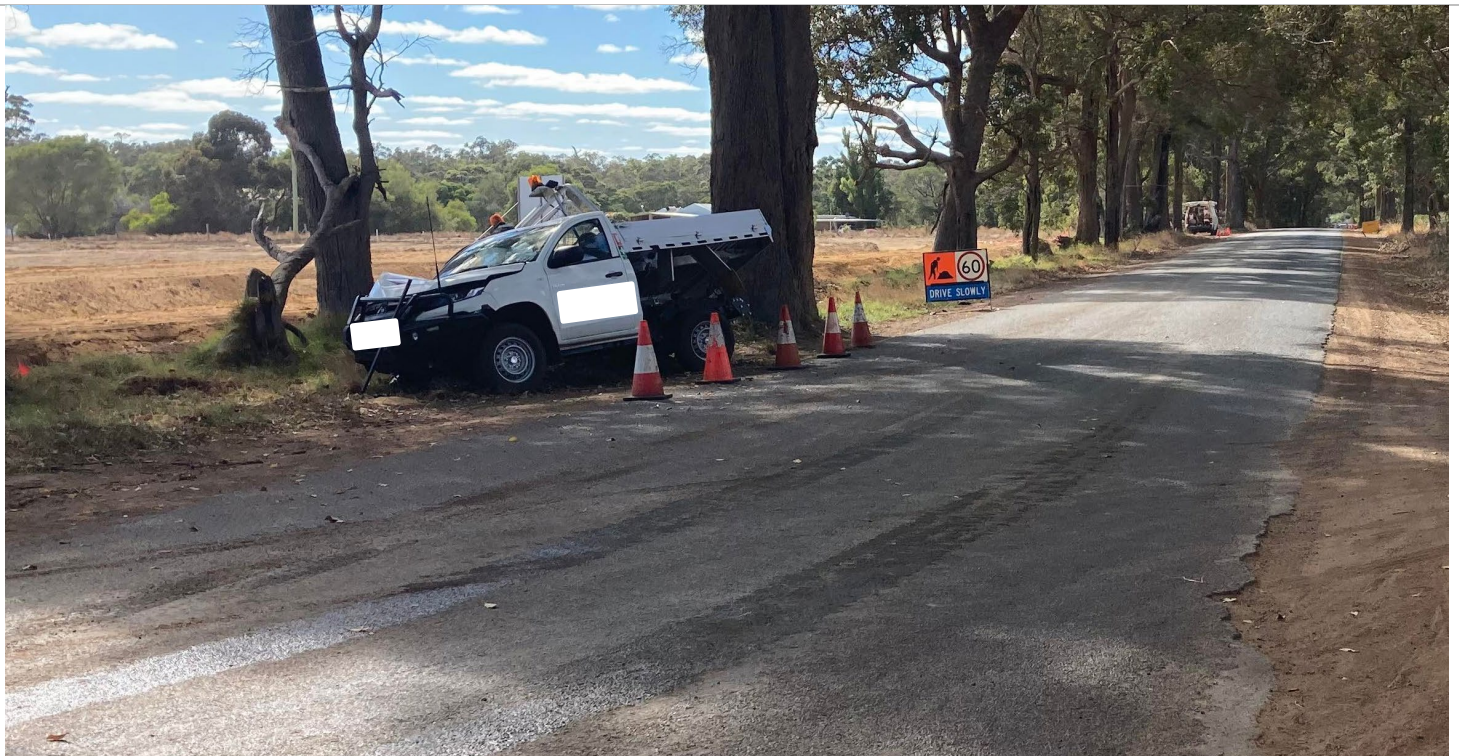
***Vehicle travelling westbound, crossing to opposing (eastbound) lane.***

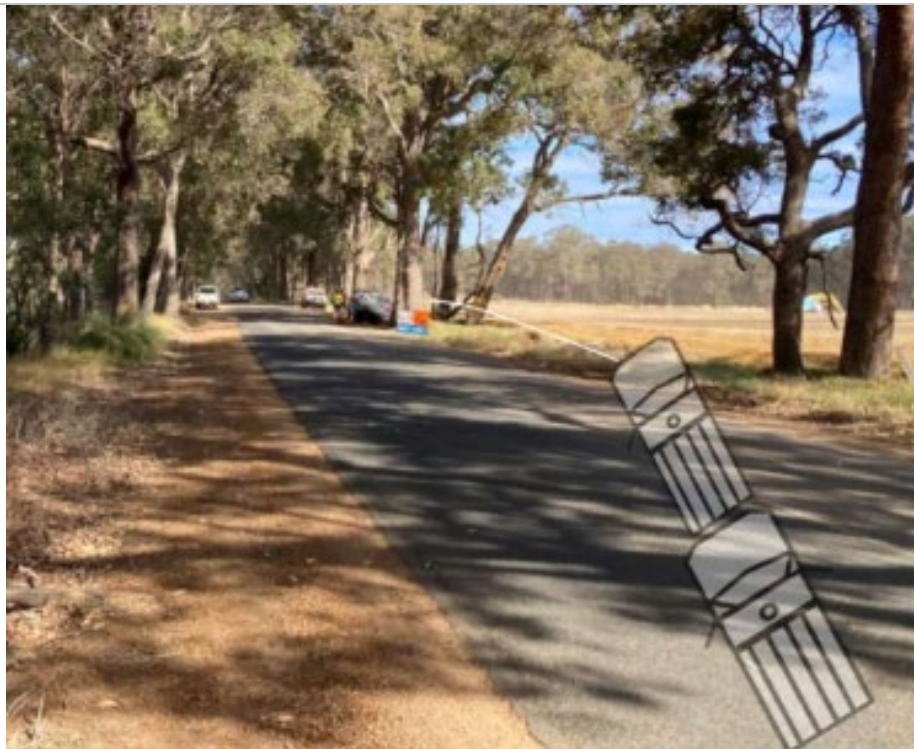
***Image showing projected path of vehicle off road***

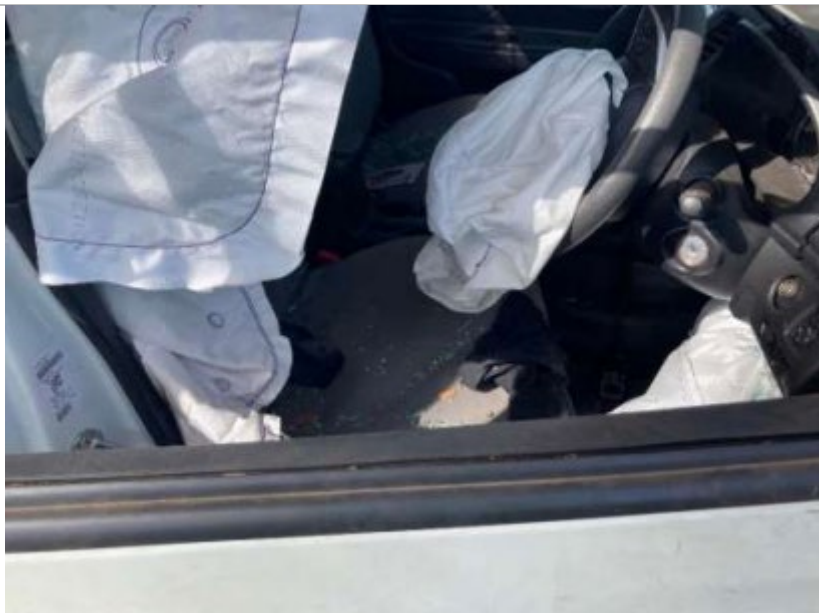
***Internal view of ute showing airbag activation***
