# SHW Serious Incident (SI) – Final Notice

| <b>Incident Short Description:</b> | Two Trucks travelling wrong way in live lane. |

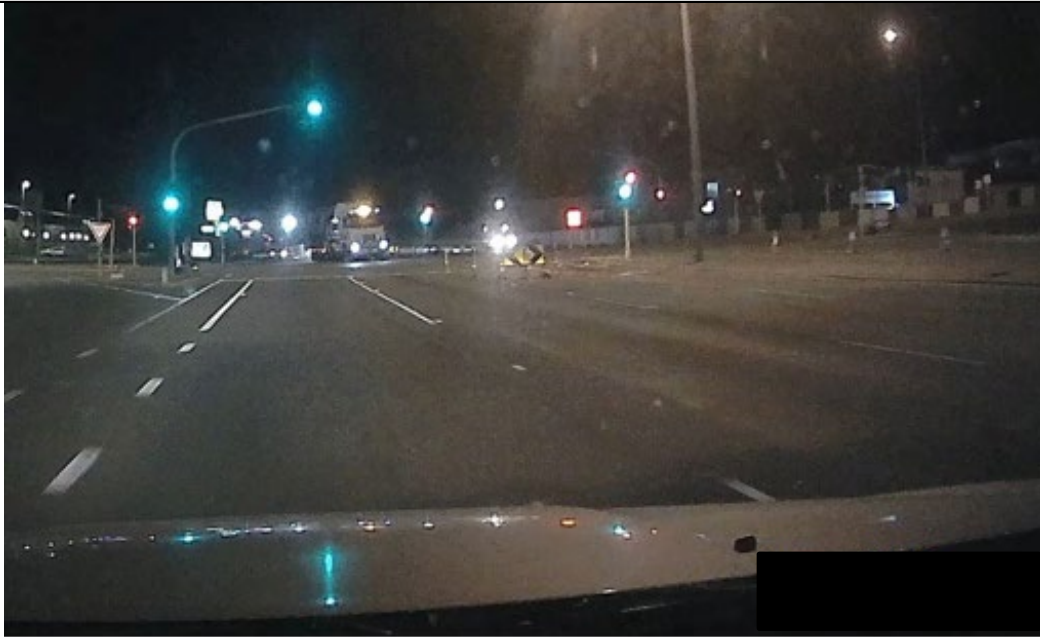
**Image 1: Contractor heavy vehicle in the centre oncoming lane.**

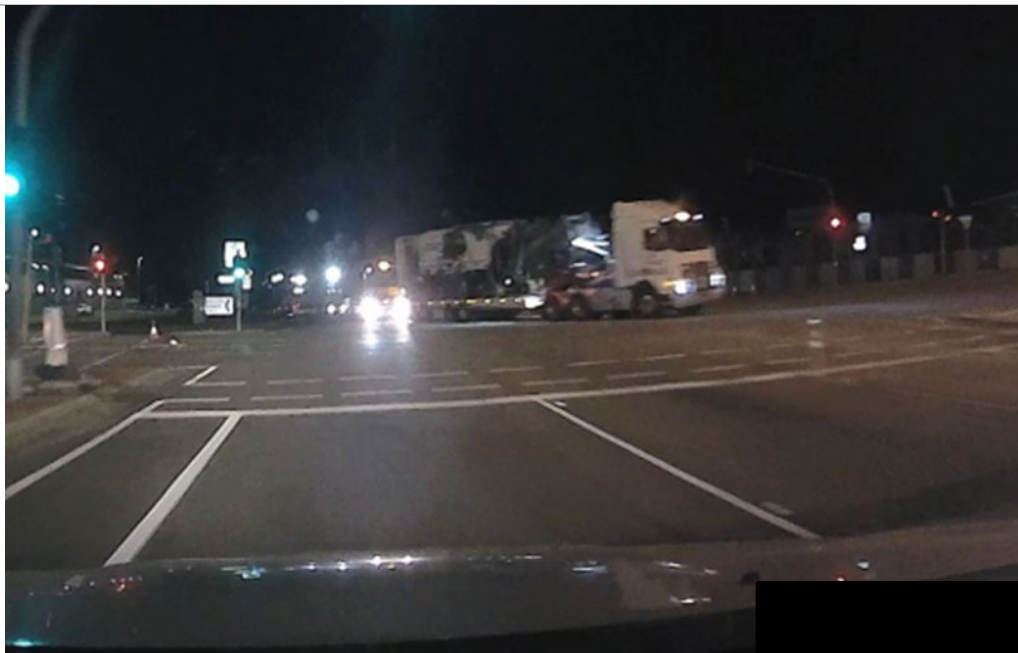
**Image 2: Contractor heavy vehicle crossing over to the correct lane at the intersection**

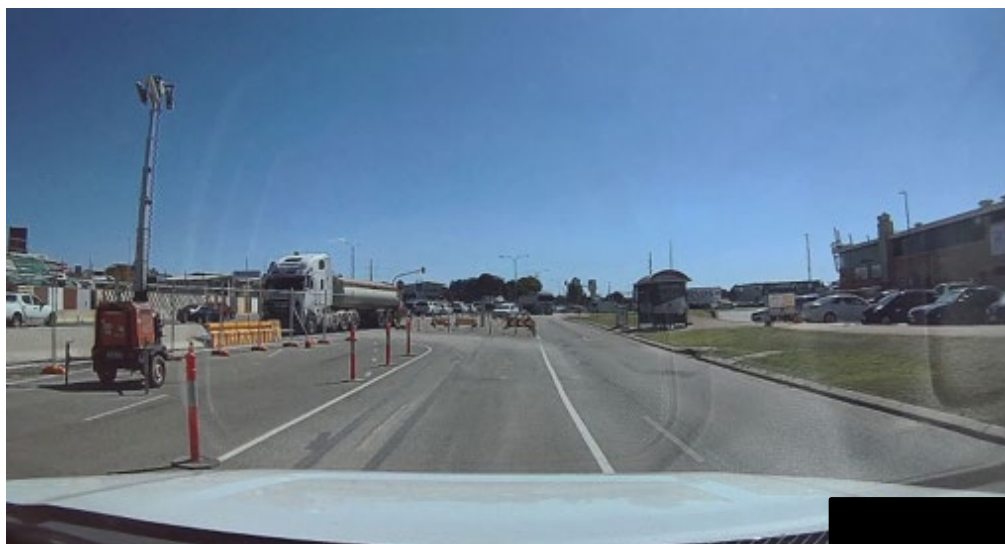
**Image 3: Exit of the carpark on to Ranford Rd – Temporary Traffic Management in place with restricted space**

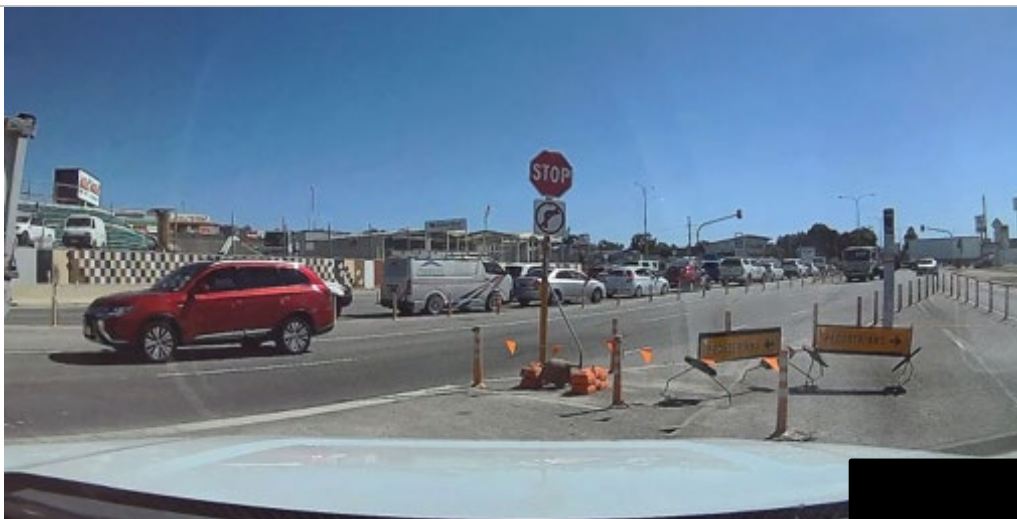
**Image 4: Exit of the carpark on to Ranford Rd – where heavy vehicles turned right**
