# SHW Serious Incident (SI) – Final Notice

| <b>Incident Short Description:</b> | 8 tonne double drum roller slides down batter and overturns. |

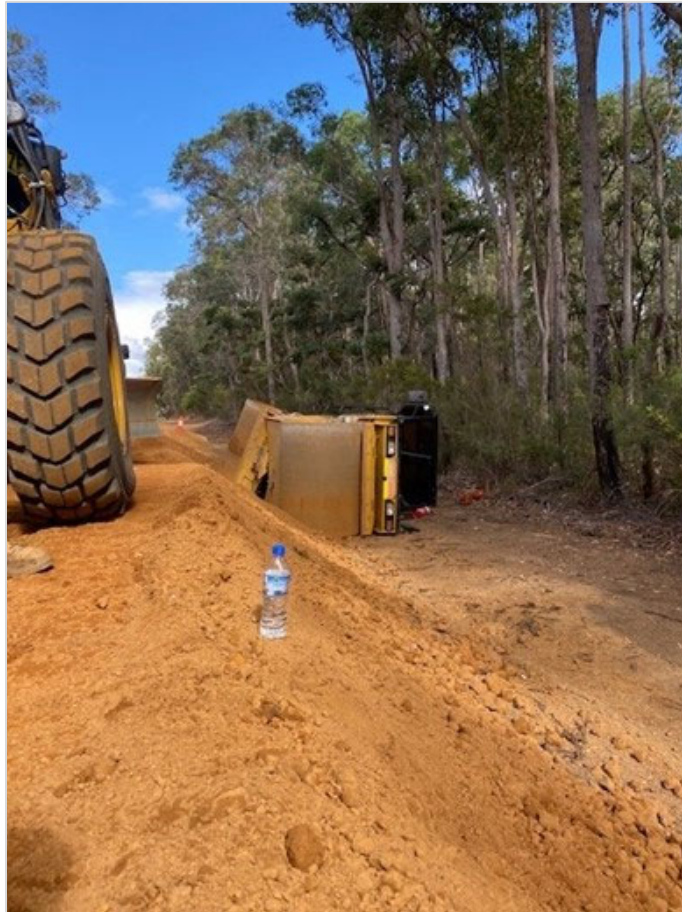
***View 1: Overturned Drum Roller***

- The Site recovery procedure was not followed. Passively tolerated violation of recovery procedure by the subcontractor.
- The injured person (IP) did not adequately assess risk.
- The IP's perception of hazards associated with recovering the drum roller was different to that of the roller operator.
- Soft shoulder and steep incline.
- Noted in pre-start that rain was expected at lunch time.

- Review of the Subcontractor risk management process with respect to the recovery of machinery.
- Issue a Contractor Company Stop Work for Safety Reset.

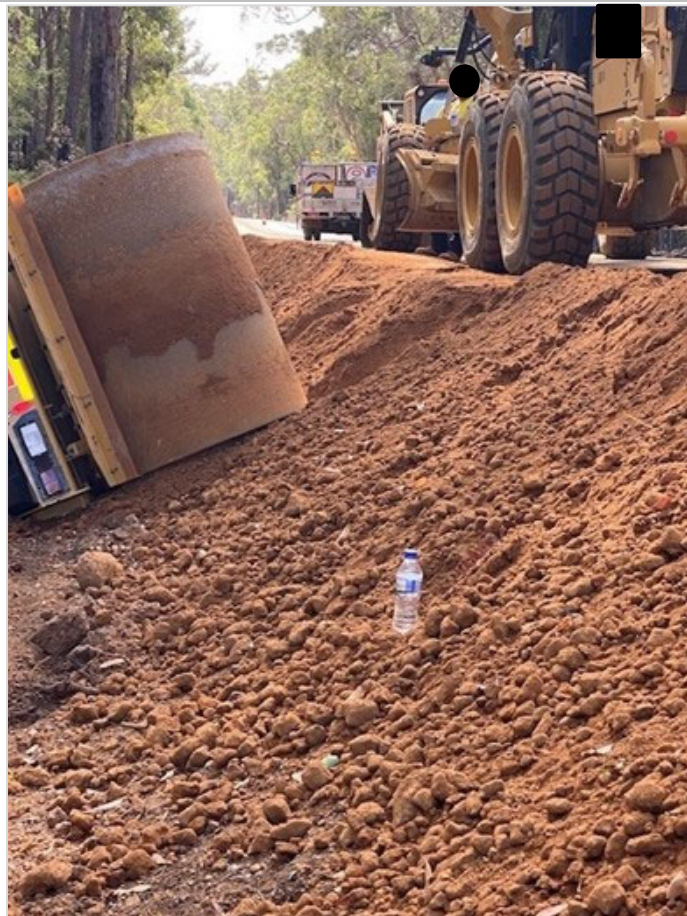
***View 2: Overturned Drum Roller***

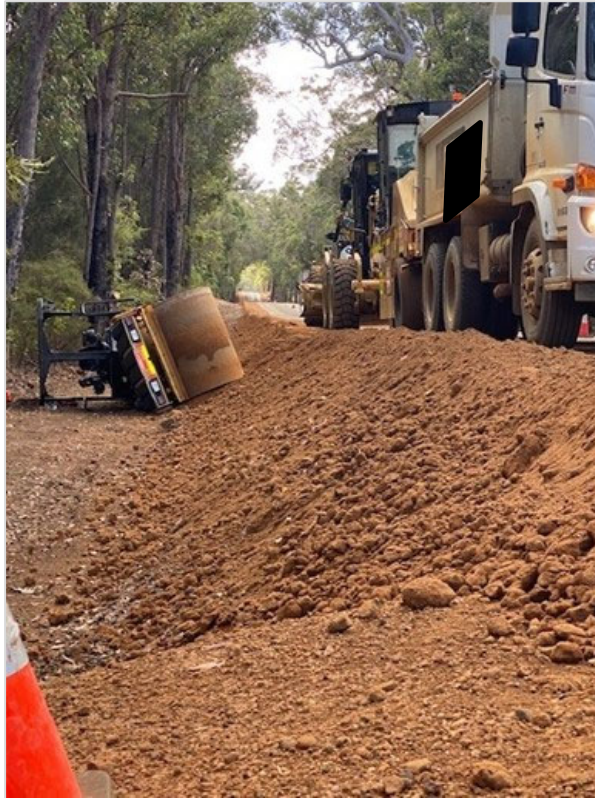
**View 3: Overturned Drum Roller**
