mainroads  
WESTERN AUSTRALIA

# SHW Serious Incident (SI) – Final Notice

| <b>Incident Short Description:</b> | Burst high pressure hydraulic hose resulting in Lost Time Injury (LTI) |

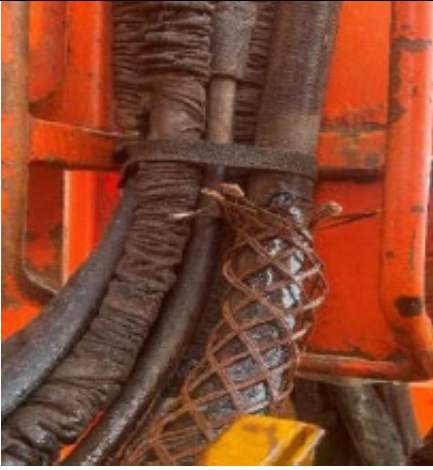
From 12:00pm Worker B started drilling and was assisted by Worker C. The drilling continued as normal until 1:30pm. Around 1:30pm Worker B had finished his drill run down to 31 metres and was flushing the hole to lift all the drill cuttings out of the hole. He was using 100% water flow to complete this action. The water hose to the drill head burst at this time, and the water and drill mud splashed through the hole. Worker B moved his safety glasses from the position on his face and looked at the hose. Suddenly, water from the hole struck into Worker B's left eye and face.

**Burst Hose**

- Wear and tear of the water hose.
- First aid not given on site / eyes of the injured person was not flushed on site.
- The Injured Person moved their safety glasses from their face.

- Comprehensive inspection shall be conducted on the company drill rigs to identify the condition of hydraulic and pneumatic hoses.
- Conduct a periodic inspection to check all pressure release valves are correctly set.
- Implement periodic water delivery systems checks, including burst sock conditions, pressure release valve pressure, static testing of hoses and whip check condition.
- Provide training to all staff on selecting, using, and maintaining PPE in a proper manner.
- Ensure at least two trained first aid providers on site.

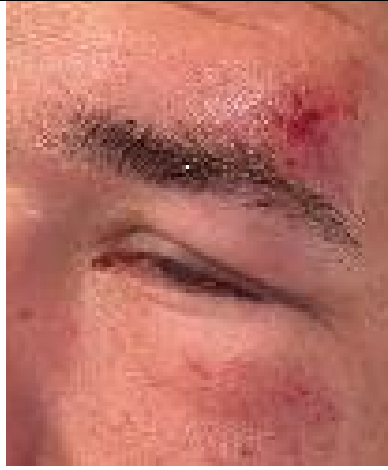
**Eye Injury**
