# SHW Serious Incident (SI) – Final Notice

| <b>Incident Short Description:</b> | Prime Mover collided with Water Cart |

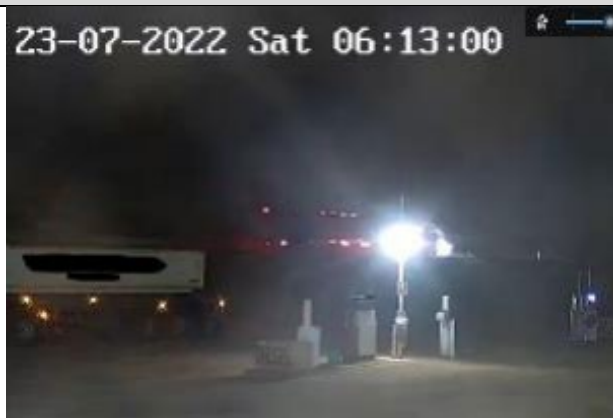
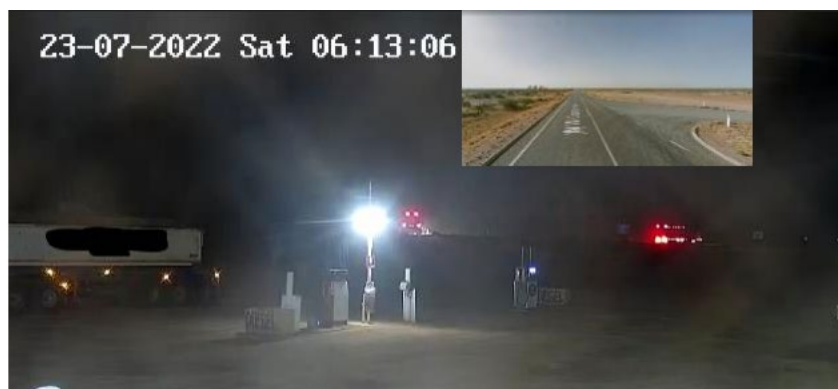
On the 23rd of July 2022 at 06:13am, the Operator of a Hino 500 Water Cart exited the North Intersection from the Minilya Roadhouse whilst being incorrectly positioned. Upon entering North West Coastal Hwy, subsequent Operator inattention failed to also recognise any lights from an oncoming Freightliner Prime Mover and Double Trailer Combination. Consequently, this resulted in the Water Cart bull bar contacting the side of the Prime Mover fuel tank, the first trailer tyre and mirror-to-mirror contact.

***Point of contact between Freightliner and Water Cart***

- Main Roads and/or Minilya Roadhouse to evaluate improving the design criteria for entry and exit from Minilya Roadhouse.
- Review on-highway service truck build specification and vehicle risk assessment for the requirements of extra cab windows to be glass for additional visibility.
- Review the Traffic Management Plans for relevant company instruction and notification process to local Police in the event of traffic accidents.
- Risk assess and implement change management to the parking assembly requirements for the project; Intent is to limit travel movements from the project and interaction with the public and road users.

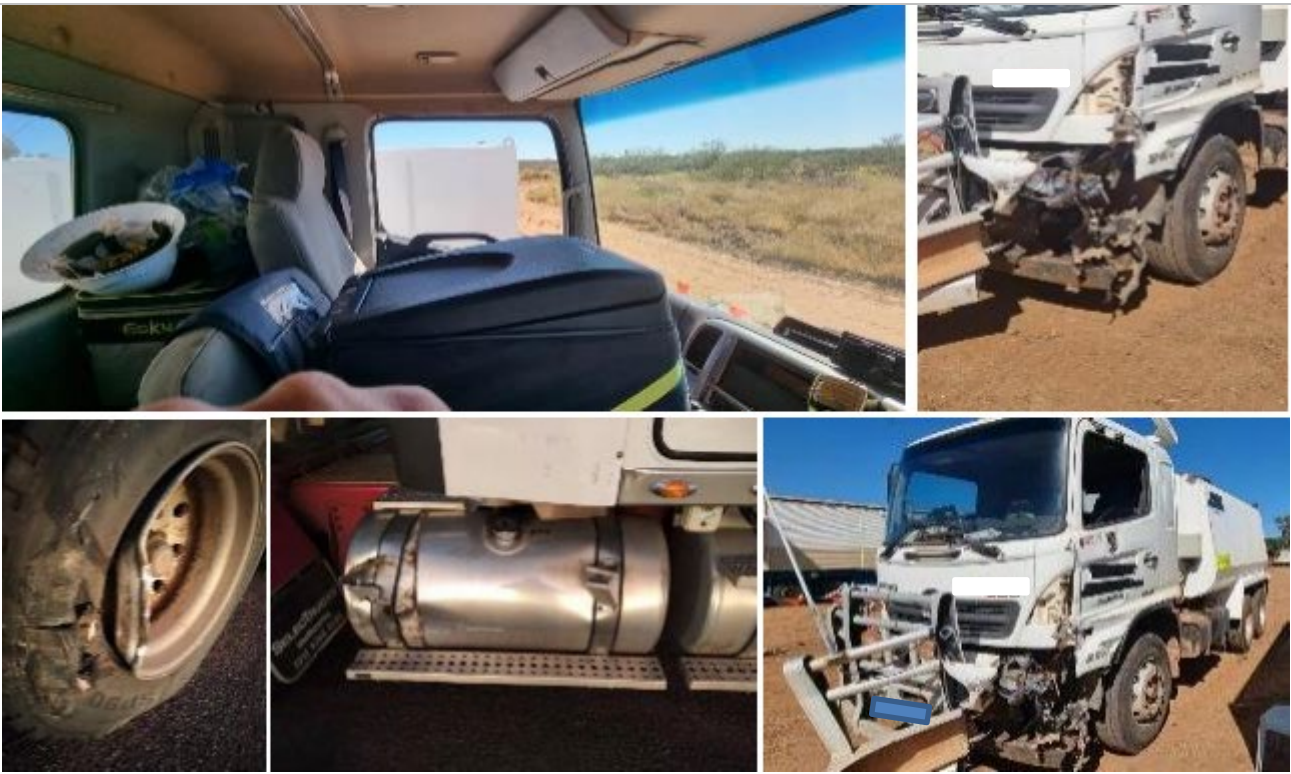
***Photos of inside of the Water Cart. Series of post event damage to the Water Cart, Freightliner and Trailer Rim / Tyre.***

- Operating on-highway trucks to turn from the north intersection into the Main Roads Depot access road is less than 20m.
- The rear cab window is blocked by the water tank; the extra-cab side windows are not featured on this model, combined with bright LEDs of the Water Cart blocking out other light sources this all contributed slightly to reducing visibility whilst travelling up a gradient of 4.6 degrees.
