# SHW Serious Incident (SI) – Final Notice

| <b>Incident Short Description:</b> | Night Works was conducted without proper authorisation, potential fatigue risk |

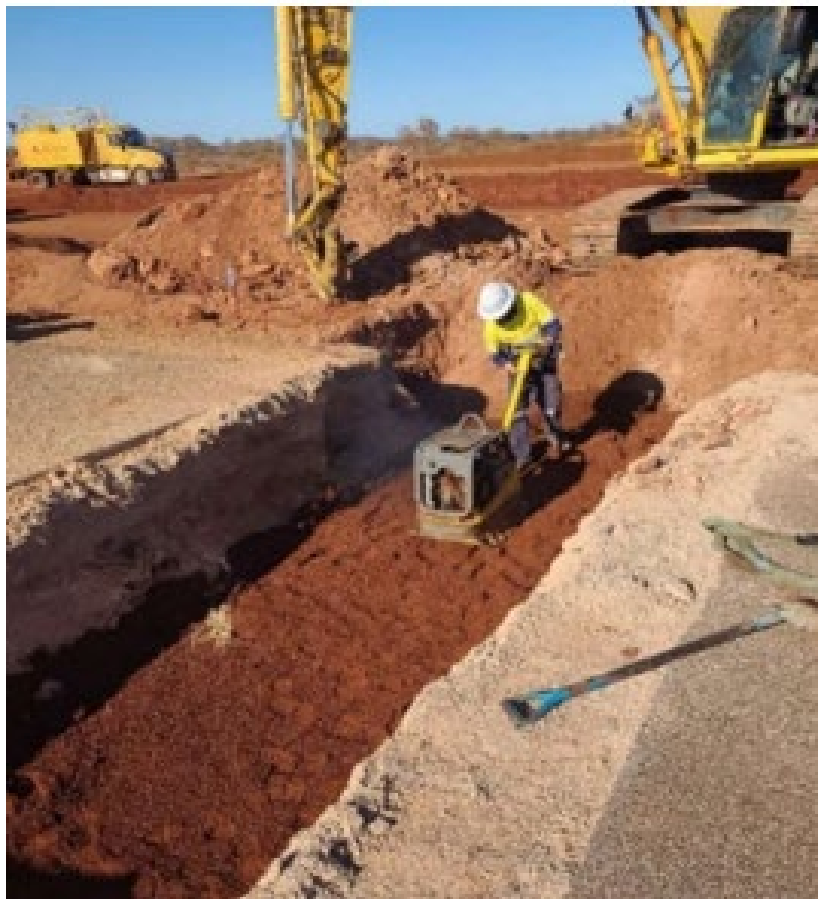
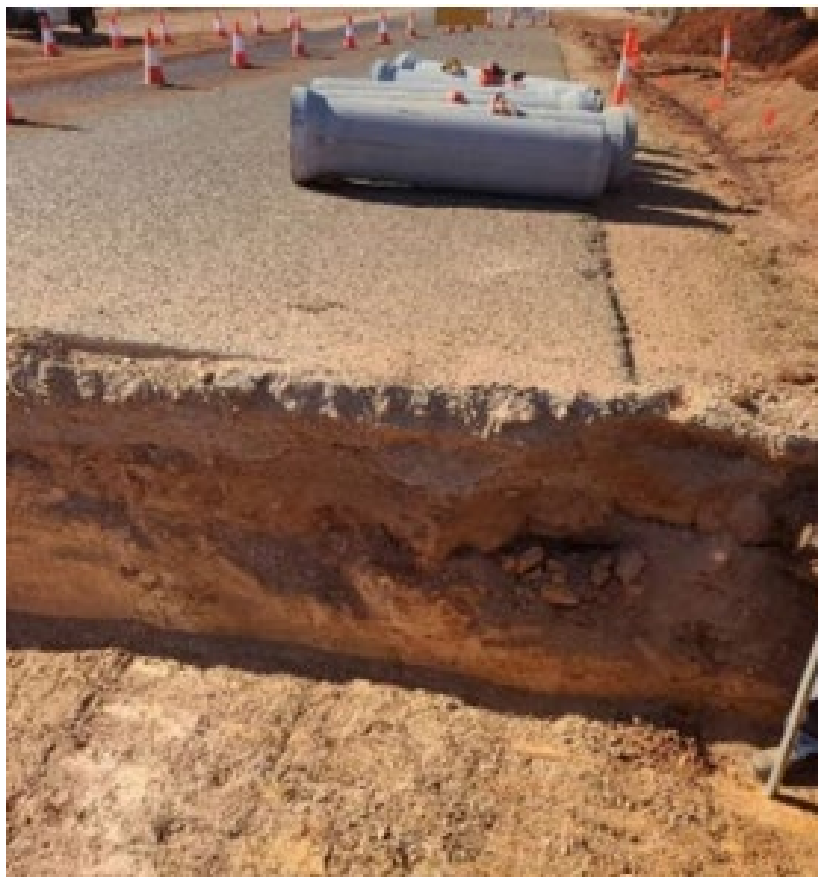
**Drain excavation and compaction**

| Contributing Factors: | |
|---|---|
| <ul style="list-style-type: none"> <li>• Delays in works due to rock encountered during excavation and stabilized material batches were non-conforming</li> <li>• Did not seek approval from Main Roads to work beyond scheduled hours</li> <li>• Communication to relevant stakeholders</li> <li>• Works conducted after 6 pm were not in accordance with the Traffic Management Plan and Safety Management Plan</li> </ul> | |

| Contributing Factors: | |
|---|---|
| <ul style="list-style-type: none"> <li>• Communication Procedures to be updated to include requirements about carrying out work outside the notified working hours or on days other than the working days notified.</li> <li>• Ensure workers are aware of the <a href="#">Code of Practice working hours</a>. Certain Working hours arrangements have been linked to safety and health risks, such as fatigue and impaired performance and increased exposure to some hazards.</li> </ul> | |
