# SHW Serious Incident (SI) – Final Notice

| <b>Date of Incident:</b> | 7/9/2022 | <b>Time of Incident:</b> | 0725 |

| <b>Incident Short Description:</b> | Operator falls out of Roller while reversing with door open, avoids being crushed, climbs back into moving roller, and shuts it off successfully. |

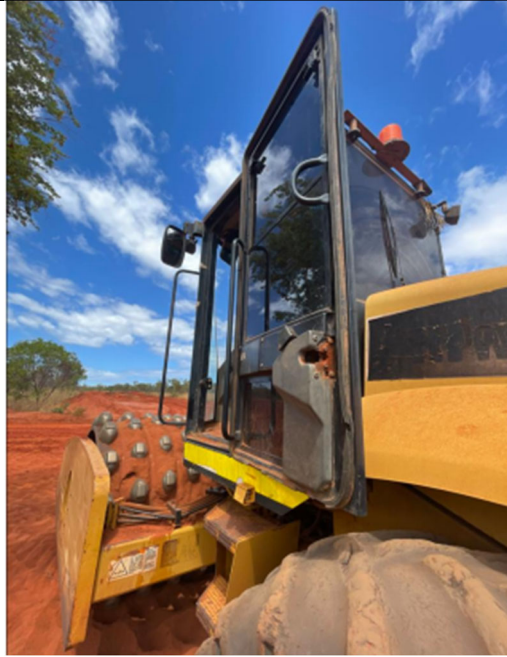
On Wednesday the 7th of September at 6:00am an operator of a padfoot roller had not signed onto a project SWMS however, conducted a Prestart check. The operator identified that the padfoot roller had no flashing beacon, mirror was broken, and the air conditioner was not working. Even though the plant had the identified issues it was deemed fit to be operated. Due to the aircon not working the operator decided to operate the Padfoot roller with the door open and with a donut cushion on the seat as the operator stated the seat was not comfortable.

Padfoot Roller with door open

- Review first aiders to ensure training is current.
- Develop flow chart of plant management process for when pre-starts are completed, and issues are identified and dealt with.
- Review project risk register
- Pre – start topic on safe work method statements

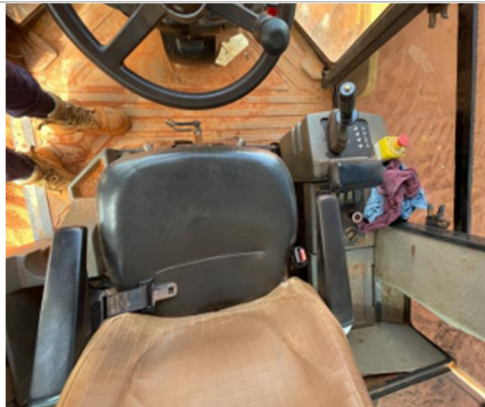
There are statements that suggested the worker was not wearing their seatbelt while operating the roller.

Seatbelt in the Padfoot Roller

- Ensure all workers have signed onto the SWMS
- If equipment is unsafe every operator has the right to stop task
- Always wear a seatbelt

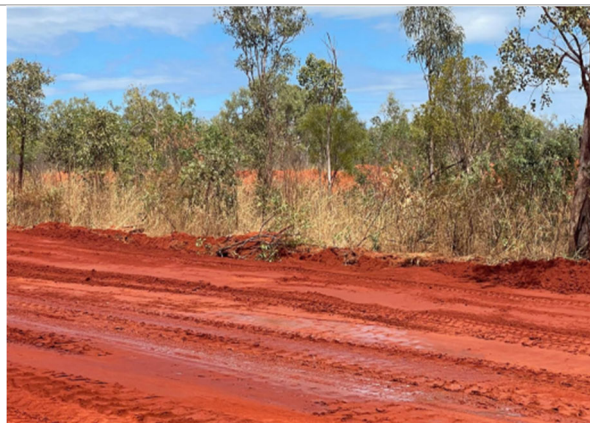
The operator then commenced work, at 7:25 am the padfoot roller operator was instructed to move off the work area and park up. At this time the padfoot roller was situated on a slight slope and started reversing along a tree line. While reversing the operator hit a bump causing them to fall out of the padfoot roller backwards onto the ground floor. The padfoot roller was still in gear and continued to roll, the operator had to quickly move their legs to avoid them being crushed. The operator then jumped up and climbed back into the padfoot roller whilst it was still in motion to successfully stop the roller.

Location of where the incident occurred
