# SHW Serious Incident (SI) – Final Notice

| <b>Incident Short Description:</b> | A concrete pipe has been released, rolled down a trailer ramp and come to rest on a windrow. |

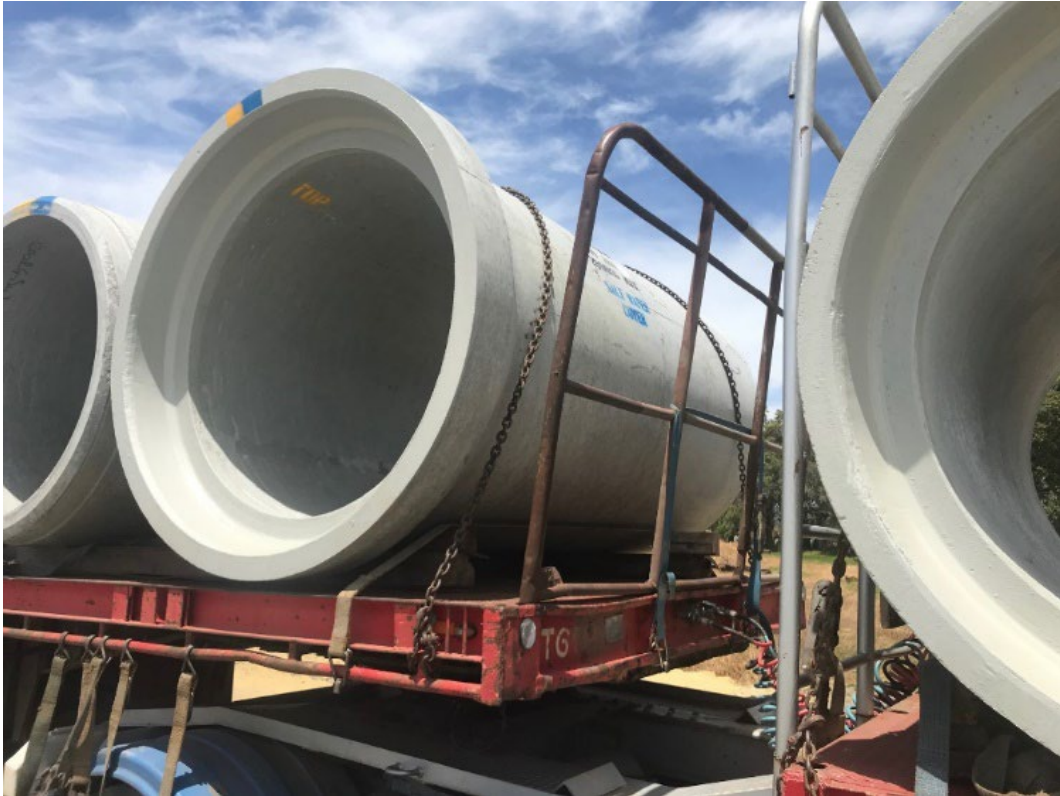
***Pipes loaded on the trailer***

- Safety Inspections not completed. Site Engineer began quality check of pipe prior to safety inspection
- Individual chocks are used when securing back pipe and not a solid bar/chock across trailer. Driver was experienced however had not previously transported pipes of this size. Chock missing at rear of trailer securing pipe 3 x separate inspections completed by Supplier workers did not identify inadequate chocks or issues that could arise during unloading

- Supplier to confirm contractors engaged to deliver materials are adequately trained as per the Load Restraint Guide 2018.
- Driver Checklist: to be provided to the supplier by the Senior Project Engineer. This checklist is to be supplied to the driver of the vehicle by the supplier. The driver is to provide this inspection upon arrival to site to the designated Inspection Supervisor.

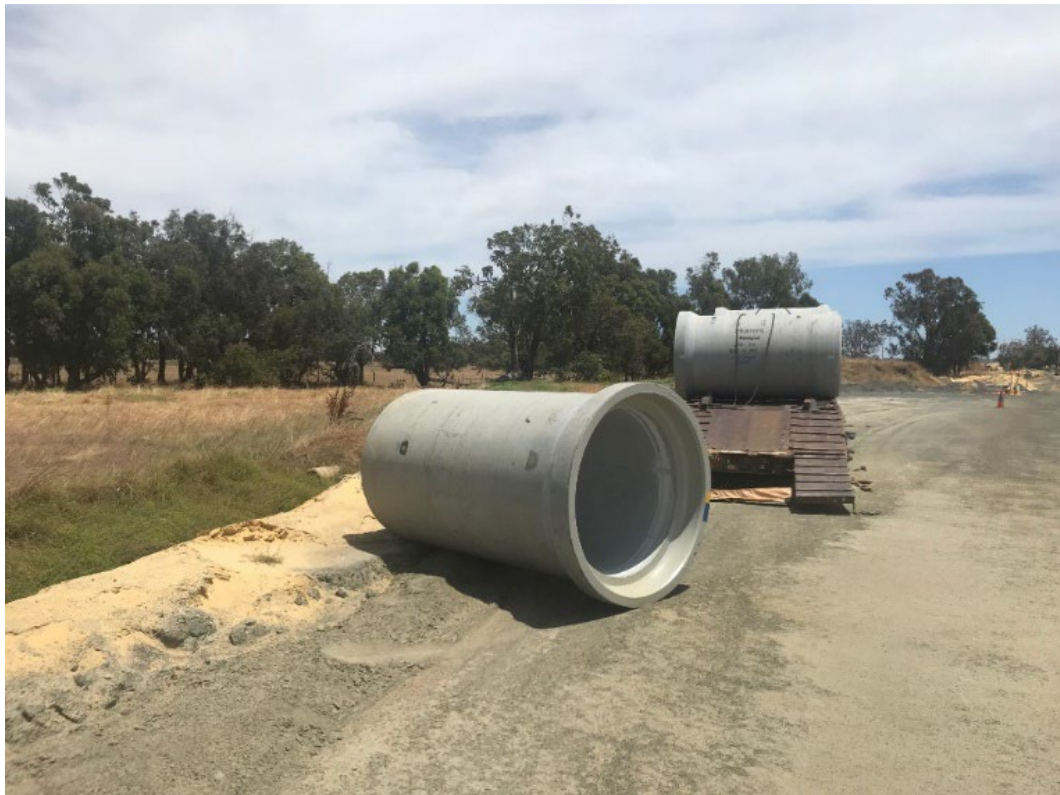
During the course of removing the restraints on the rear trailer the last pipe has moved from its position and rolled down the ramp to the rear of the trailer coming to rest on a windrow within the designated unloading area.

***Pipe came to rest against a windrow***
