# SHW Serious Incident (SI) – Final Notice

| <b>Incident Short Description:</b> | TC Supervisor walks in live traffic lane and later in shift removes centreline cones, under free-flowing two-way traffic |

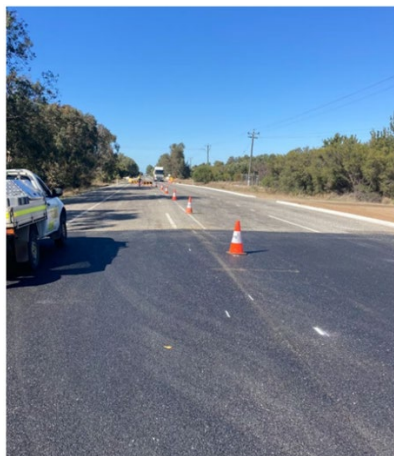
On the 27 April 2023 at approximately 10:00am after having given a Traffic Controller their scheduled break, the Traffic Management Team Leader proceeded to cross the live traffic lane over to the working lane without checking for oncoming traffic. The team leader only acknowledged there was traffic on approach when alerted by the Principal Contracting Supervisor, however proceeded to cross to the working lane in front of the approaching vehicles.

The Traffic Control Team Leader was removing the reflective delineators from the centreline, under reverse flow traffic management conditions with the portable traffic lights both on red. After realising the traffic lights had been on red for some time, the Team Leader contacted the traffic controllers, instructing them to release the traffic in both directions, without removing themselves from the centreline resulting in being exposed to live traffic with no escape route.

*Photo of road where both Near Miss incidents occurred*

| <ul style="list-style-type: none"> <li>• Failure by Traffic Management team leader to identify the line of fire hazard.</li> <li>• Procedure for the removal of the Traffic Guidance Scheme as per documented traffic management guidelines was not followed.</li> <li>• The Team Leader failed to consider their position on the centreline prior to sending traffic.</li> <li>• Principle Contractor relied on subcontractor to provide professional and experienced traffic management personnel to lead the traffic crew and did not confirm the subcontracting company had an adequate process in place for the selection of their team leaders.</li> </ul> | |

| <ul style="list-style-type: none"> <li>• Traffic management teams to review and understand the process for set up and removal of Traffic Guidance Schemes.</li> <li>• Ensure rules and regulations around Traffic Management are communicated.</li> <li>• Apply just culture model to the individual (as applicable).</li> <li>• Principal Contractor required to review and accept site leaders on the basis that the Subcontracting Traffic Management workgroup provides their process for the selection of Traffic Management Team Leaders, and/or the in-house training protocols.</li> </ul> | |
