# SHW Serious Incident (SI) – Final Notice

| <b>Incident Short Description:</b> | Surveyor on Foot Within 1.2m of Live Traffic |

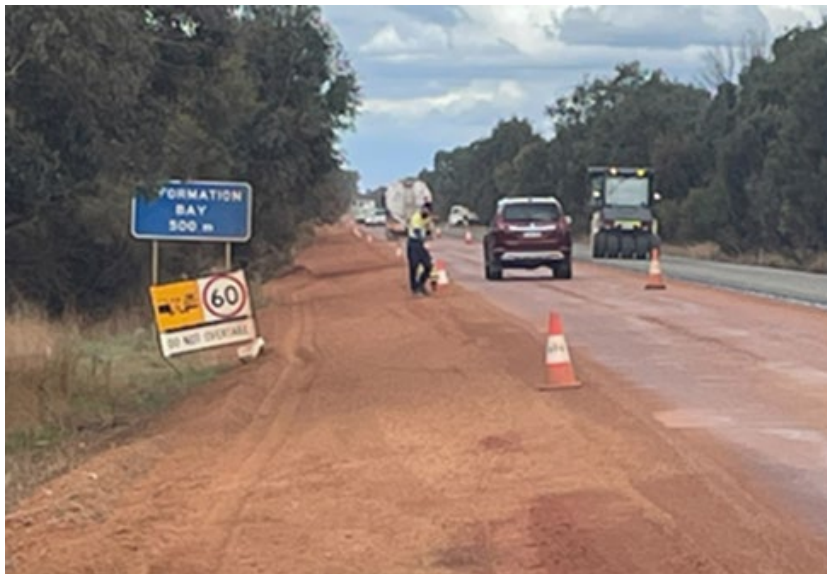
***Surveyor operating within 1.2m of traffic lane***

***(Note that this photo does not show the surveyor at the time he had his back to traffic)***

- The Principal Contractor failed to adequately complete supervisory inspections.
- The surveyor was not aware that the traffic management treatment in place was not intended for his specific task.

- The subcontracting Surveyor did not follow the controls as defined within the approved Safe Work Method Statement, failing to maintain radio communication within the worksite.

- All worksite activities must be identified for adequate planning of Responsible Supervisor(s) are to ensure compliance to the HSEQ inspection schedule, managing the new work fronts by ensuring adherence to the TGS requirements and approved Safe Work Method Statements.
- The Principal Contractor management workgroup are to ensure all site workgroups are aware of and understand the Traffic Management requirements on site.
