# SHW Serious Incident (SI) – Final Notice

| <b>Incident Short Description:</b> | Operator riding in Excavator bucket. |

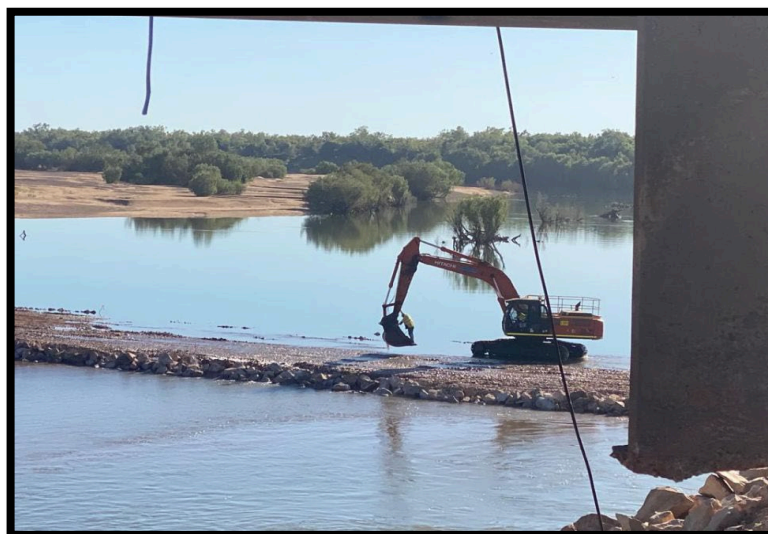
The dozer operator requested a ride back to the dozer in the excavator bucket to avoid getting wet boots.

An anonymous source took a photo of the dozer operator riding in the excavator bucket and sent it to the Project Manager.

| <ul style="list-style-type: none"> <li>• Operator didn't want to get his boots wet.</li> <li>• Excavator operator agreed to transport the dozer operator.</li> <li>• Both plant operators acknowledged they understood this practice should not be performed.</li> </ul> | |

| <ul style="list-style-type: none"> <li>• The Site Supervisor spoke to the operators and the operators' employer.</li> <li>• The Supervisor told all parties that a future safety breach will lead to instant dismissal.</li> <li>• Notify contractor immediately and discuss the violation to prevent reoccurrence. Implement (documented) disciplinary action with both Operators.</li> <li>• Communicate the potential dangers associated with riding on mobile plant at the Pre-Start Meeting.</li> </ul> <p>This serious potential incident aligns with the Main Roads Critical Risk profile relating to: <b>Mobile Plant</b></p> | |
