# SHW Serious Incident (SI) – Final Notice

| <b>Incident Short Description:</b> | Operator lacerates leg when exiting grader, resulting in LTI |

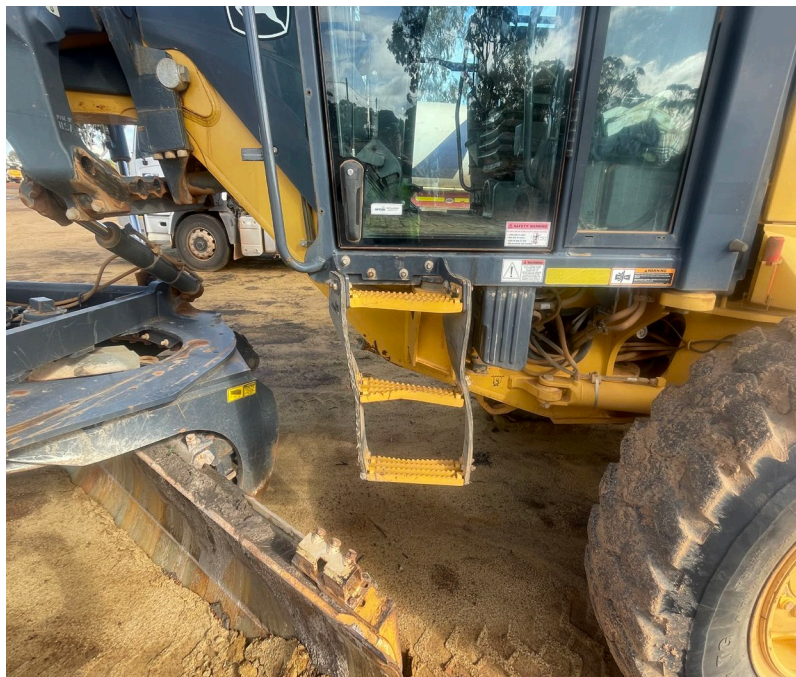
***Damaged steps which the operator was attempting to scale***

| Contributing Factors: | |
|---|---|
| <ul style="list-style-type: none"><li>• No prestart book available in plant for the operator to report defects.</li><li>• Operator assumed it was safer to access the ladder from the grader blade rather than the ground due to muddy conditions from recent heavy rain events.</li><li>• Not taking the condition of steps and weather into consideration when climbing hastily into grader.</li><li>• Rain had made handrails and steps wet and slippery.</li><li>• Damage to steps on both sides of grader.</li><li>• No maintenance records were available for the grader.</li><li>• No site inspections completed to ensure plant prestarts were being conducted.</li></ul> | |

| Contributing Factors: | |
|---|---|
| <ul style="list-style-type: none"><li>• Steps on the grader were replaced.</li><li>• Risk assessments were conducted on all contractor owned plant.</li><li>• Incident communicated across contractors organisation.</li><li>• Plant prestart books were sourced.</li></ul> | |
