# SHW Serious Incident (SI) – Final Notice

| <b>Incident Short Description:</b> | MOP collides with stationary Traffic Control utility, injuring Traffic Controller. |

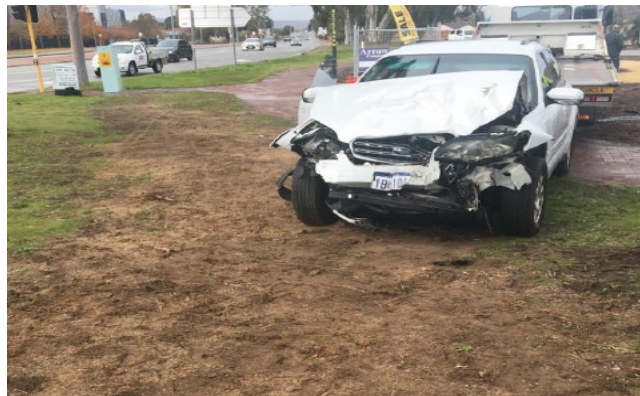
***Member of Public Vehicle***

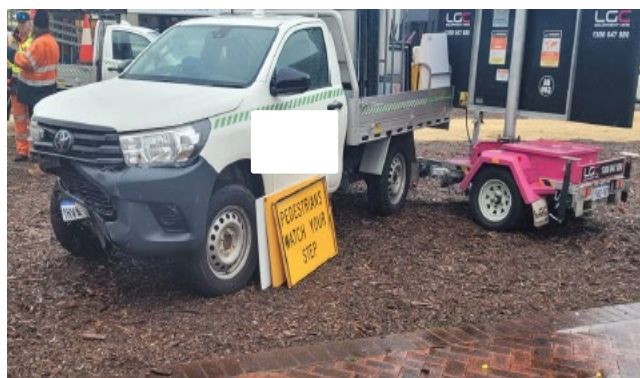
***Traffic Management utility***
