# SHW Serious Incident (SI) – Final Notice

| <b>Incident Short Description</b> | Three-point turn conducted across carriageway in maintenance truck |

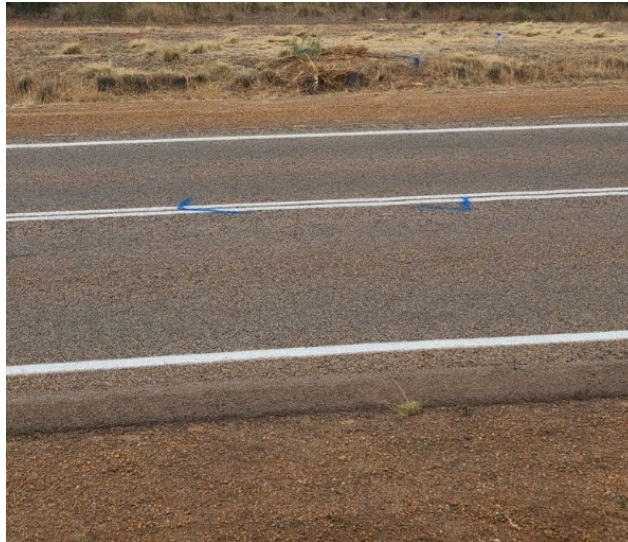
The westbound passing truck (double – Cat 5) had to steer across the double white lines and into the opposite (East bound) lane to navigate past the maintenance truck.

***Marks on the shoulder shows where the maintenance truck's front wheels were after the first turn across the carriageway, and the centre line where the end of the truck was situated as the Cat- 5 double was passing.***

- Failure to follow safe driving rules.
- No direct supervision of the work group on the day, and this is not unusual given the size of the network, mobility of works and the management resources available.
- Failure to assess the risk of completing the "U" turn or stopping on a highway with heavy vehicles approaching and a limited line of site.

- Reset behavioural expectations at all levels of the organisation.
- Leaders Induction (all frontline Leaders & Managers) to set expectations and provide guidance on positive interactions.
- Increase of Management presence on Network to influence compliance / safety culture.

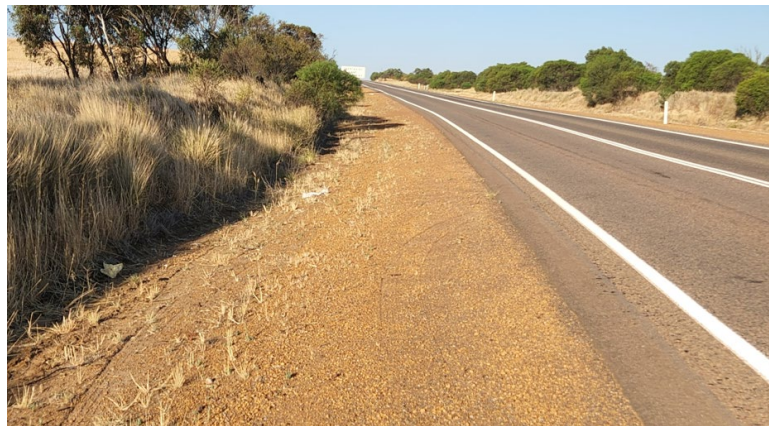
***Eastbound line of sight***

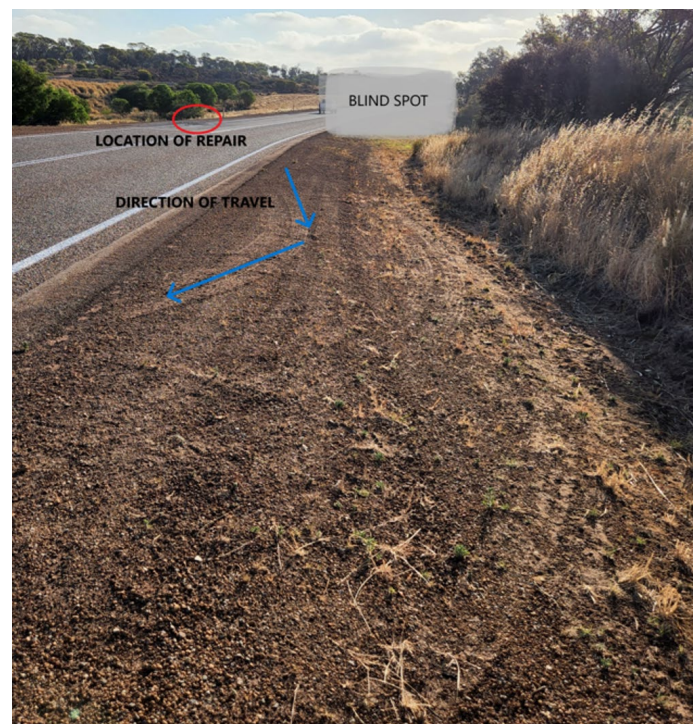
***Westbound line of sight***
