## SHW Serious Incident (SI) – Final Notice

| <b>Region / Directorate:</b> | Goldfields Esperance | <b>Main Roads or Contractor:</b> | Contractor |

| <b>Incident Short Description:</b> | Traffic Management Breach - Lab (core) Tester working within 1.2m of live traffic travelling 110km/h |

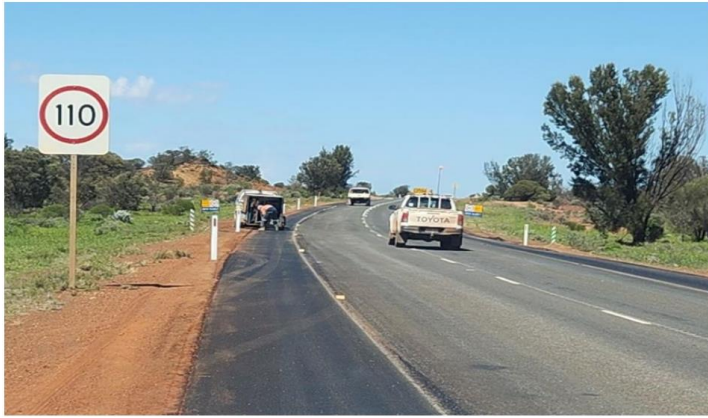
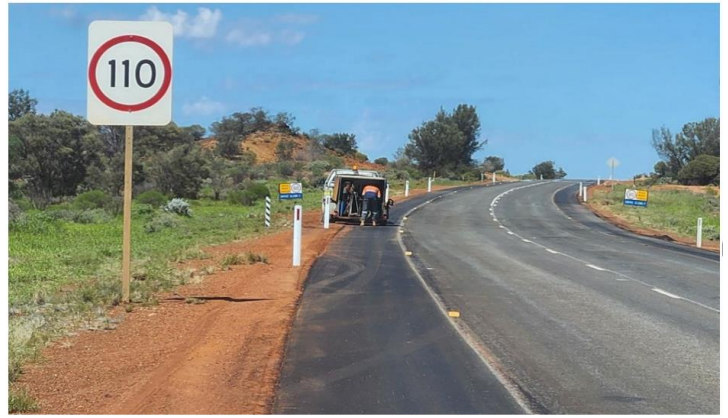
- The speed reduction signs for the core testing failed to be set up in accordance with the approved TGS of the traffic management plan. The traffic controllers provided a shadow vehicle instead of setting up the speed reduction signs required for works to being undertaken within 1.2 metres of live traffic.

***Worker standing behind vehicle undertaking core testing without traffic controller shadow vehicle or spotter***

- Supervision was deficient, due to scheduled departure times of the site supervisor and project engineer prior to the holiday break.
- The traffic controllers provided a shadow vehicle instead of setting up the speed reduction signs required for works to be undertaken within 1.2 of live traffic traveling at a speed of 110km per hour in accordance with the approved TGS-3 of the traffic management plan.

- The roster and the start and finish times are to be reviewed and amended to ensure workers are not under any perceived time pressures on last day of swing.
- The roster and the start and finish times are to be reviewed and amended to ensure adequate supervision and management of people and works.
- The correct TGS designed for testing activities must be implemented prior to commencing work.
- The SWMS are to be current, acknowledged by workers, and reviewed according to set procedures.
