# SHW Serious Incident (SI) – Final Notice

| <b>Incident Short Description</b> | Traffic Controllers and work vehicles within 1.2m of live traffic lane. |

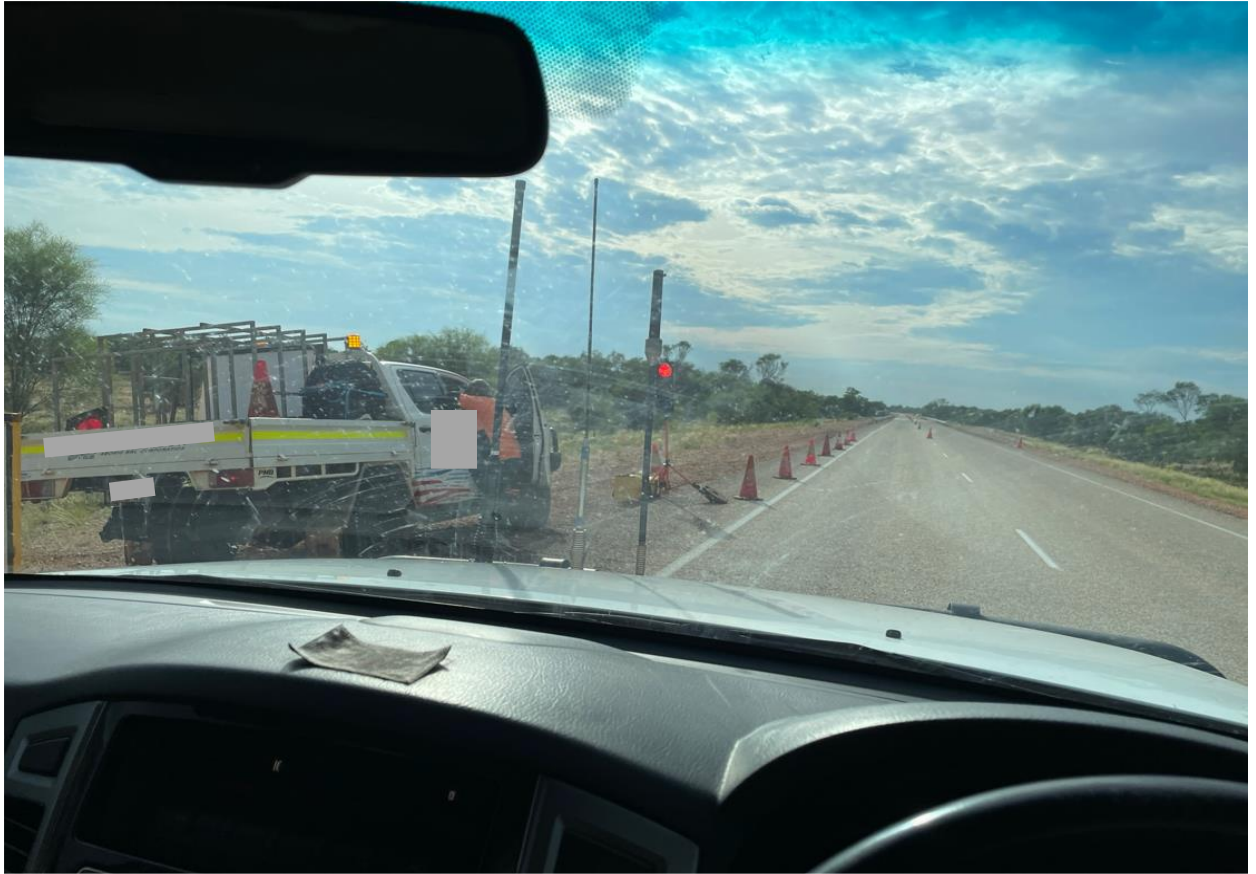
A Traffic Controller was observed setting up a chair next to the traffic signals without a clear escape route, or adequate distance from the risk zone of passing vehicles.

*Traffic Controller too close to the road with no escape route.*

- Traffic Controllers were not fully aware of the hazards, and how to implement effective controls as specified in the Safe Work Method Statement (SWMS).
- Traffic control set up was not verified correctly.
- There is no evidence of ongoing training and support by the service provider for the Traffic Controllers.

- Site Supervisors are to verify Work Instructions / Procedures are implemented by traffic control teams before work commences.
- Site Supervisors to verify traffic controls are in place and workers/vehicles are not in any danger zones.
- Site specific Traffic Management SWMS to be reviewed and updated by the traffic management teams (including the crews).
- Onsite training and supervision to be implemented through observations, inspections, communication, and consultation.

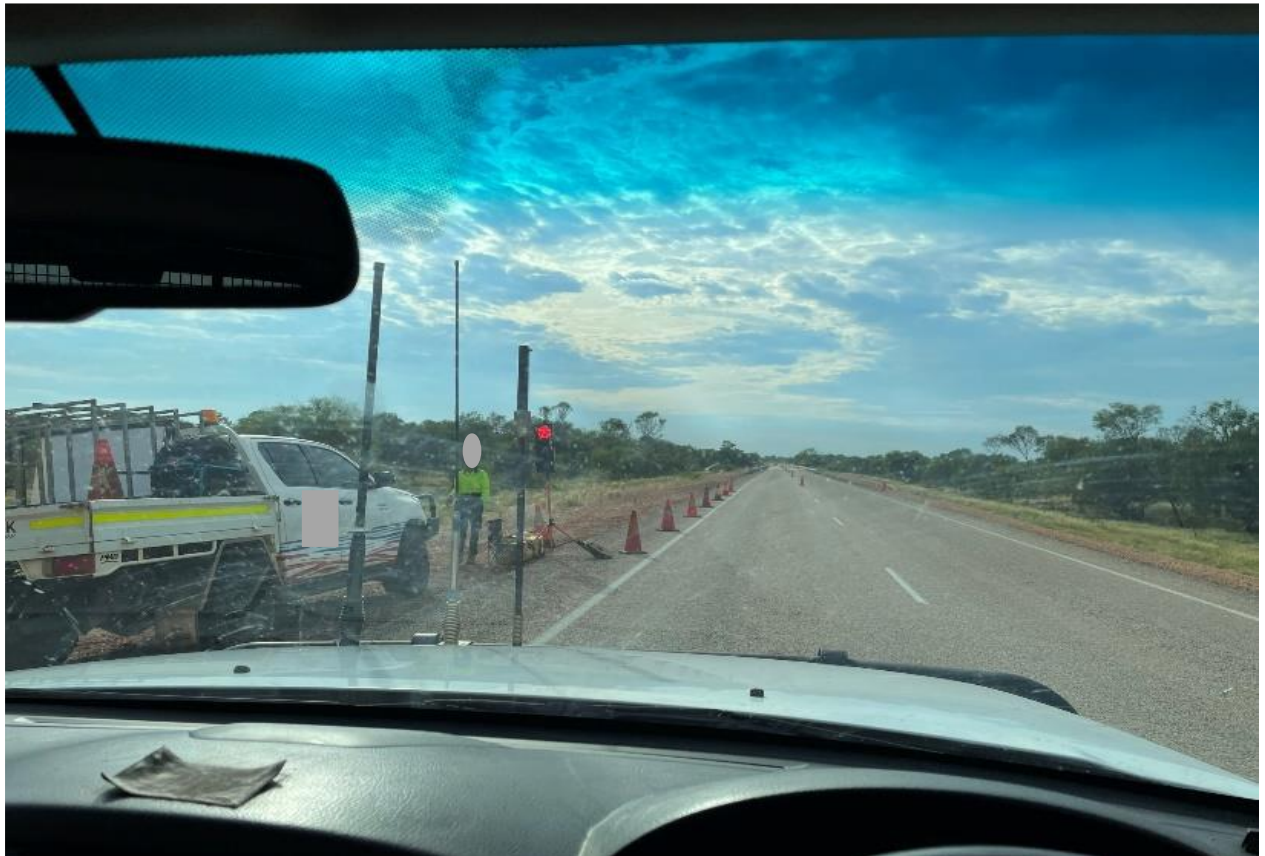
The worker has observed that the Traffic Controllers and their work vehicles were within 1.2m of the live traffic lane.

*Traffic Stop set up too close to the road.*
