# SHW Serious Incident (SI) – Final Notice

| <b>Incident Short Description</b> | Laceration from Quick Cut Saw |

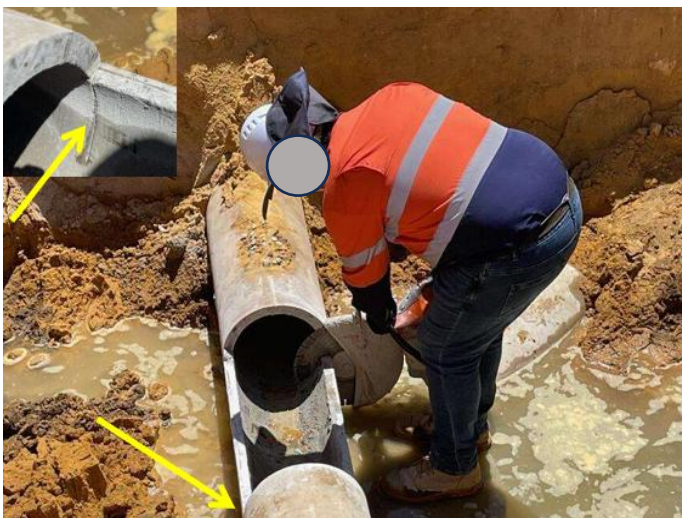
*Recreation of cutting method with arrows showing exact position of cut that caused kick back*

- The workpiece being cut was not adequately supported resulting in pipe sagging and pinching the quick cut blade causing kickback.
- The Quick Cut saw being used was not equipped with an anti-kickback blade brake.

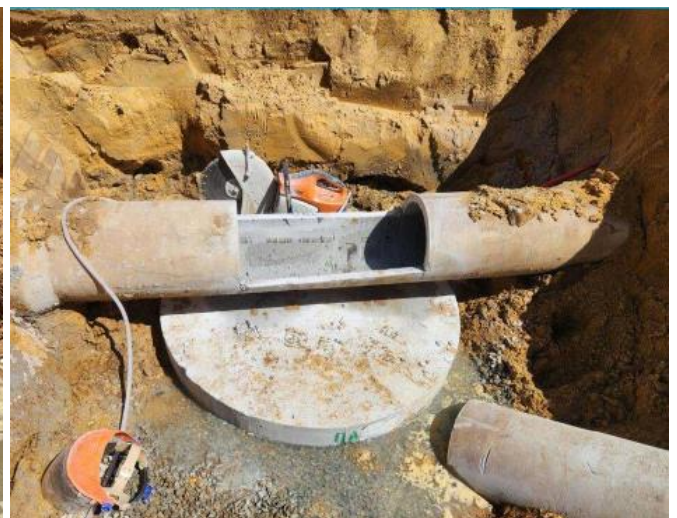
*Excavation and Pipe Setup*
