# SHW Serious Incident (SI) – Final Notice

| <b>Incident Short Description</b> | Worker Experiences pain in arm while disconnecting hydraulic hose |

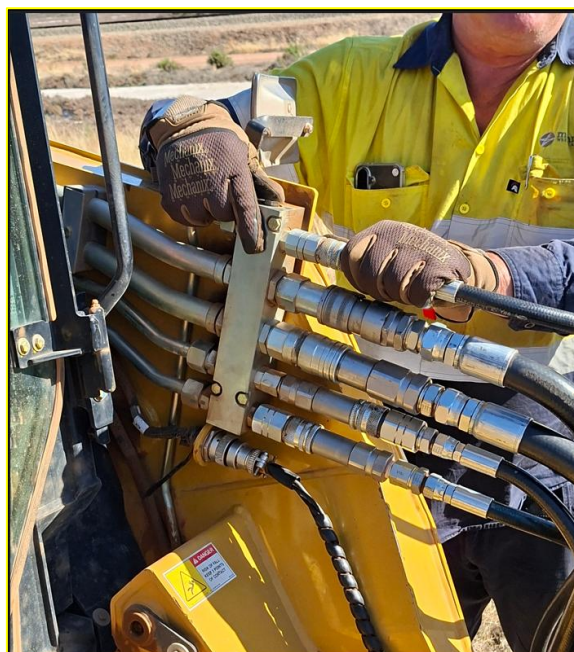
When the IP had completed cleaning the area, they approached the skidsteer, where they grasped the hydraulic block connection with their left hand (while wearing gloves). As this occurred, the IP reported feeling a sensation, which they stated resembled that of an electric shock, move through their arm. The IP released their grip on the connection block.

*Re-enactment photo of the position of the IP's hands*

- The Auto-electrician's report confirms that there was no transient voltage leak through any part of the body earth system back from EMF or other source.
- Based on the information provided in the auto-electricians report and research conducted, it is assumed that the "shock" sensation was potentially that of a static build up because of the flow of hydraulic fluid. Alternatively, it may have also been felt because of nerve or ligament strain.
- The IP was wearing their gloves at the time of the incident.
- No previous incidents of "electric shock" sensations had been reported.
- The skid steer and mill undergo a regular maintenance program.
- There were no underground services in the area.

- Skid steer and Mill were tested by an Auto-electrician to determine if an electrical leakage existed.

- Ensure that all plant and equipment undergo a maintenance program in accordance with manufacturers specifications.
