# SHW Serious Incident (SI) – Final Notice

| <b>Incident Short Description</b> | Worker crossed the live lane onsite |

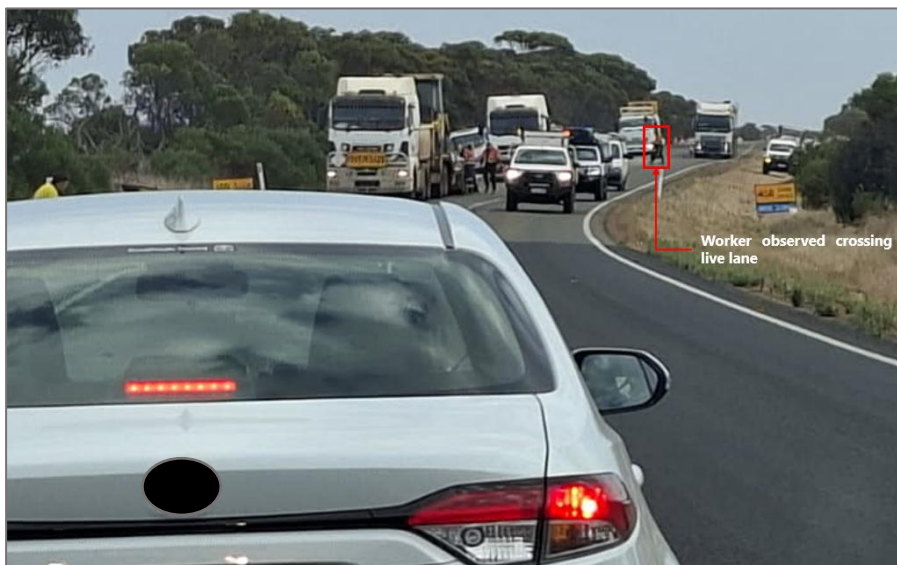
On 9 March 2026, a worker was observed crossing the road in the live lane between traffic that was being escorted through site by the 'follow me' vehicle. The posted speed was 60 km/h, with the queued traffic moving at 40 km/h. The worker failed to contact traffic control and did not have a spotter when crossing in front of a single truck, which did not appear to have needed to brake or slow its speed. The worker crossed into the area where plant was operating within the traffic setup.

*Photo of worker crossing live lane*

- A spotter was not used and traffic control was not notified before the worker crossed the live lane.
- Worksite planning and layout were insufficient, resulting in congestion and limited parking for work vehicles.
- The hazard of worksite congestion was not adequately identified or managed during site set up.
- Congestion from multiple vehicles, combined with steep and wet shoulders, limited suitable parking options and led to the worker parking across the road.
- The hazard of workers crossing live lanes during medium and high impact works or congested worksites was not fully assessed or mitigated in the Project Risk Assessment.
- The SWMSs did not adequately address workers crossing the road.

- Ensure spotters are utilised when workers are required to cross roads and in high risk or congested worksite situations.
- Improve site planning and layout by providing adequate space for vehicles, plant and pedestrian movement, and by considering worksite congestion and environmental constraints (e.g., steep or wet shoulders). Extend worksite areas where required.

- Strengthen risk management by reviewing and updating the Project Risk Assessment to address workers crossing live lanes, worksite congestion in medium to high traffic areas, site layout, environmental conditions, and vehicle–pedestrian interactions. Ensure Contractor and Sub-Contractor SWMSs adequately address these risks.
