## RED BANNER ALERT

## SHW Serious Incident (SI) – Preliminary Notice

| <b>Incident Short Description</b> | Three-point turn conducted across carriageway in maintenance truck |

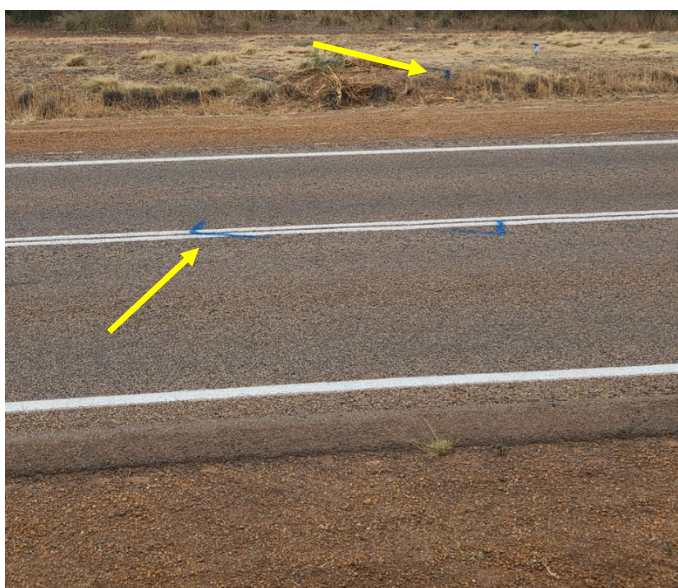
**Marks on the shoulder shows where the maintenance truck's front wheels were after the first turn across the carriageway, and the centre line where the end of the truck was situated as the Cat- 5 double was passing.**
