**RED BANNER ALERT**

**mainroads**  
WESTERN AUSTRALIA**SHW Serious Incident (SI) – Preliminary Notice**

| <b>Incident Short Description</b> | Leaf Spring Dislodges from trailer & injures Member of Public. |

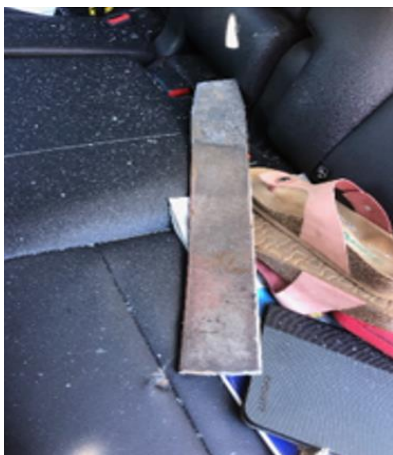
During the journey, a leaf spring from the prime mover trailer has broken and dislodged from the trailer.

**Section of Leaf spring**

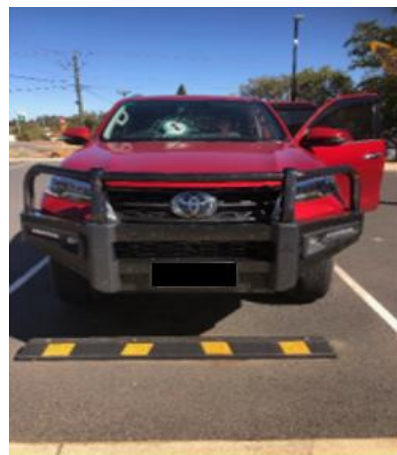
The section of leaf spring (approx. 600mm) has become a projectile and has speared through the windscreen of the member of public's vehicle. The piece of leaf spring has struck the passenger of the vehicle on the head, resulting in a laceration. The section of leaf spring has then come to rest on the back seat of the vehicle.

**Damage to Member of Public's windscreen**
