# ID CONDITION REPORT

## ATLANTIC GENEVA

IMO 9330848

Date of inspection:  
**March 07 2026**

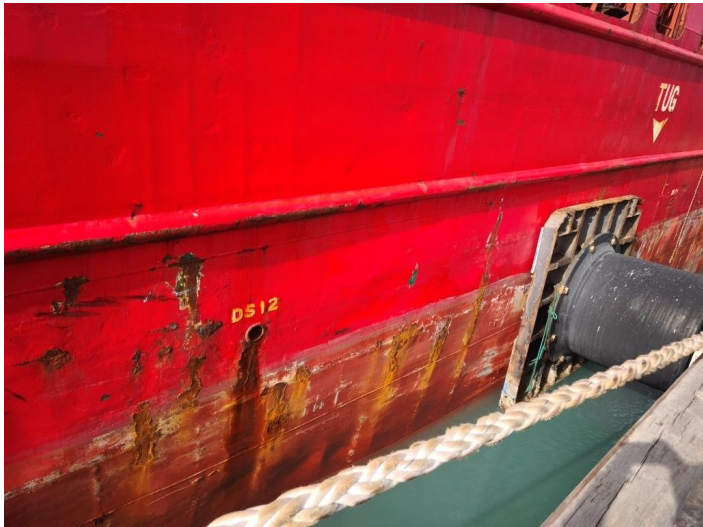
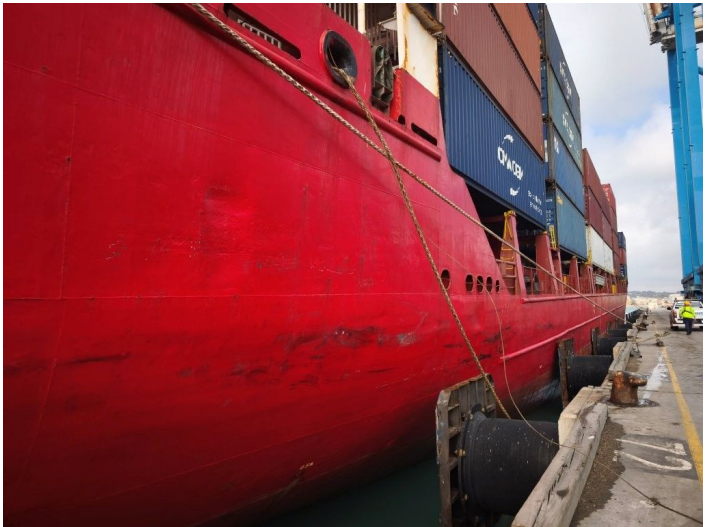
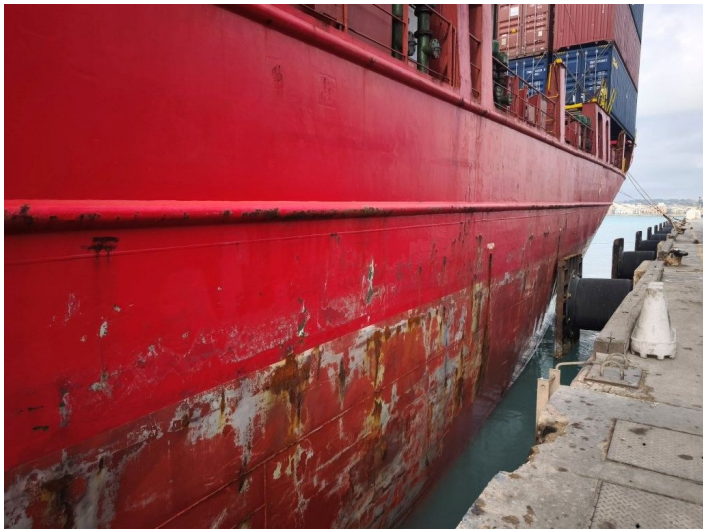
The hull was seen to be in fair overall condition, as inspected from the starboard side, and although the vessel was free of major structural defects there were , minor indentations and rib caging noted on the aft shell plate and boot top. Moderate scattered scaling, surface and spot corrosion covered approximately 15% of the surface area, with isolated areas of corrosion and detachment were present on the boot top and top sides, with more developed areas of moderate scattered corrosion and detachment on the antifouling. Hull markings were considered to be illegible with staining and detachment obscuring these. No marine fouling was observed. Fenders fitted to the hull were found in good overall condition. Annual surveys were last carried out on the 17th July 2025 at Malta, which included an underwater bottom survey, with the next docking and renewal surveys due by the 14th May 2027.

| Priority | Description | Recommendations |
|---|---|---|
| | <p>Defect ID: 1-598-132-225</p> <p>Minor indentations and rib caging were noted on the aft shell plate, with isolated areas of corrosion and detachment on the boot top and top sides. More developed areas of moderate scattered corrosion and detachment were noted on the antifouling.</p> | <p>It is recommended to internally inspect the areas of indentation to ensure that there is no coating cracking or deterioration. The hull corrosion should be touched up in the worst affected areas to reduce diminution.</p> |

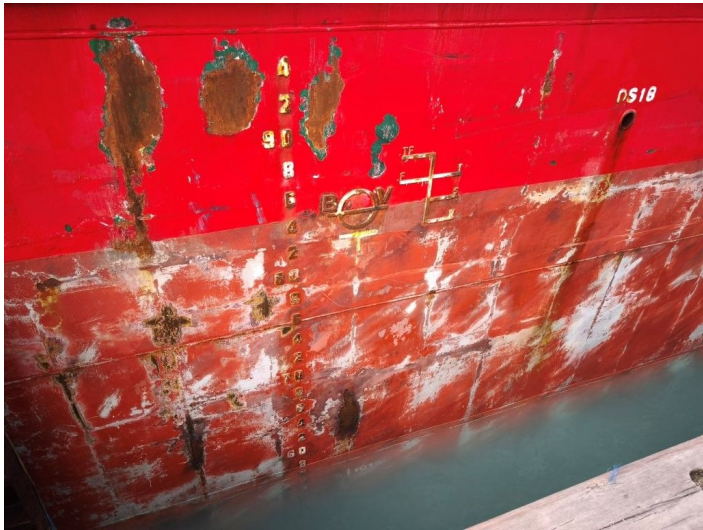
Defect ID: 2-034-376-708  
Draft and load line markings were partially illegible, obscured by corrosion and staining.

The draft and load lines should be touched up at the earliest opportunity to ensure legibility.

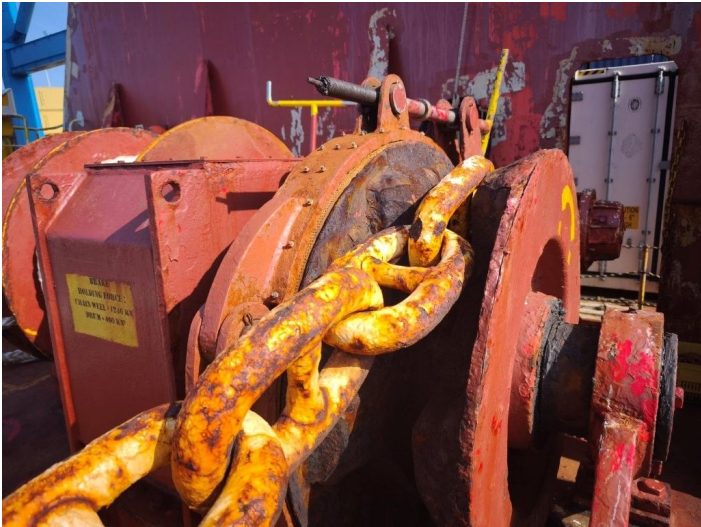
| Priority | Description | Recommendations |
|---|---|---|
| | <p>Defect ID: 1-598-283-781</p> <p>Age related pitting was evident on the mooring winches and windlasses with developing corrosion noted on the brake band assemblies and foundations. The Windlass gypsy wheels were noted with moderate diminution and corrosion.</p> | <p>It is recommended to carry out cosmetic maintenance to address the corrosion although the diminution on the gypsy wheels may need to be built up during the next repair period.</p> |

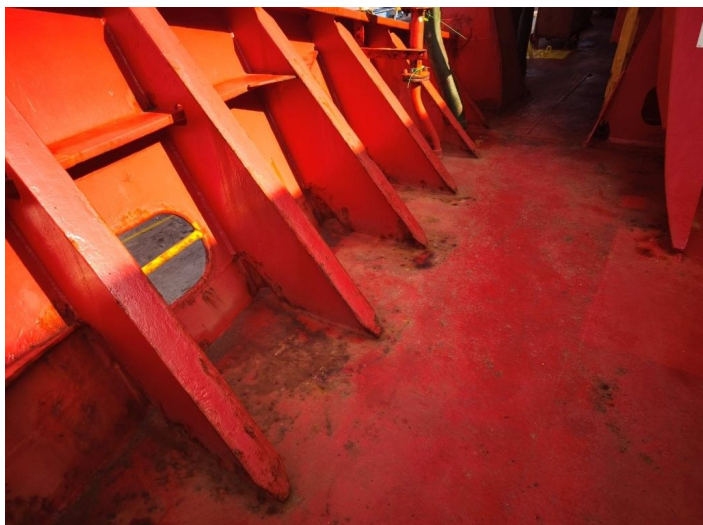
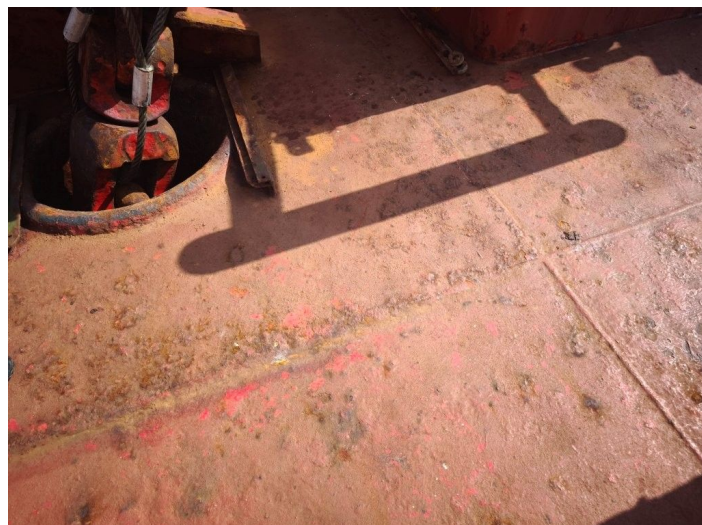
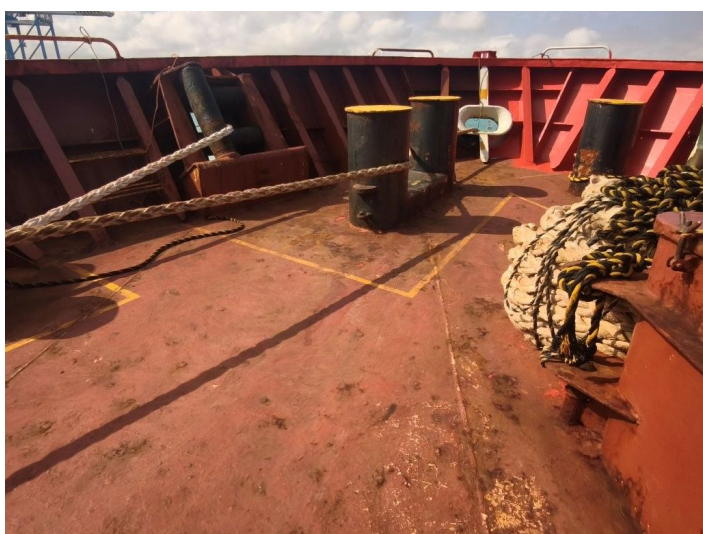
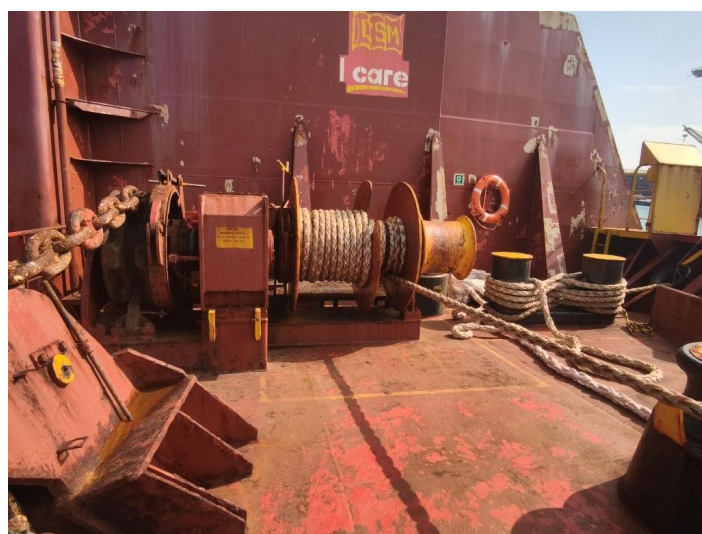
| Priority | Description | Recommendations |
|---|---|---|
| | <p>Defect ID: 1-598-160-899</p> <p>Blistering and corrosion was noted on the mooring deck plate and welding seams, including near the bulwarks and mooring machinery.</p> | <p>It is advisable to de-scale, prime and re-coat the forward and aft decks at the next opportunity.</p> |

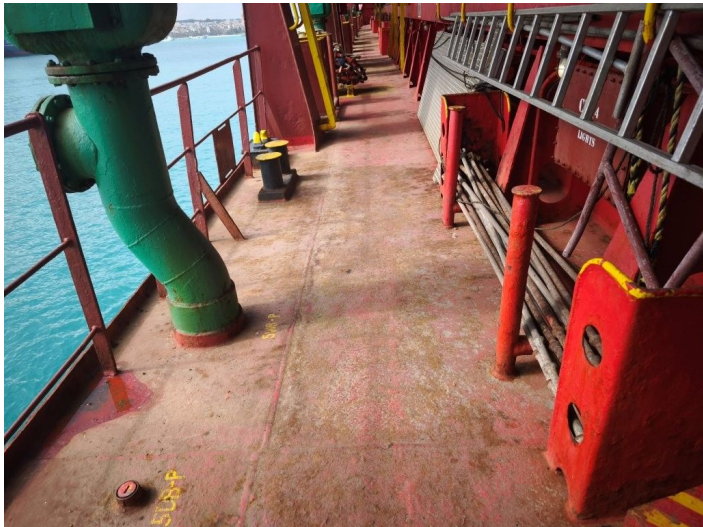
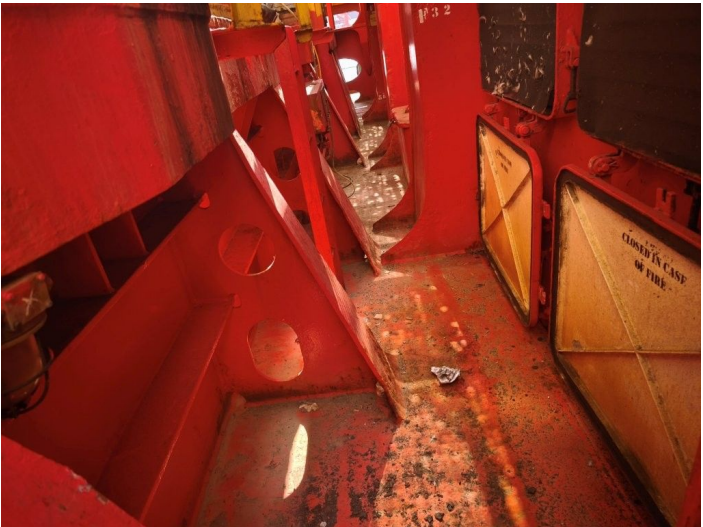
| Priority | Description | Recommendations |
|---|---|---|
| | <p>Defect ID: 2-034-348-034</p> <p>The main deck was noted with moderate with corrosion breakthrough on the main deck and cross deck walkways with historic pitting evident.</p> | <p>Areas of Coating Breakdown and Corrosion should be addressed when possible.</p> |

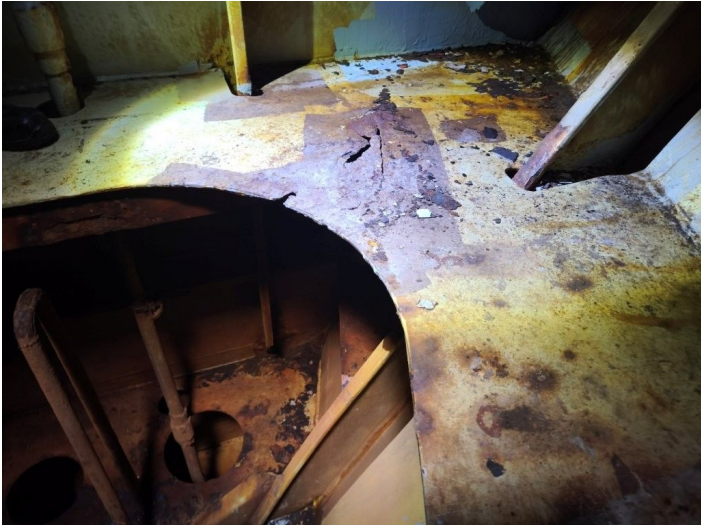
| Priority | Description | Recommendations |
|---|---|---|
| | <p>Defect ID: 1-598-074-886</p> <p>The Fore Peak Tank first stringer was noted to have a crack, with wastage and diminution noted on the plate edges.</p> | <p>The area of damage should be reported to Class if not done so already and promptly and thoroughly repaired to Class satisfaction if required at the earliest opportunity.</p> |

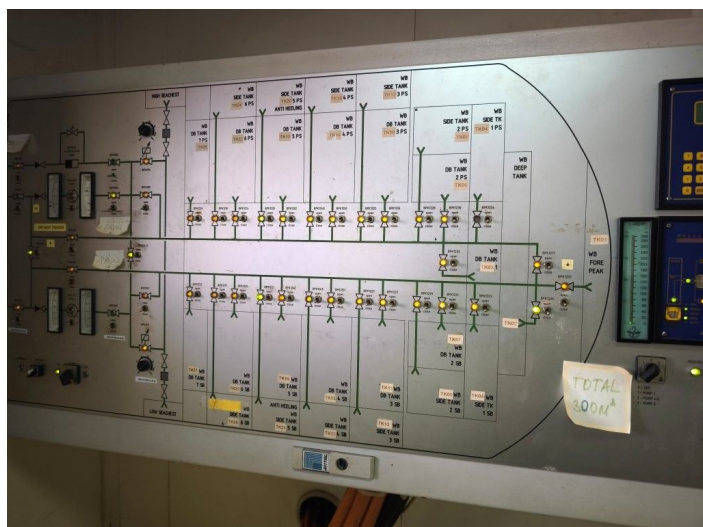
| Priority | Description | Recommendations |
|---|---|---|
| | <p>Defect ID: 1-598-222-345</p> <p>The Ballast Tank remote gauging system was reported to provide erratic readings which were described as inaccurate and unreliable based on the vessel own inspection reports.</p> | <p>It is recommended to investigate and resolve the remote gauging system in order to rectify the inaccuracies.</p> |

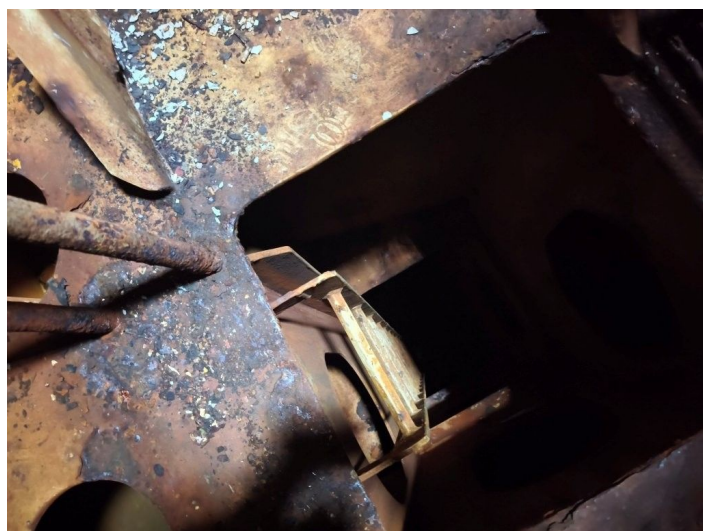
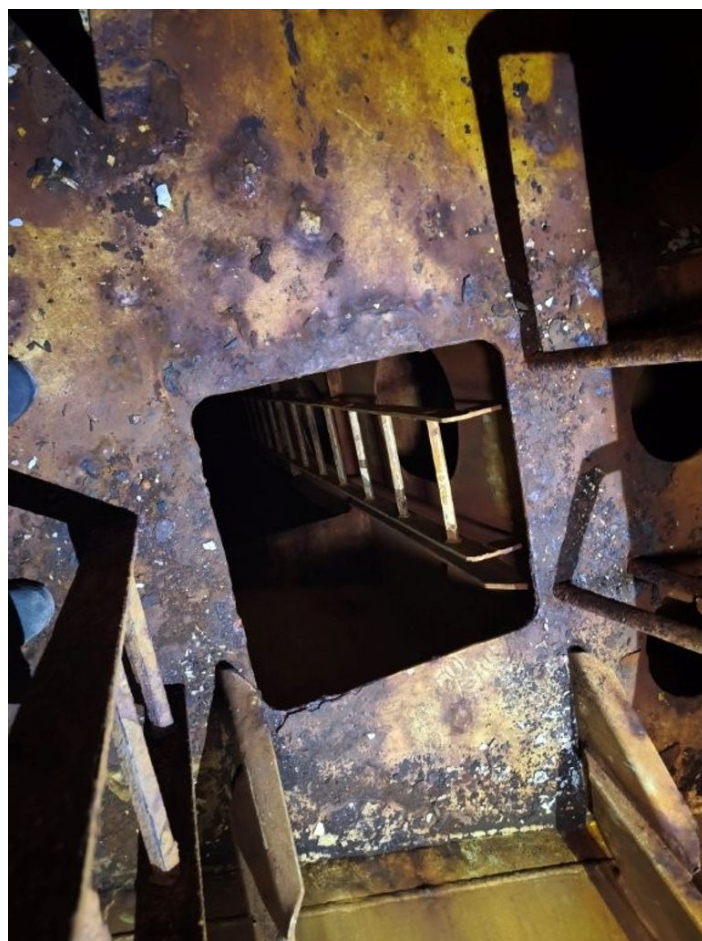
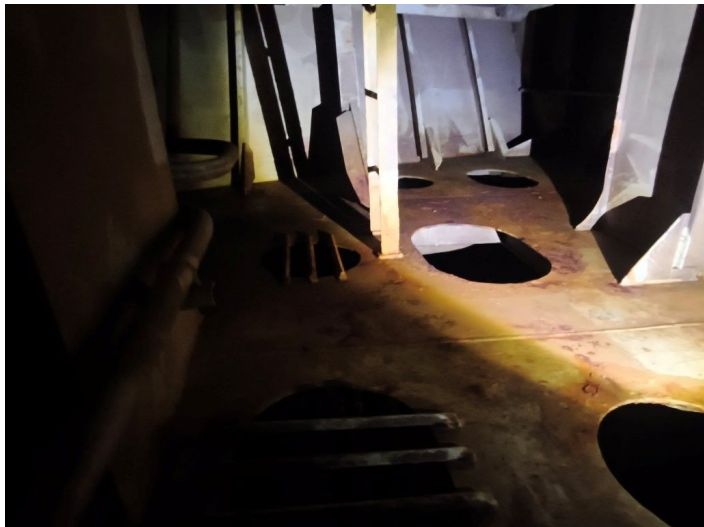
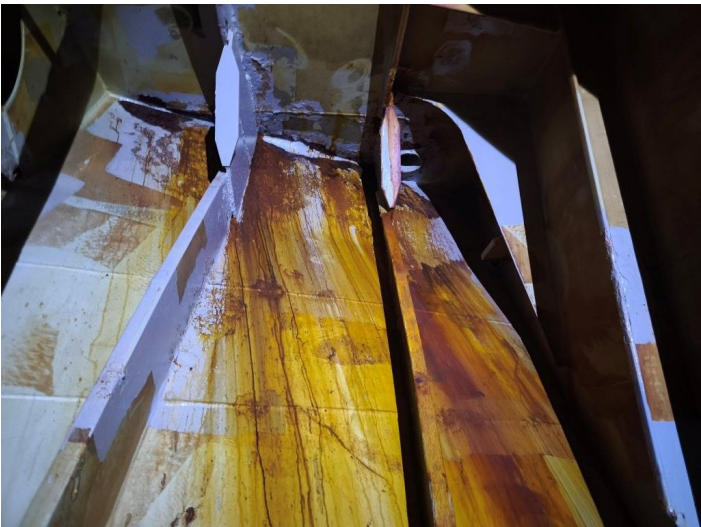
**Defect ID: 1-598-255-111**

Ballast tank corrosion was most prevalent on the first stringer floor plating, with corrosion breakthrough noted on the underside plate areas, frame face plates, welding seams and stiffeners. Moderate corrosion was noted in the Fore peak particularly on the upper shell plate welding seams were noted with moderate corrosion and although this had been coated recently, staining was evident.

The areas of corrosion should be de-scaled, primed and re-coated to avoid further deterioration.

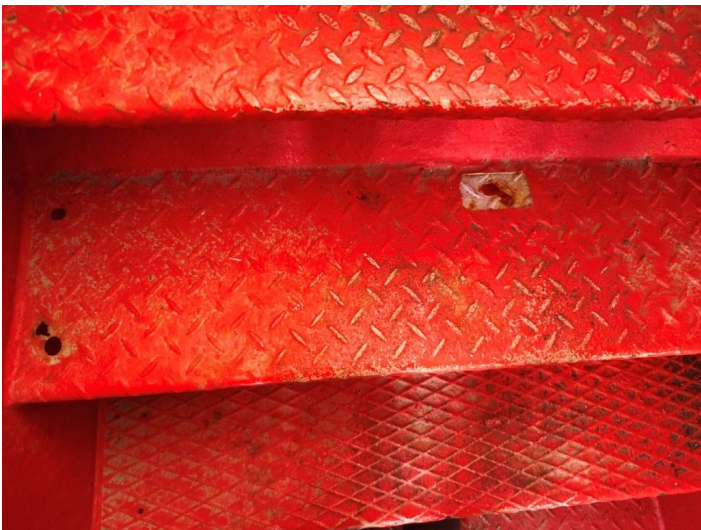
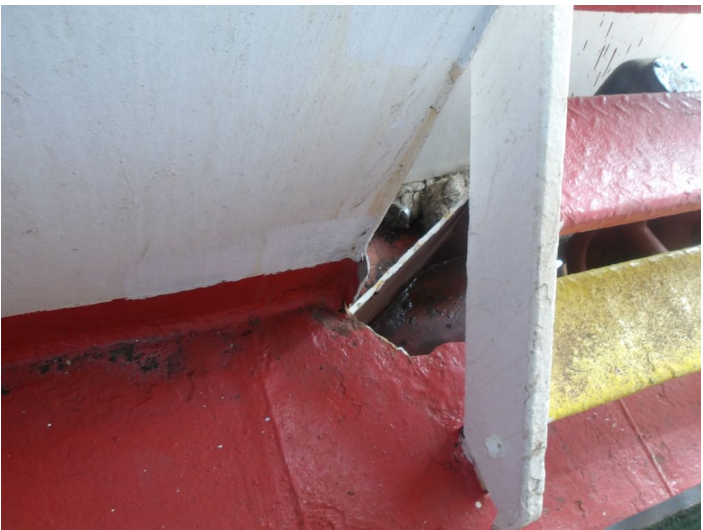
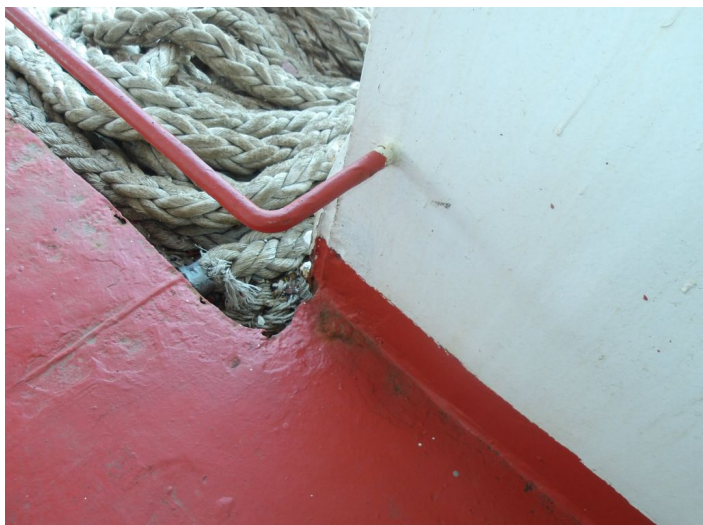
| Priority | Description | Recommendations |
|---|---|---|
| | <p>Defect ID: 3-628-232-704</p> <p>Steps and platforms were noted to be partially holed with diminution and wastage on the plate edges.</p> | <p>The affected steps should be replaced and the platform edges cropped and renewed when possible.</p> |

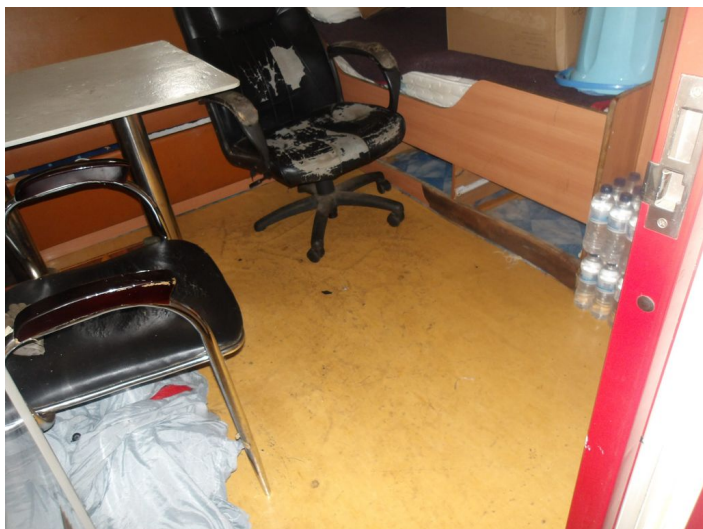
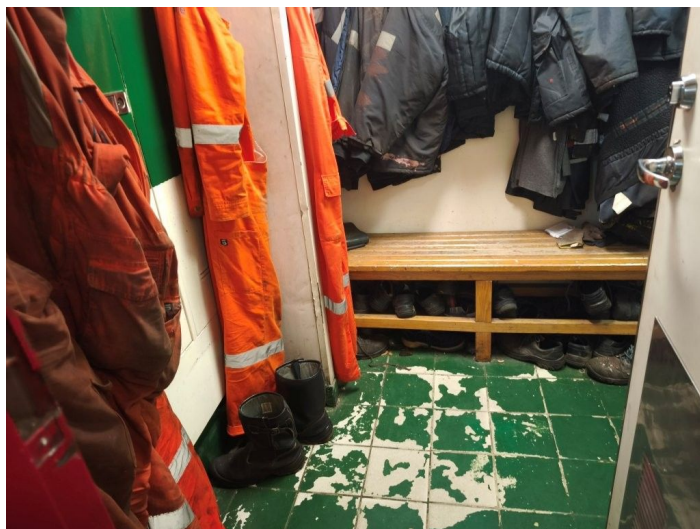
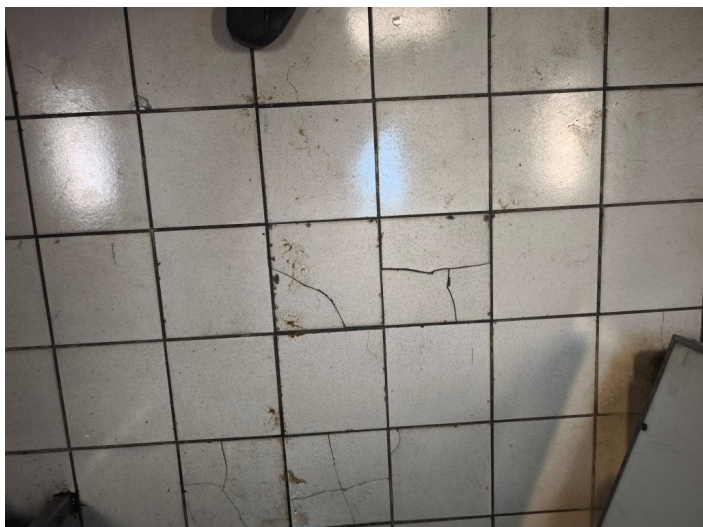
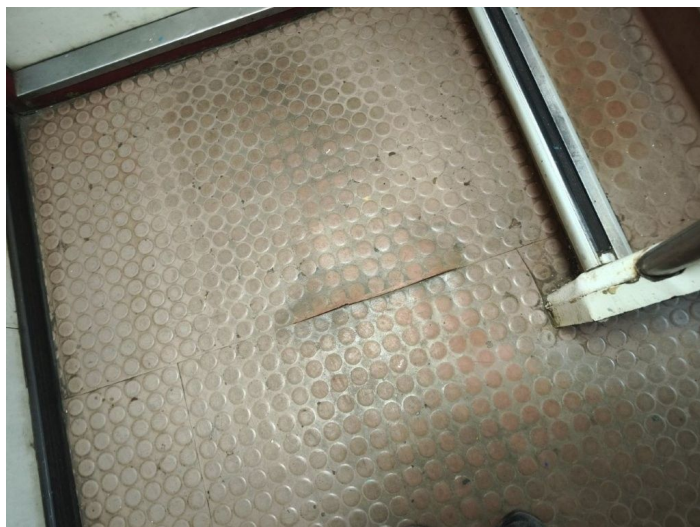
Defect ID: 1-598-066-698

Linoleum flooring in the accommodation was noted with damage, with chairs noted to have age-related deterioration, some of which had cracked covers, with floor tiles including in the galley were noted to be cracked.

It is recommended to replace the damaged linoleum and cracked galley floor tiles, and to re-cover or replace the damaged chairs.

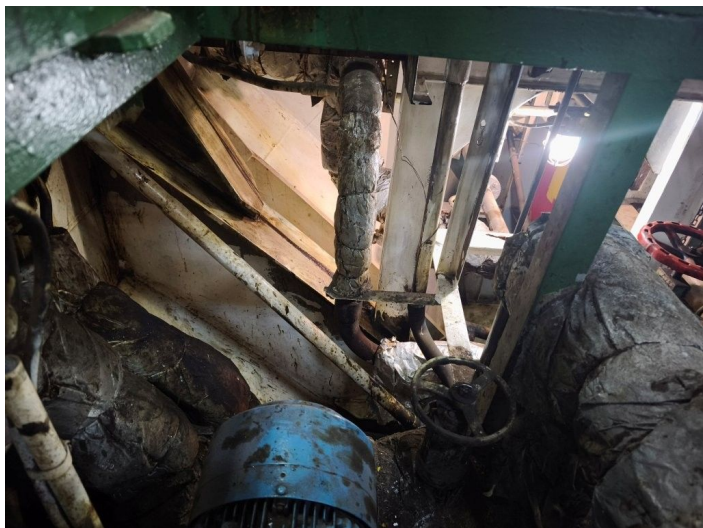
Defect ID: 1-598-242-829

The general cleanliness of the engine room had previously been noted by PSC, and while cleaning was evident, further bilge cleaning is recommended, with some laggings found damaged and partially stained.

Remedial housekeeping and cleaning should be carried out as soon as practical. The damaged, stained and partially detached laggings should also be replaced to avoid a repeat of the previous PSC deficiency.

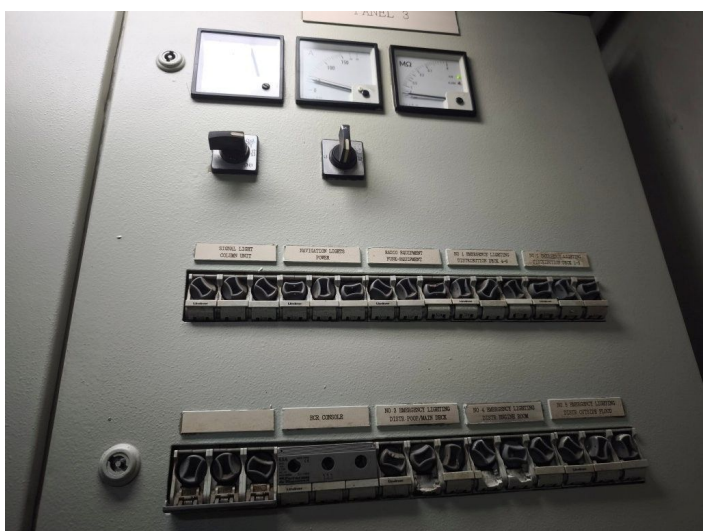
Defect ID: 2-034-368-521

The emergency switchboard breakers were partially damaged.

It is advisable to check options for replacement of the damaged emergency switchboard circuit breakers.

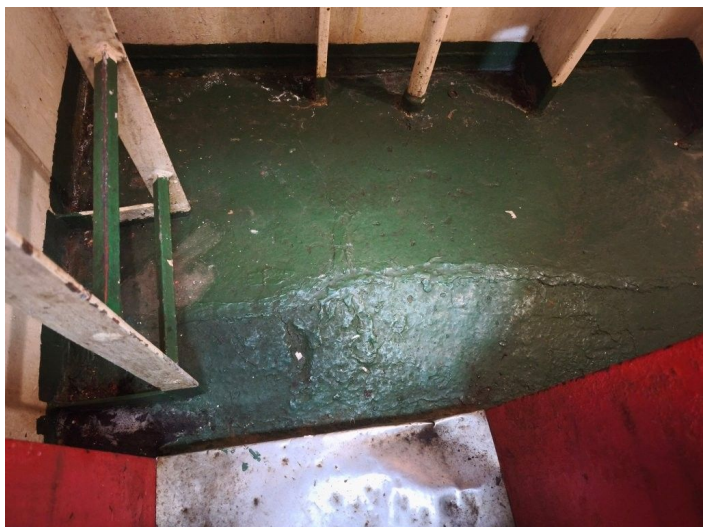
Defect ID: 2-034-409-482

The engine room emergency escape floor was noted to be deformed.

The affected floor plate should be cropped and renewed when possible.

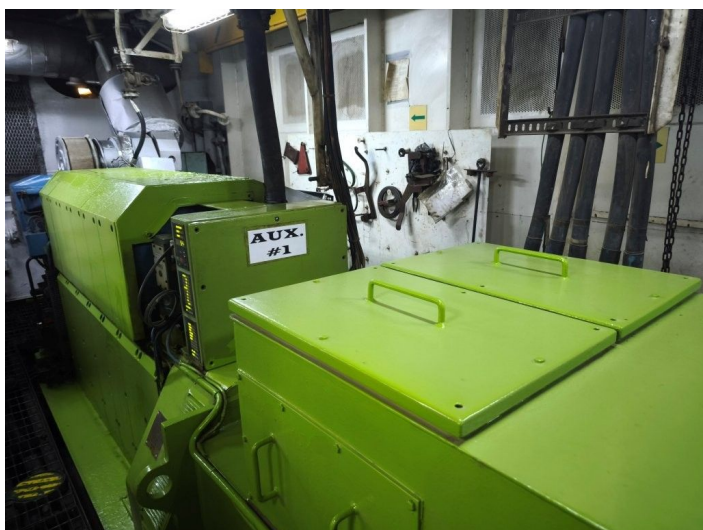
**Defect ID: 3-217-285-120**

A review of the supplied auxiliary engines running hours showed no areas of concern, although the 12,000 hour overhaul of auxiliary engine No1 was due imminently, with the running hours noted as 11,877 hours. Auxiliary engine No2 was also due overhaul this year and was at 10,178 hours.

The auxiliary engine No1 should be overhauled at the next opportunity, and the No2 engine overhaul scheduled when convenient.

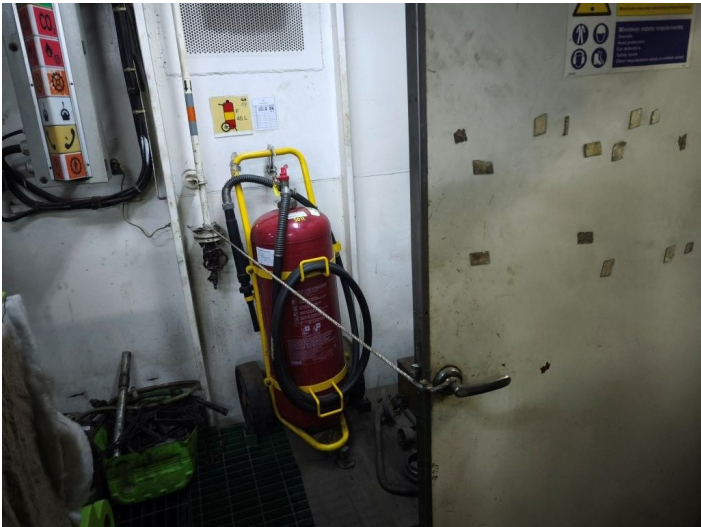
| Priority | Description | Recommendations |
|---|---|---|
| | <p>Defect ID: 1-598-218-260</p> <p>The engine room emergency escape fire door was found to be tied back and held open.</p> | <p>Ensure fire doors are free from unauthorised 'hold-open' arrangements, as this can rapid increase the risk of a fire spreading, and would have been raised as a deficiency by PSC.</p> |

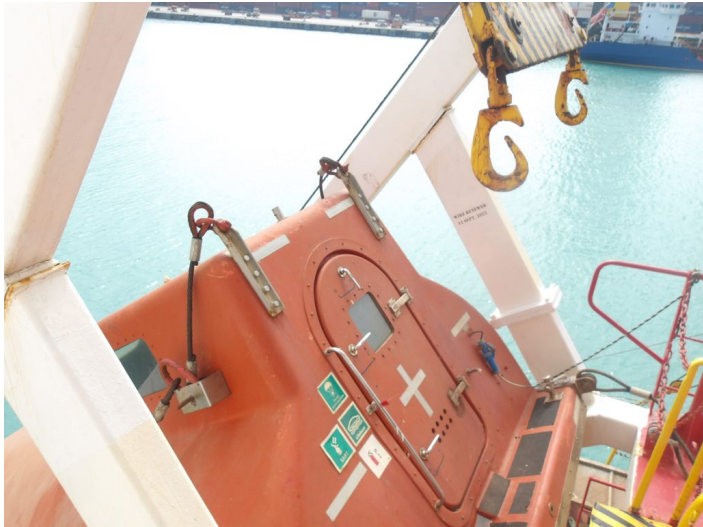
Defect ID: 1-598-283-798  
The lifeboat davit hooks had no safety latches.

Safety latches should be fitted to reduce the risk of accidents or injury during lifeboat retrieval.

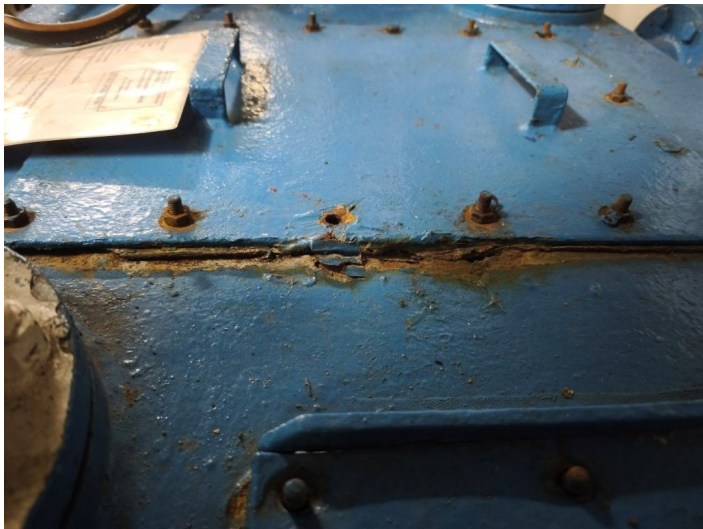
| Priority | Description | Recommendations |
|---|---|---|
| | <b>Defect ID: 2-034-429-958</b><br>The sewage treatment plant covers were loose and were missing bolts. | The bolts should be replaced and the covers tightened at the next opportunity. |

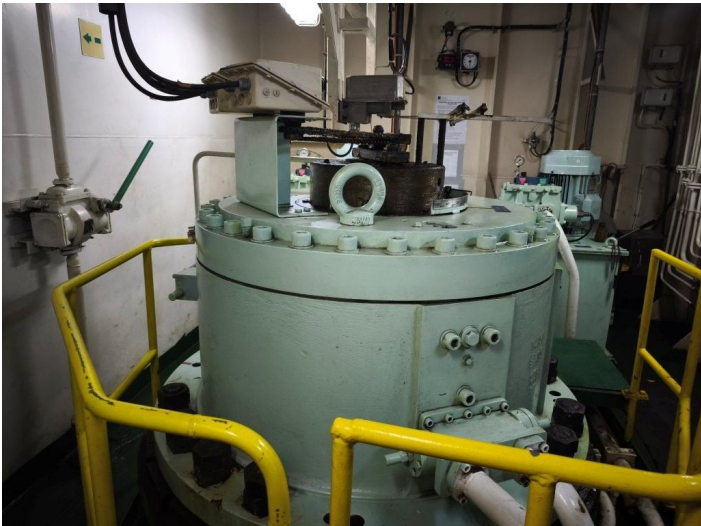
| Priority | Description | Recommendations |
|---|---|---|
| | Defect ID: 2-034-425-867<br>The steering gear was missing emergency operation instructions. | The emergency operating instructions should be posted at the next opportunity. |

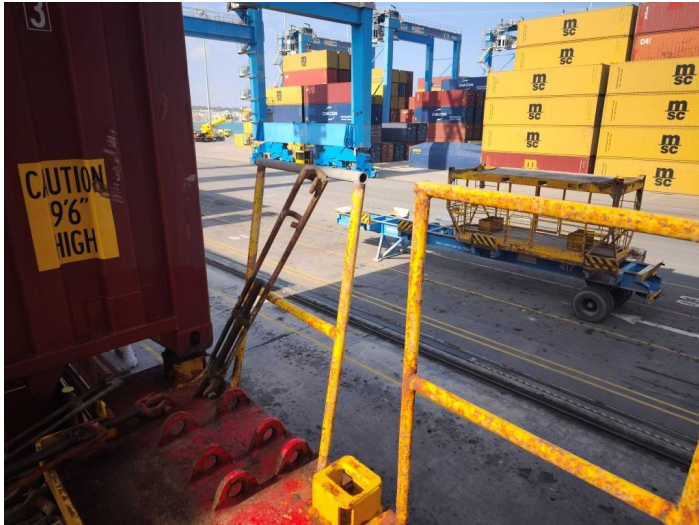
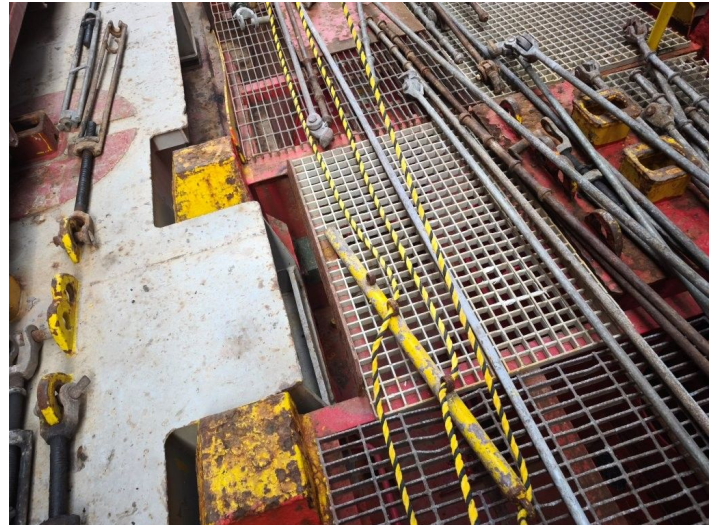
Defect ID: 2-034-290-706

Cross deck stanchions and handrails were partially damaged.

The defective stanchions and handrails should be repaired or replaced at the next opportunity.

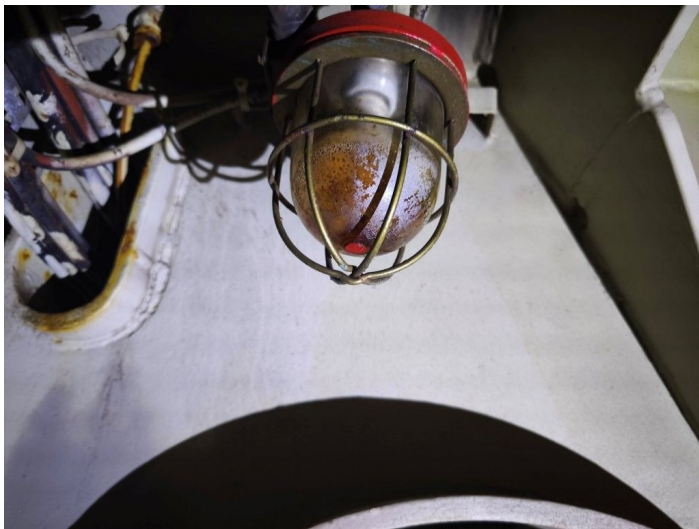
Defect ID: 2-034-397-204

Cargo hold lights were noted to be inoperative during the inspection.

The lamps should be replaced although alternative lighting may need to be considered to improve reliability.
