# ID CONDITION REPORT

## ATLANTIC MONACO

IMO 9356658

Date of inspection:  
**December 20 2025**

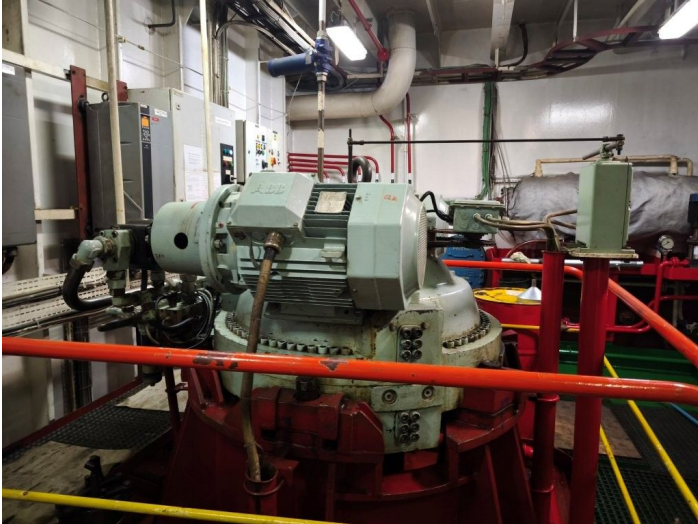
Positive ID: 2-357-317-635

The engine space was fitted with inverter drives for the steering gear unit.

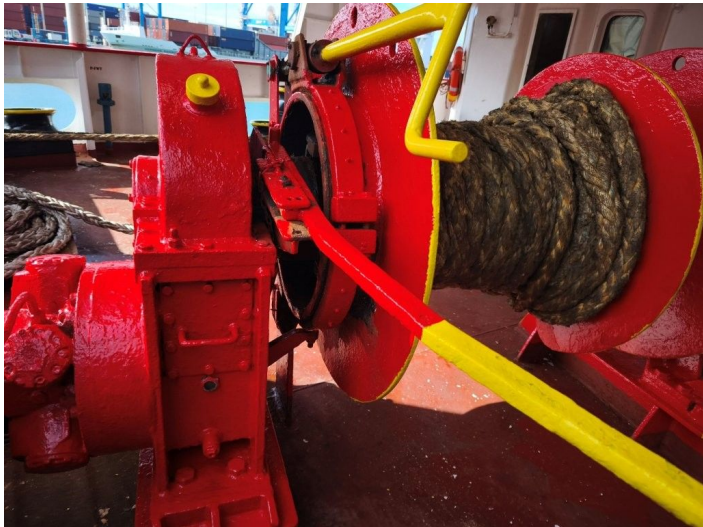
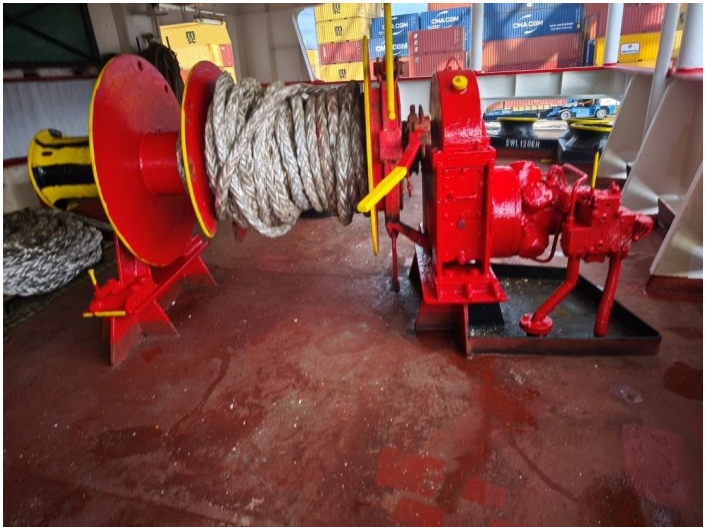
Defect ID: 2-525-138-944  
Mooring practices were seen not to be following the industry's safe practices. The winch clutch safety pins were seen missing.

Safety management system to be reviewed on best practices to be used during mooring and unmooring

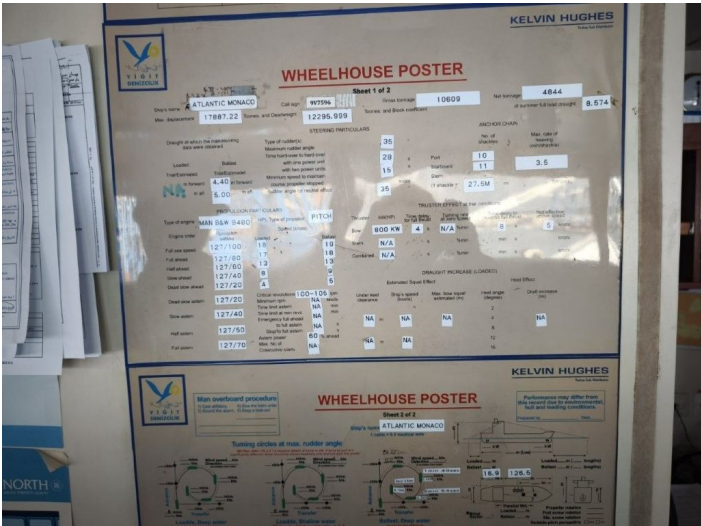
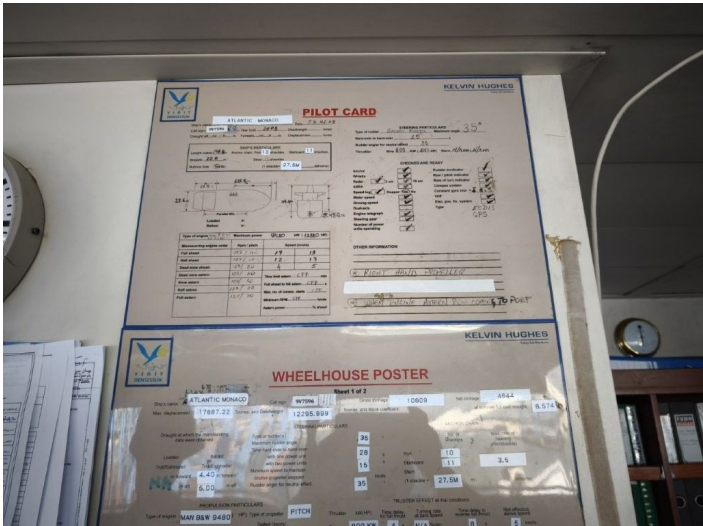
Defect ID: 4-068-614-144  
The Engine Power Limitation was not marked on the Pilot Card and wheel house poster.

To be rectified.

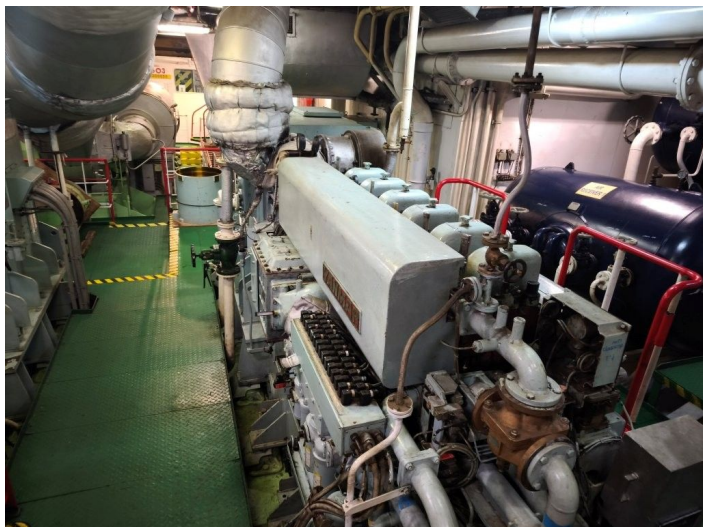
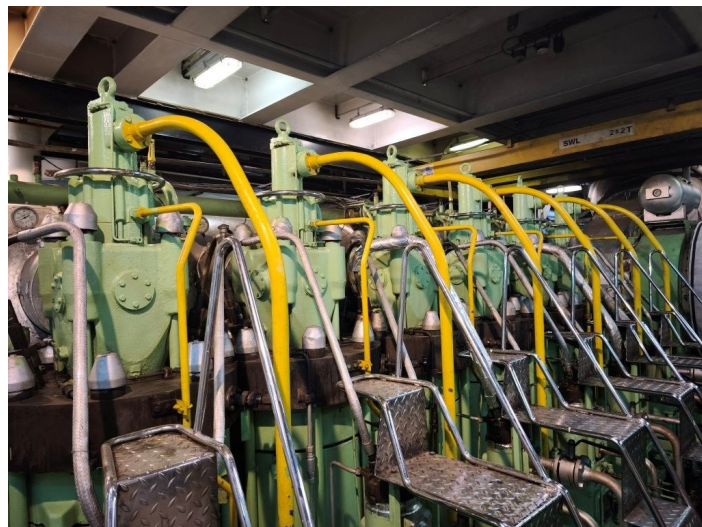
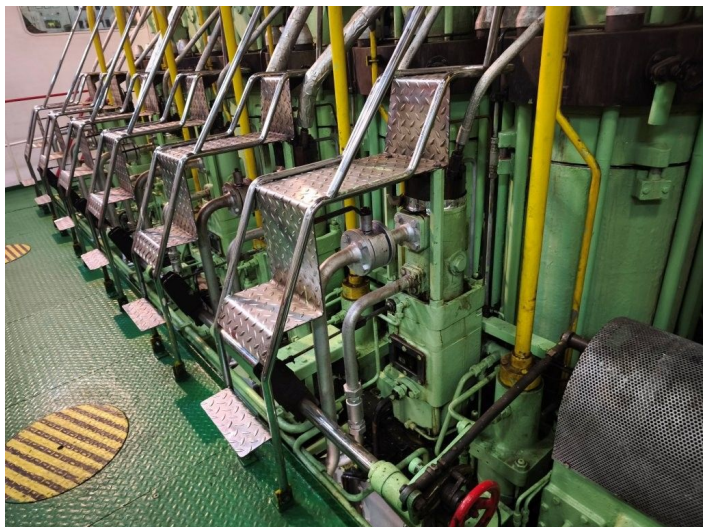
Defect ID: 2-709-659-648

Anti-splash tape was not seen to be in place at all required pipe connections.

To be rectified.

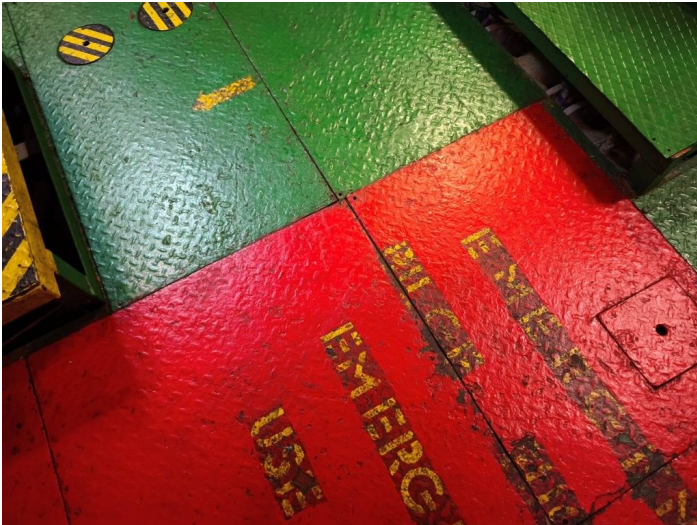
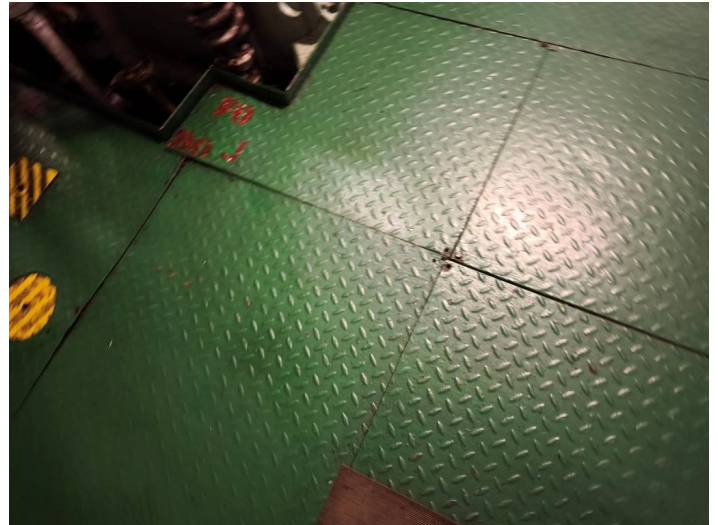
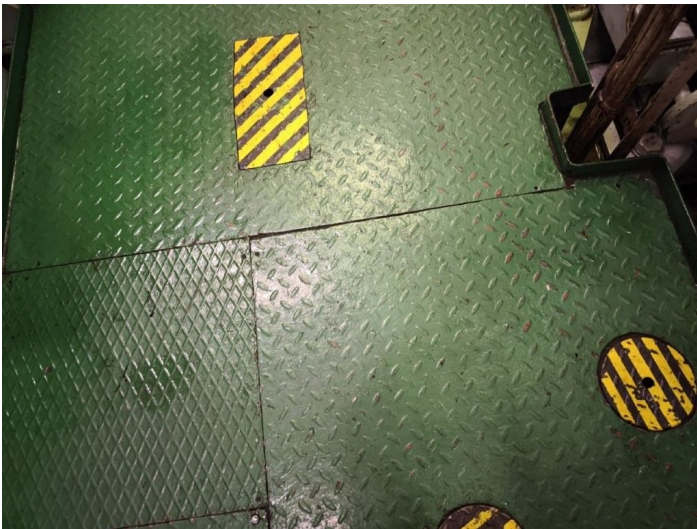
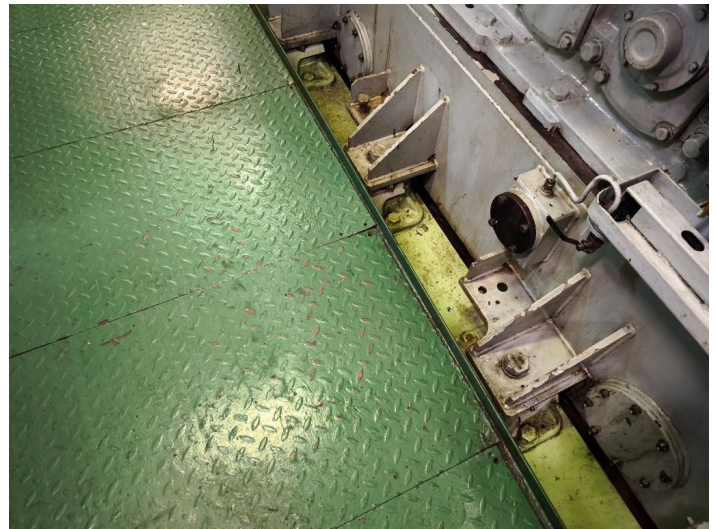
Defect ID: 4-177-768-449

The floor plating in the bow thruster room and engine space were loose and missing bolts.

Crew remedial maintenance to be carried out.

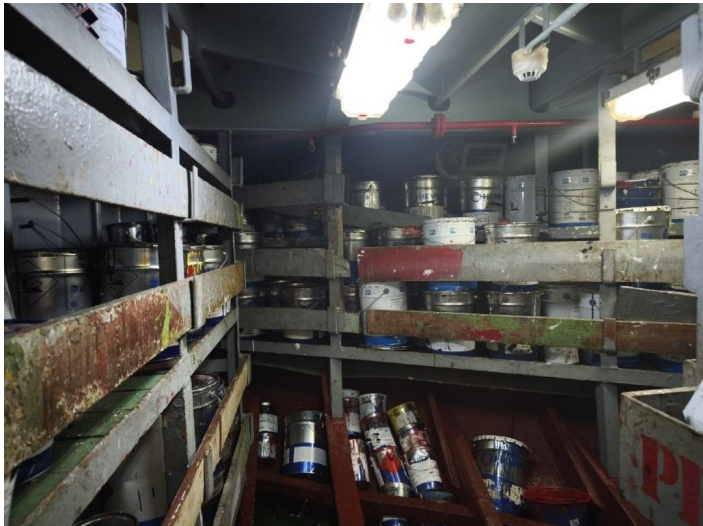
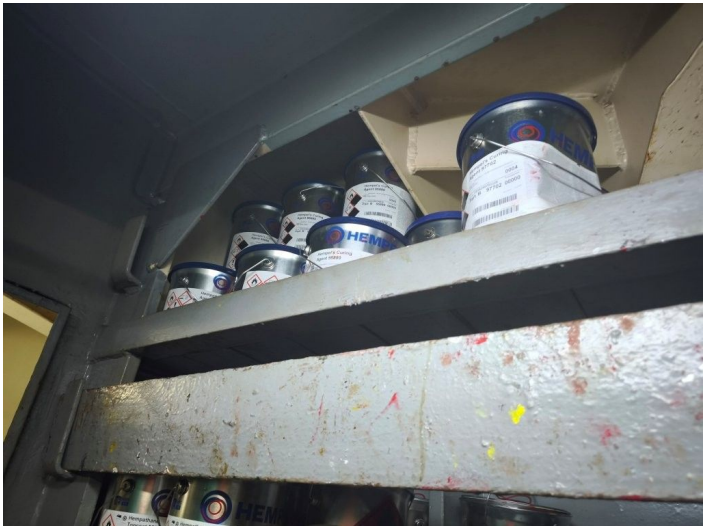
Defect ID: 2-625-634-304  
The paint store was seen with paint cans stored above the sprinkler heads, causing a safety hazard.

The maximum storage height red marker is to be applied to the area.

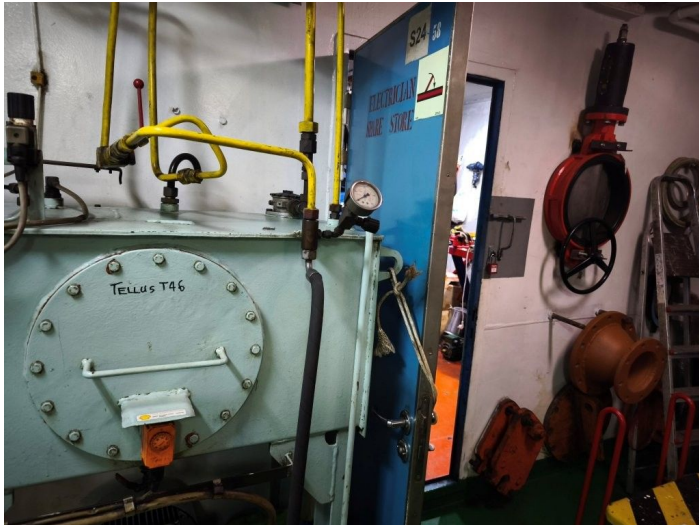
Defect ID: 3-519-070-208  
The engine space was not free of unauthorised 'hold-open' arrangements.

Safety management system to be reviewed.

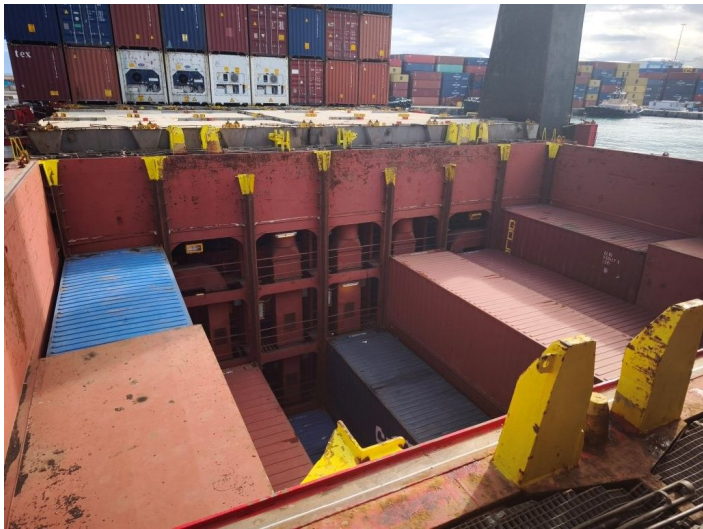
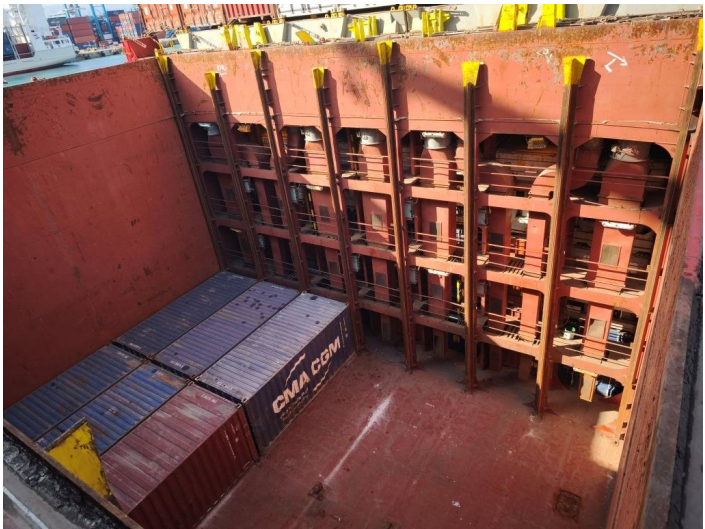
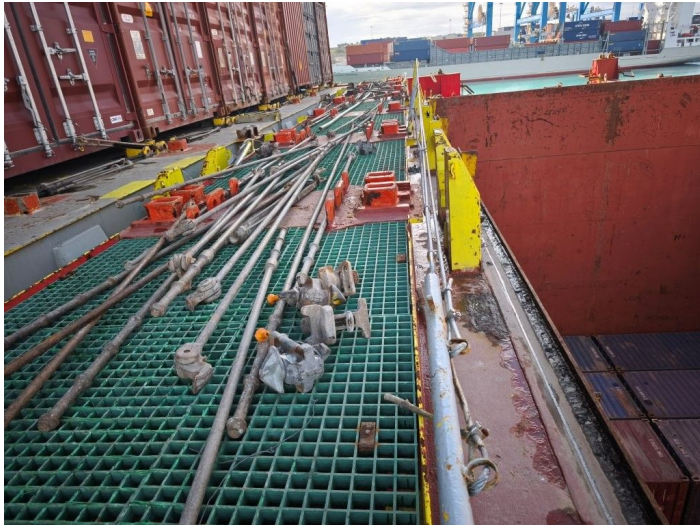
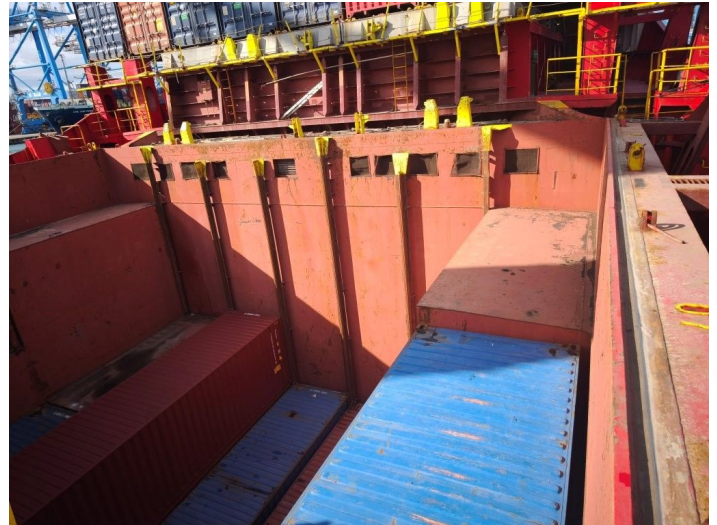
| Priority | Description | Recommendations |
|---|---|---|
| | Defect ID: 4-135-587-840<br>Open hatch covers were seen with no temporary or fixed guard railings. | Temporary or fixed guard rails should be used when hatch covers are open, restricting the chances of possible harm. |

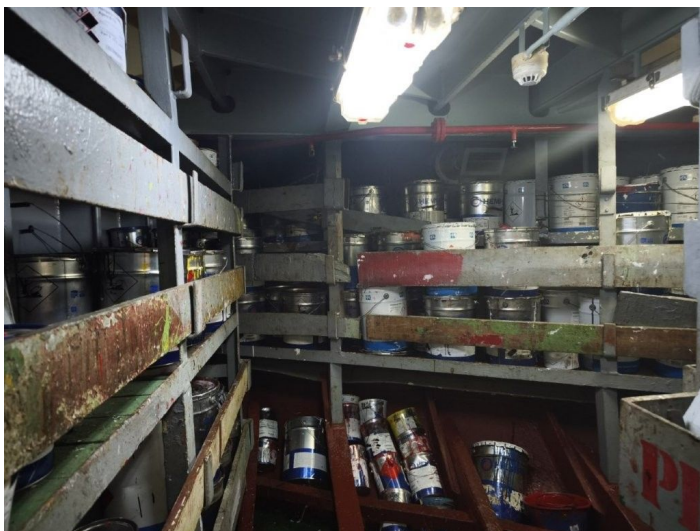
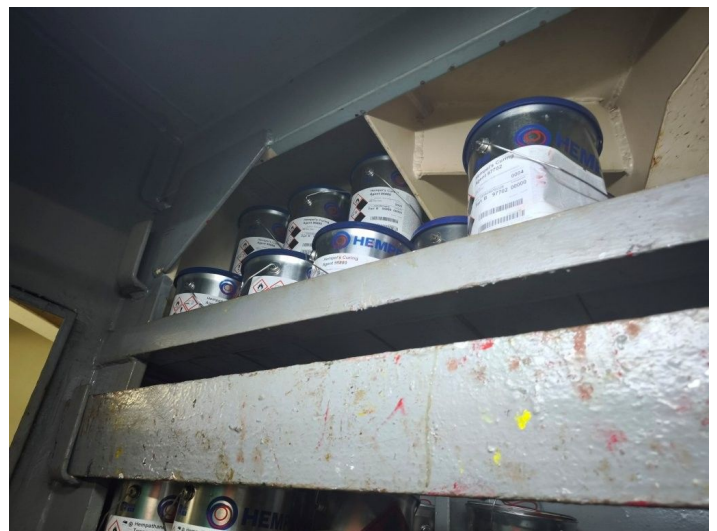
Defect ID: 2-625-634-304

The paint store was seen with paint cans stored above the sprinkler heads, causing a safety hazard.

The maximum storage height red marker is to be applied to the area.

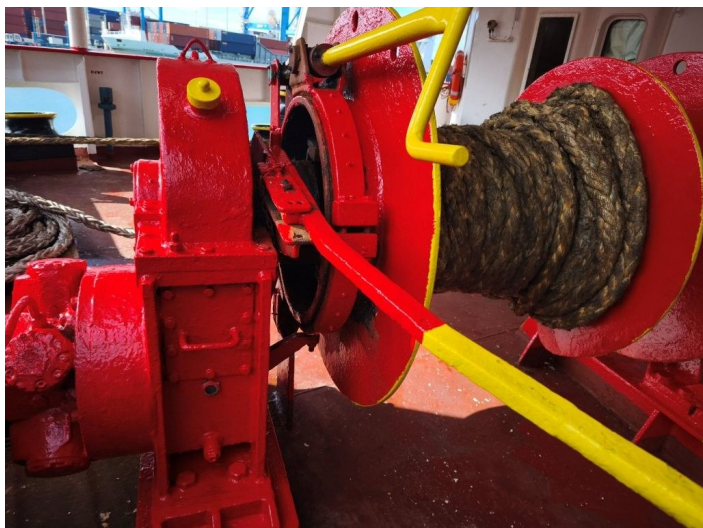
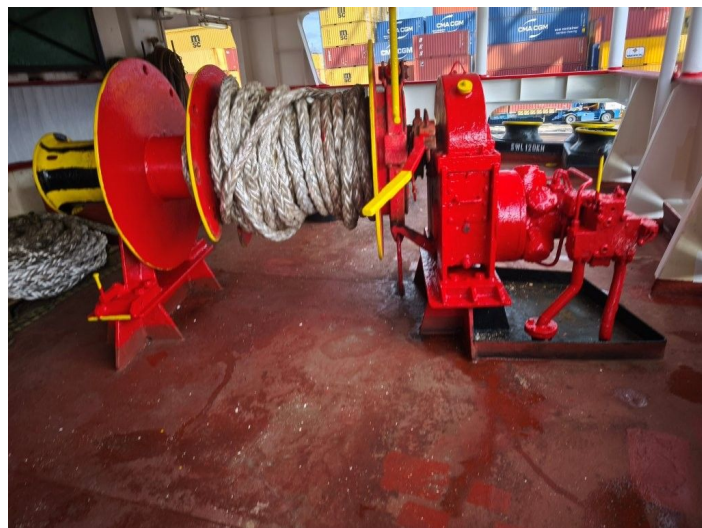
Defect ID: 2-525-138-944

Mooring practices were seen not to be following the industry's safe practices. The winch clutch safety pins were seen missing.

Safety management system to be reviewed on best practices to be used during mooring and unmooring

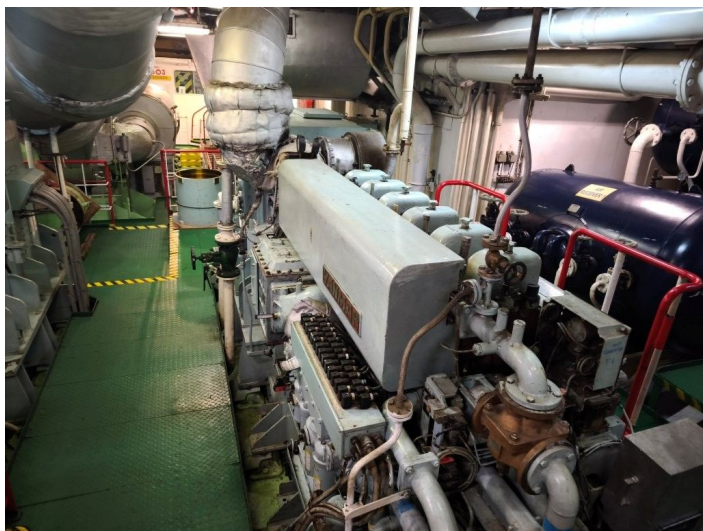
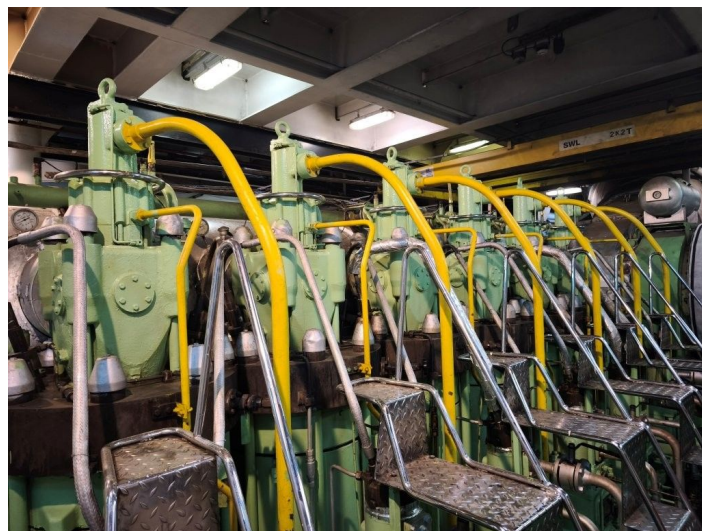
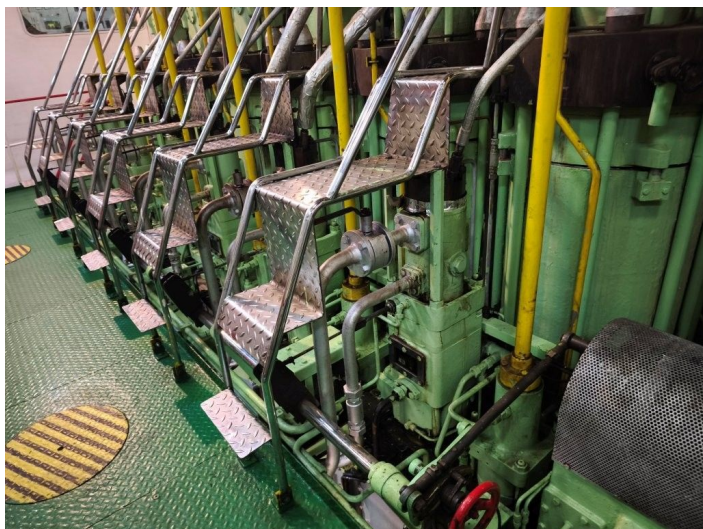
Defect ID: 2-709-659-648

Anti-splash tape was not seen to be in place at all required pipe connections.

To be rectified.

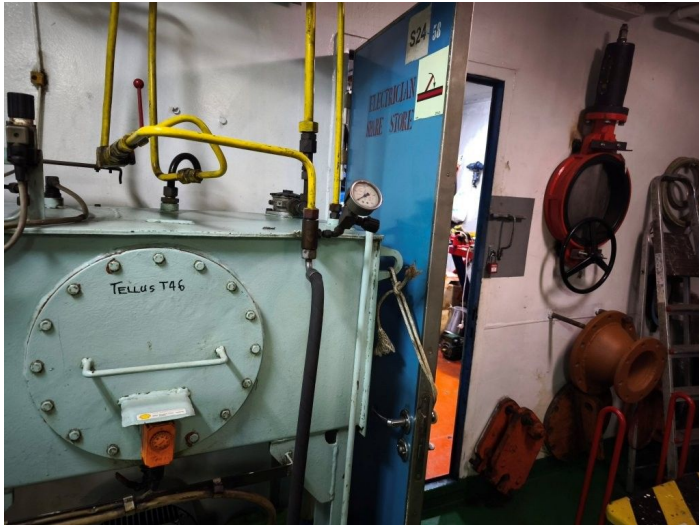
Defect ID: 3-519-070-208

The engine space was not free of unauthorised 'hold-open' arrangements.

Safety management system to be reviewed.

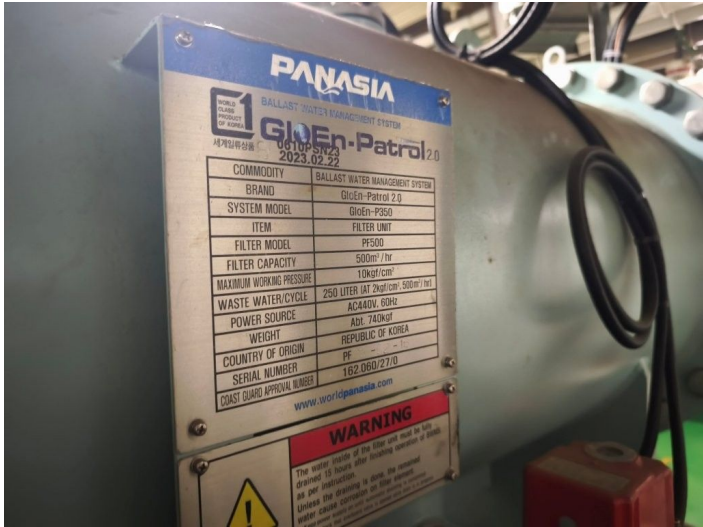
Positive ID: 2-357-411-840

It was reported that a USCG approved BWTS is installed

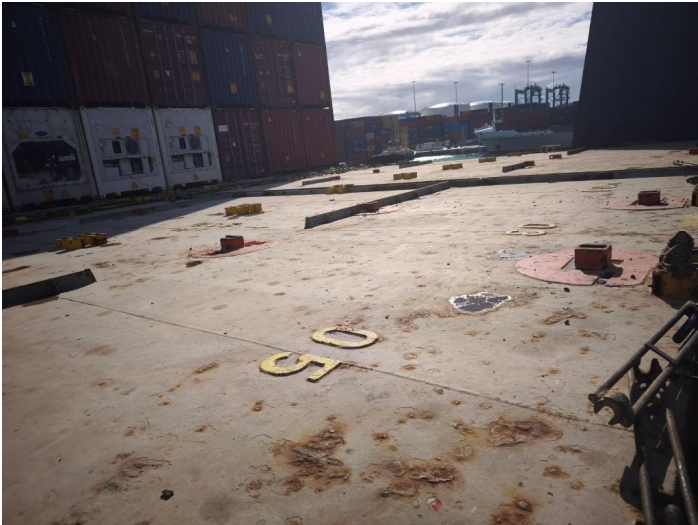
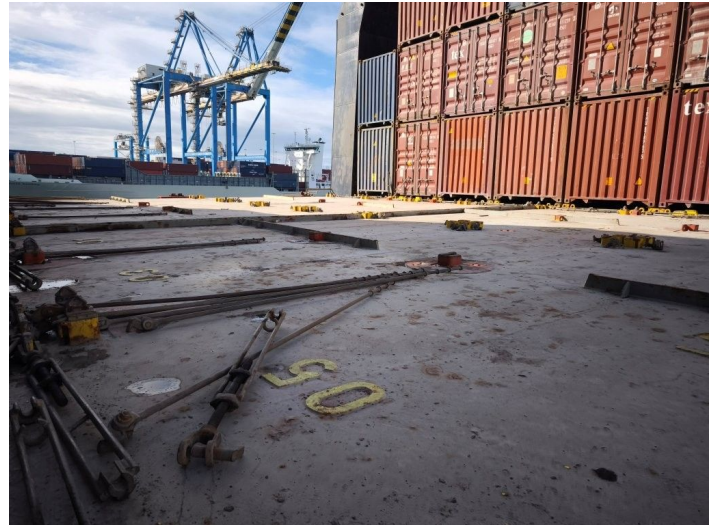
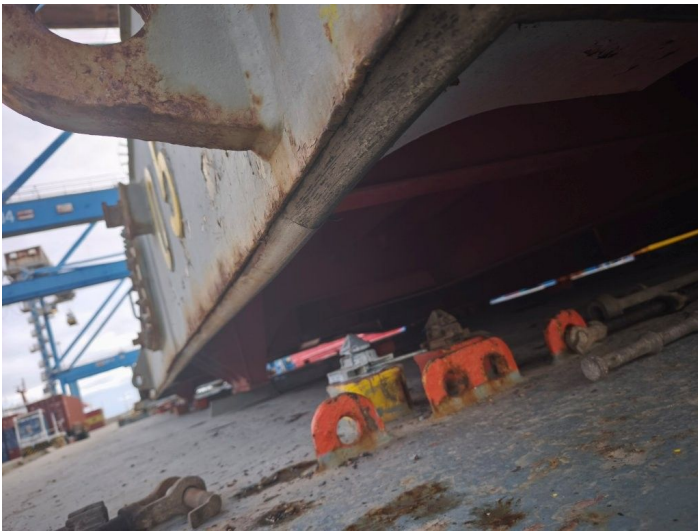
| Priority | Description | Recommendations |
|---|---|---|
| | <p>Defect ID: 4-181-897-217</p> <p>The hatch covers were seen with moderate localised spot corrosion, up to approximately 5% of the surface area. The coating breakdown was mainly located on the top plates and around the rubber packing channels.</p> | <p>Crew remedial maintenance to be carried out.</p> |
