# ID CONDITION REPORT

## ATLANTIC NORTH

IMO 9236597

Date of inspection:  
**March 08 2026**

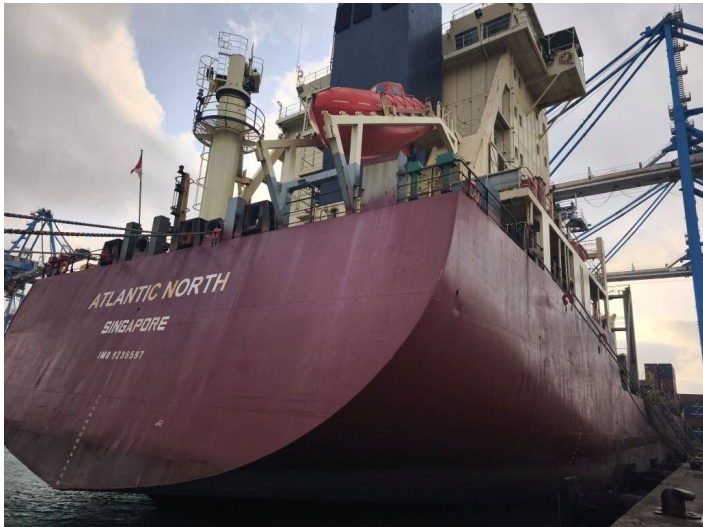
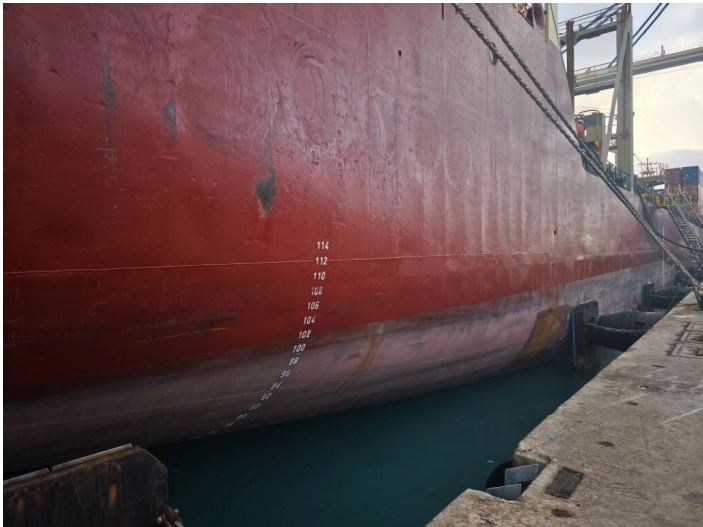
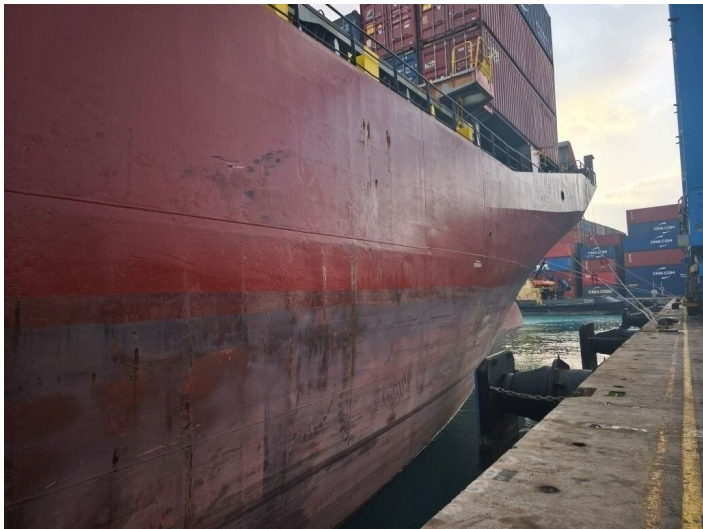
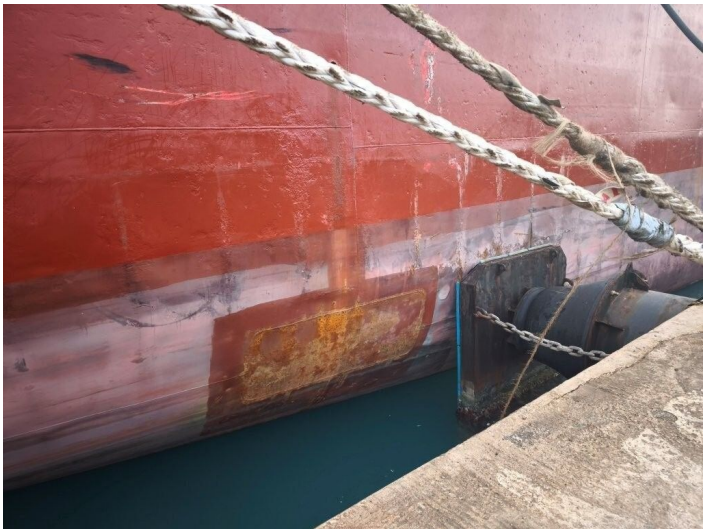
| Priority | Description | Recommendations |
|---|---|---|
| | Defect ID: 58-785-792<br>Minor indentations and signs of rib caging were seen on the forebody and afterbody of the ship's hull. | For information only. |

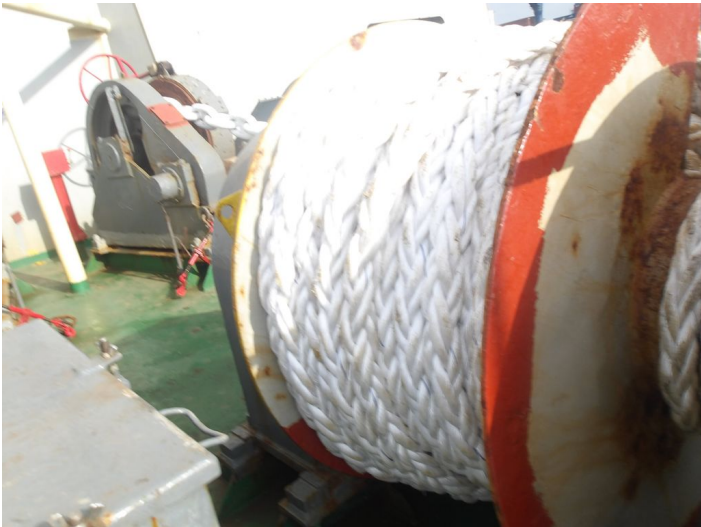
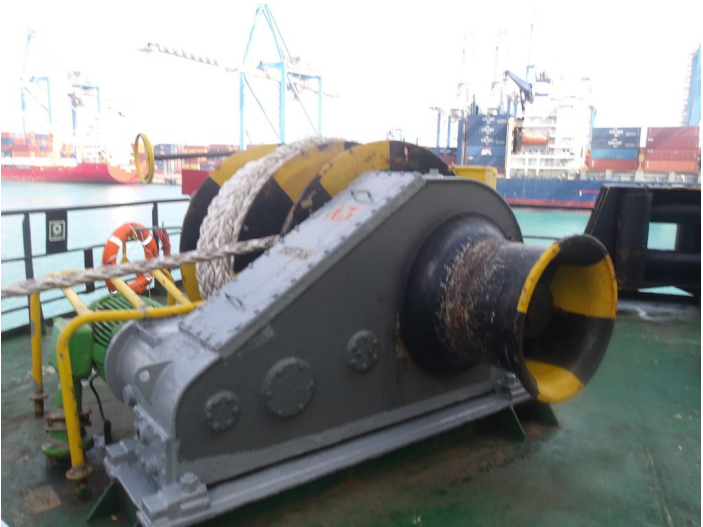
| Priority | Description | Recommendations |
|---|---|---|
| | <p>Defect ID: 58-826-753</p> <p>Some of the mooring machinery were found to have signs of developing corrosion on its warping drums and tension drums.</p> | <p>Maintenance should be carried out to reduce further development of corrosion.</p> |

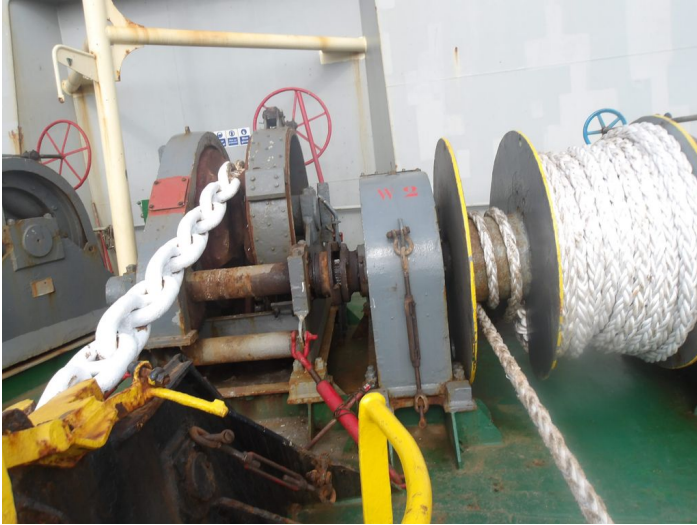
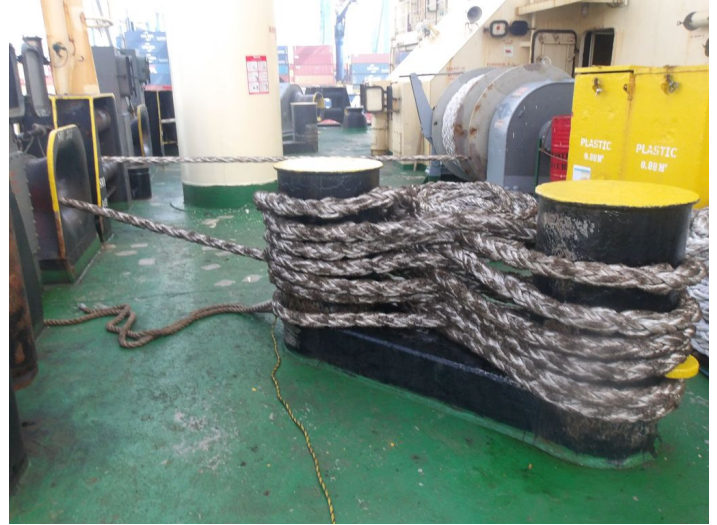
**Defect ID: 58-871-810**

Some of the mooring ropes were found to have signs of wear and fraying.

Further monitoring is recommended and carry out investigation to verify the service life of the mooring ropes. It is recommended to replace the mooring ropes that have exceeded its service life or are in deteriorated condition.

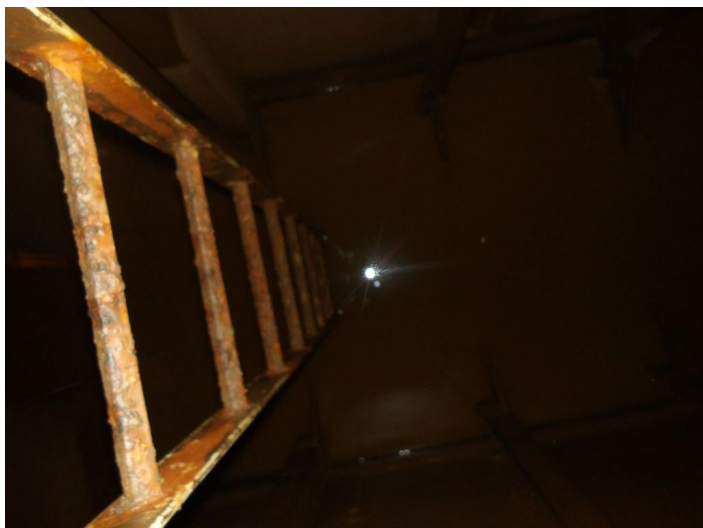
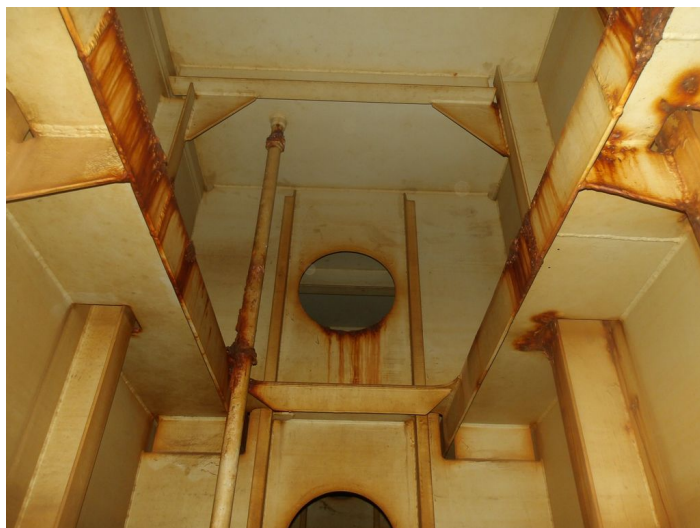
| Priority | Description | Recommendations |
|---|---|---|
| | <b>Defect ID: 58-781-700</b><br>Some of the pipes and ladders of the inspected ballast tanks were found to have areas with developing corrosion and signs of coating breakdown. | Maintenance should be carried out to improve the condition of the ballast tanks' fittings. |

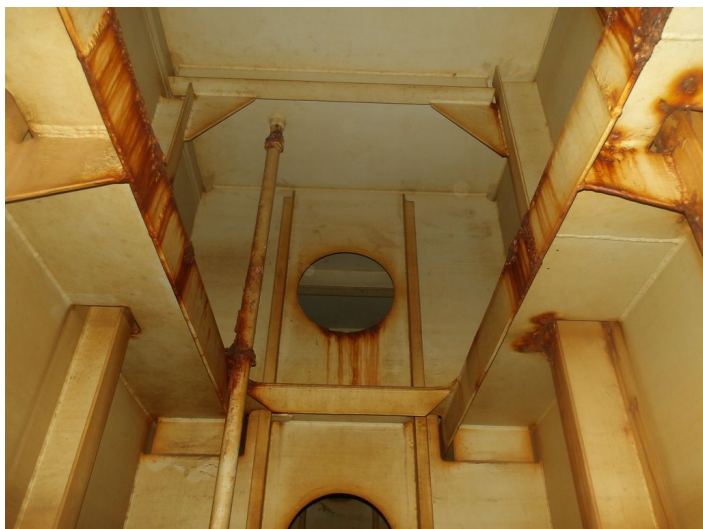
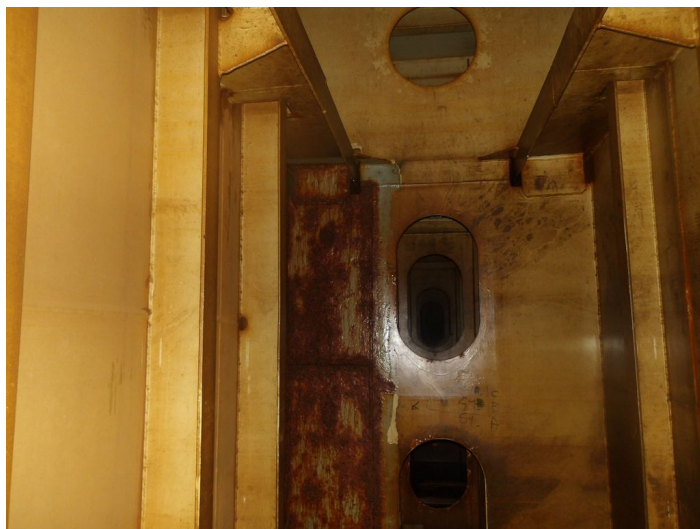
Based on the provided ballast tanks photographs, prominent corrosion and coating breakdown were pictured in some areas of the ballast tanks and fittings such as access manhole, ladders, structural framing, framing edges, pipes, and weld seams. Spot of heavy corrosion was reported on the welded parts of the frames, longitudinal, beams, air vent access hole, entrances access and stiffeners of No.4BS. Slight to moderate spot rust formation was reported in the Fore Peak Tank.

Maintenance should be carried out to improve the condition of the ballast tanks and fittings.

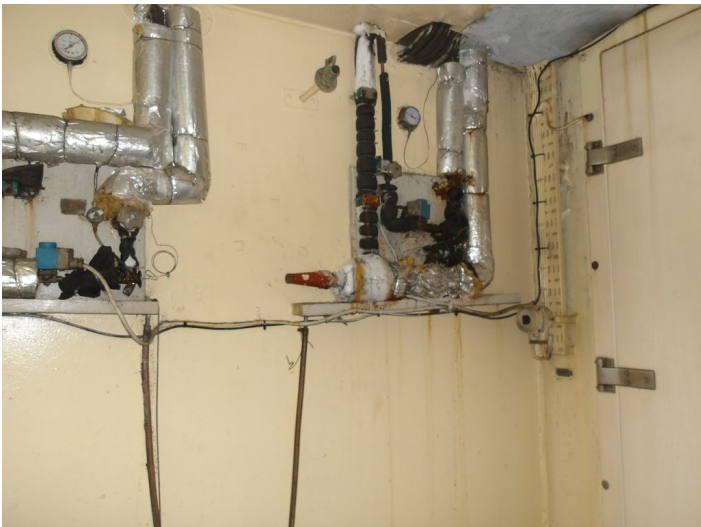
| Priority | Description | Recommendations |
|---|---|---|
| | Defect ID: 58-818-567<br>Ice accumulation was seen on some sections of the cold room refrigeration pipework. | Further investigation is recommended. |

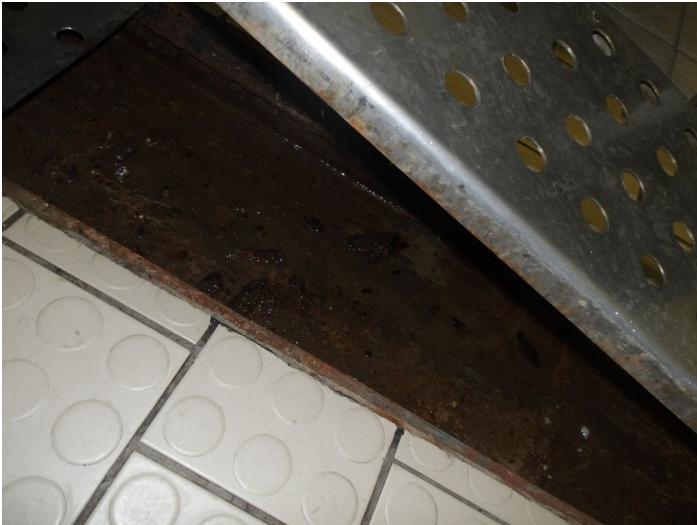
Defect ID: 58-974-228

Galley floor drain channel was found dirty with accumulated grease.

Regular cleaning is recommended.

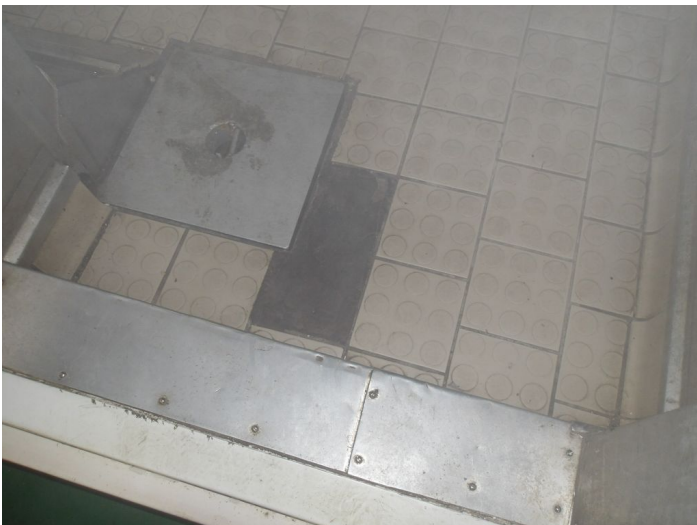
Defect ID: 58-929-158

A missing tile was seen in the refrigerating room.

Areas of deteriorated coverings should be rectified when possible.

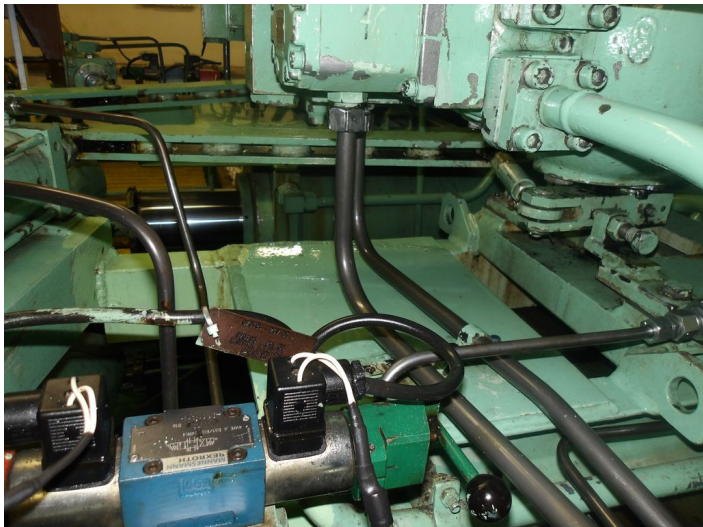
| Priority | Description | Recommendations |
|---|---|---|
| | <p>Defect ID: 3-254-931-456</p> <p>Oil leakage was seen on the surface of the steering gear.</p> | <p>Further investigation is recommended to determine the cause of the leakage and carry out corrective actions to rectify the leakage.</p> |

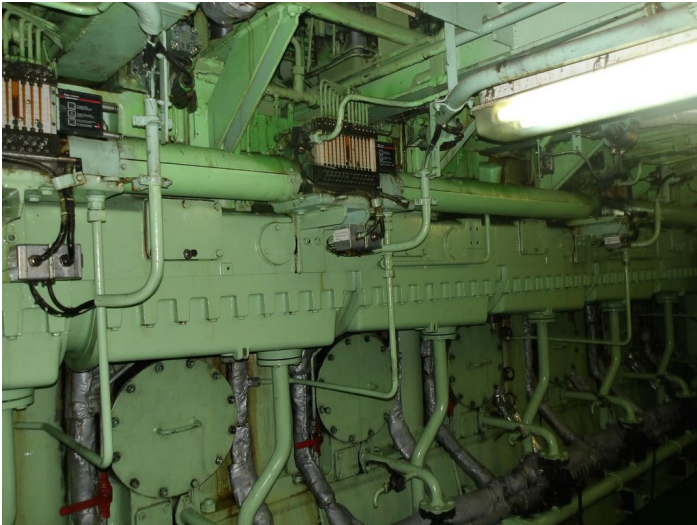
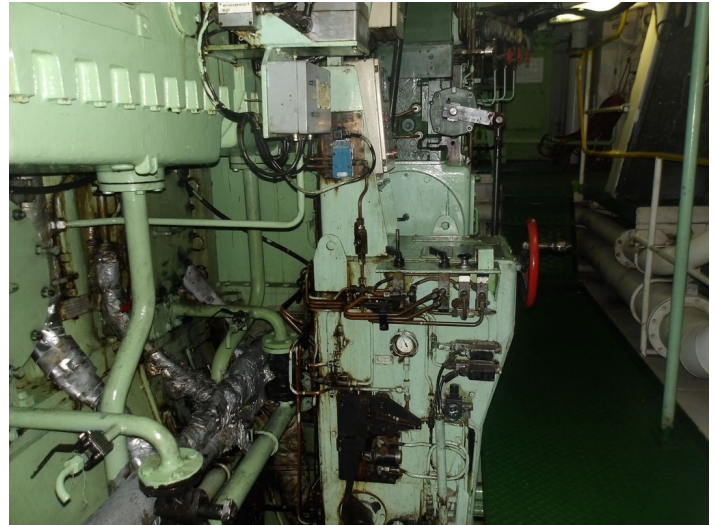
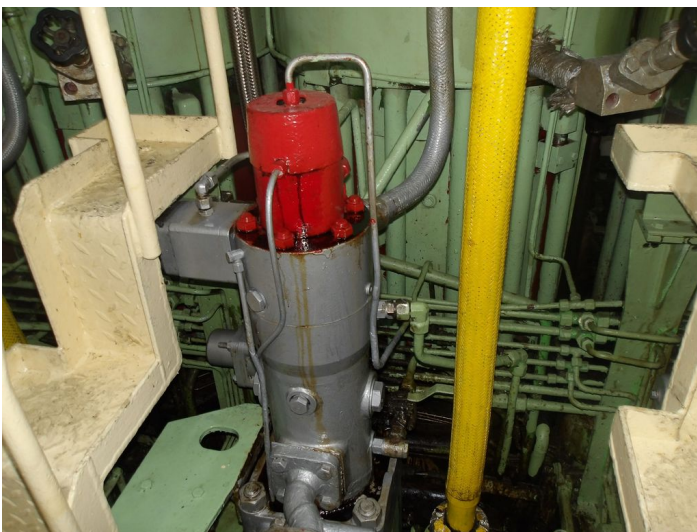
| Priority | Description | Recommendations |
|---|---|---|
| | <p>Defect ID: 58-724-362</p> <p>Leak stains were seen on the external casing of the Main Engine, and Signs of leakage were seen on one of the fuel injector pumps of the Main Engine.</p> | <p>Leak stains on the external casing of the Main Engine should be cleaned and carry out further checks to verify any active leakages. Carry out corrective actions to rectify the leakages.</p> |

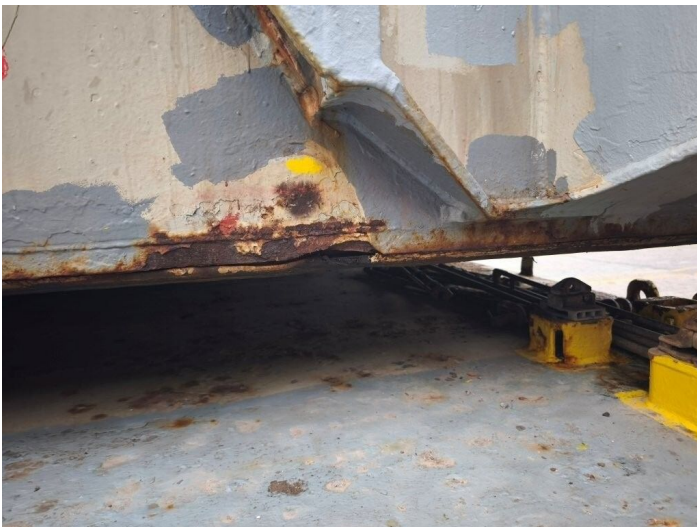
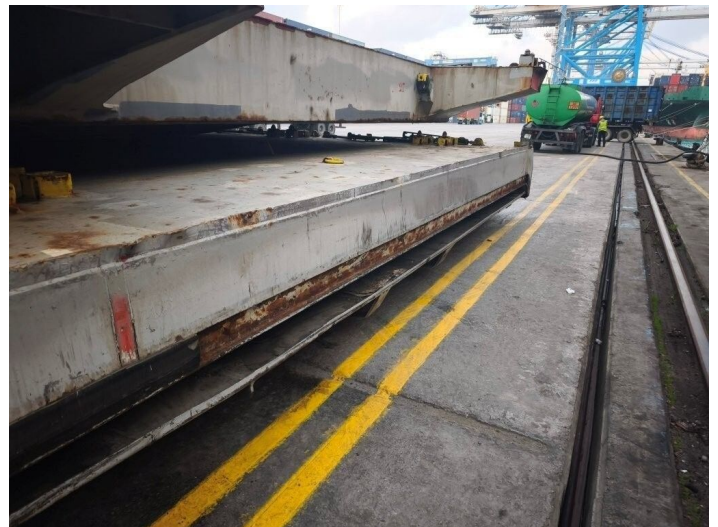
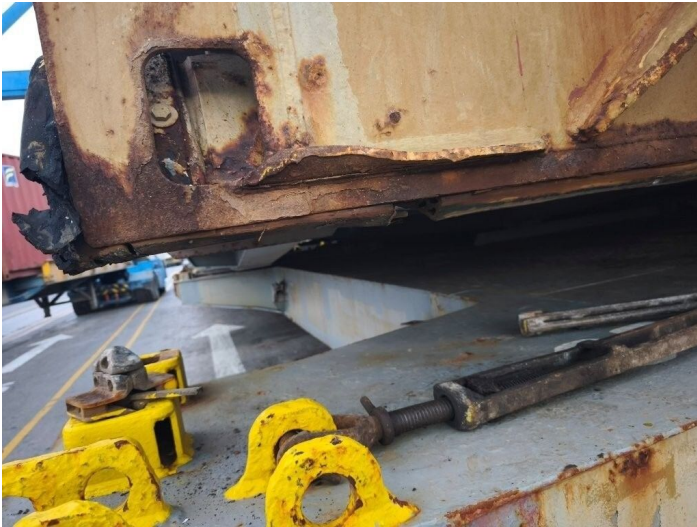
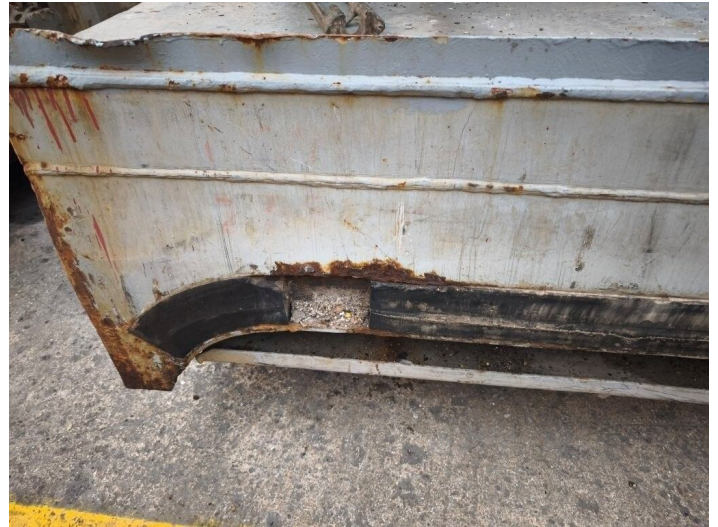
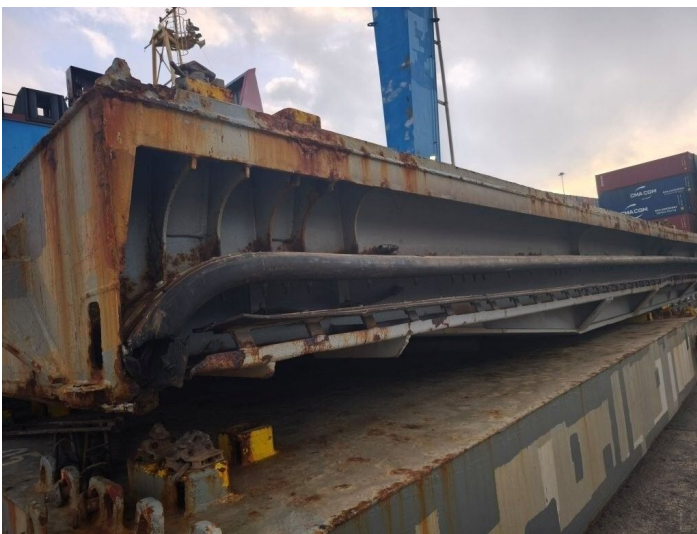
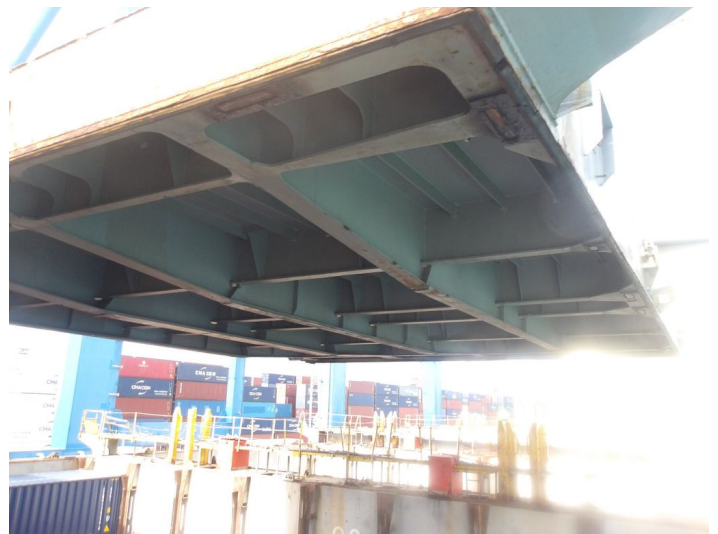
**Defect ID: 474-017-795**

Some areas of the hatch cover cross joints' rubber gaskets were found worn and in deteriorated condition, and gaps were seen on the hatch cover rubber seals of some of the hatch covers. One of the hatch covers was found missing half of the rubber gasket of its cross joint. Some sections of some of the hatch covers' retaining channels were found to have signs of wastage.

Corrective actions are to be carried out to improve the condition of the hatch cover rubber gaskets and retaining channel.

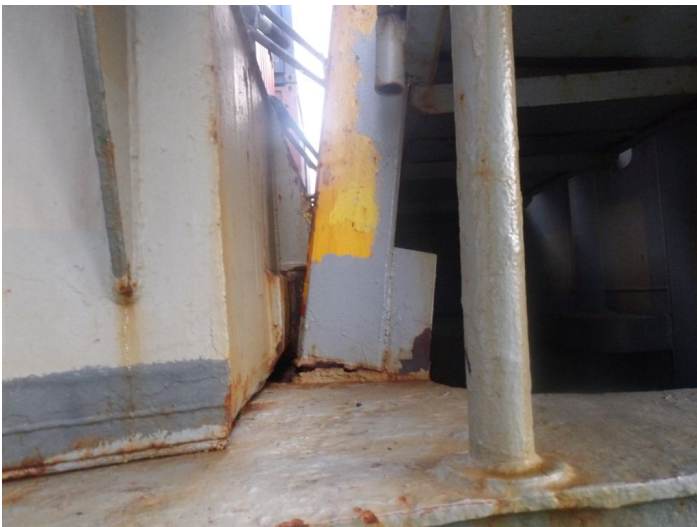
Defect ID: 474-017-797

The coaming guide of hatch coaming No.1 forward starboard was found damaged.

Repairs are to be carried out to improve the condition of the coaming guide.

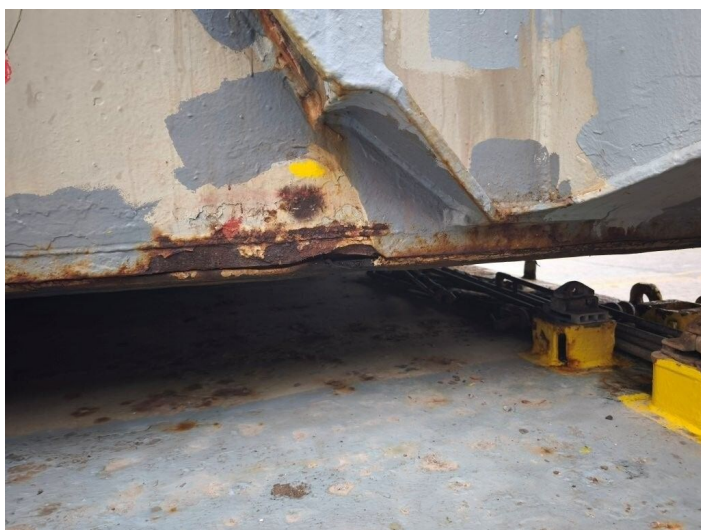
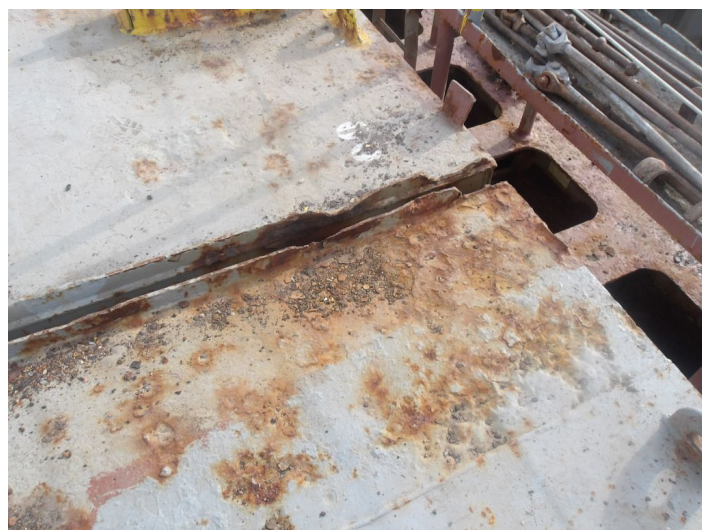
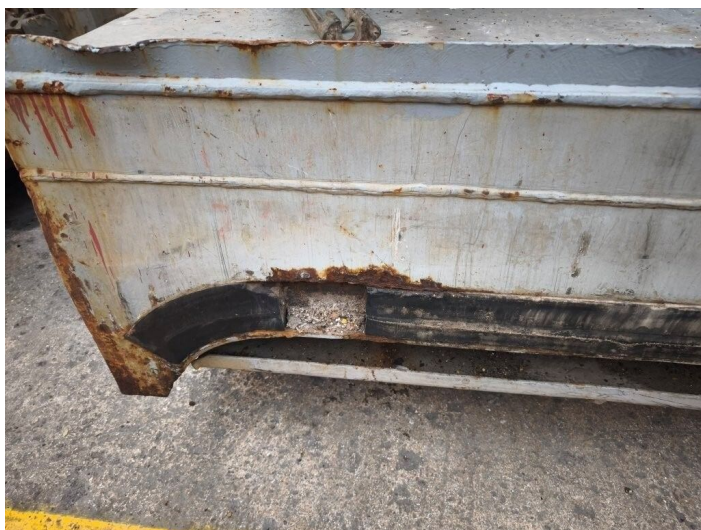
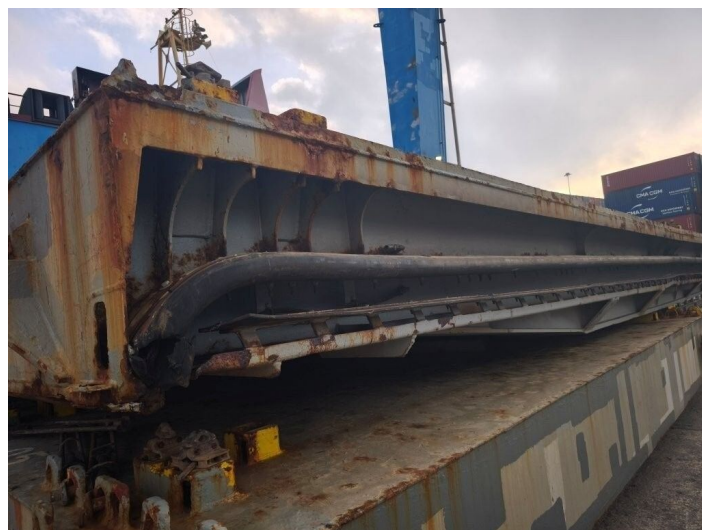
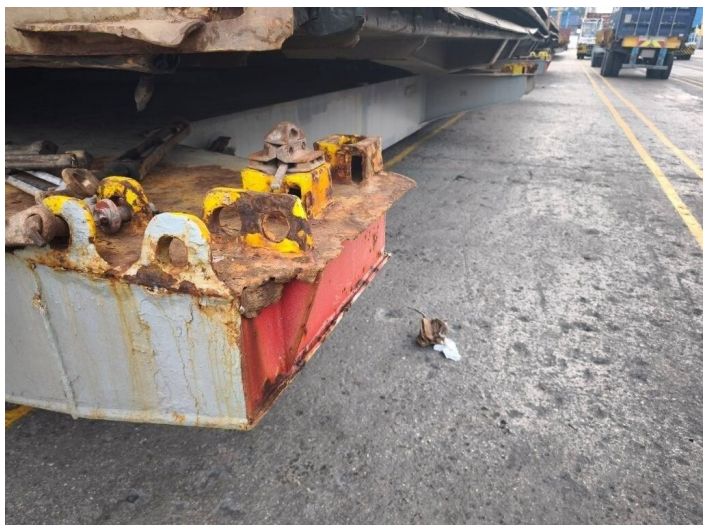
Signs of wastage and deformation were seen on localized areas of the hatch covers' edges.

Repairs are to be carried out to improve the condition of the hatch covers.

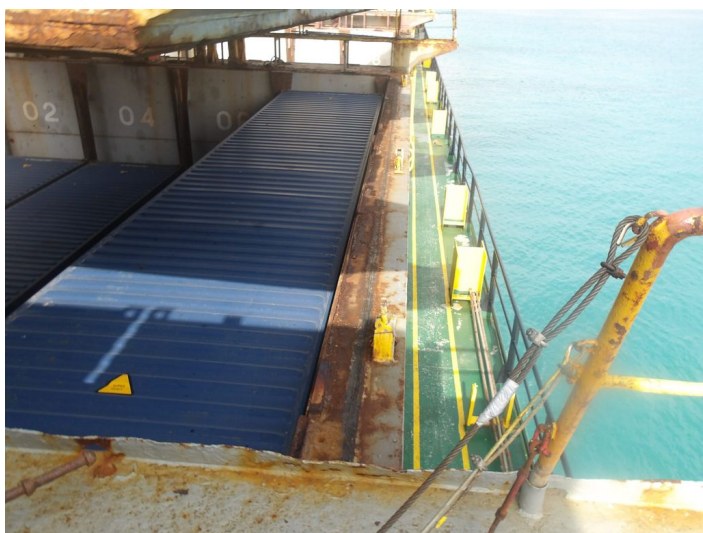
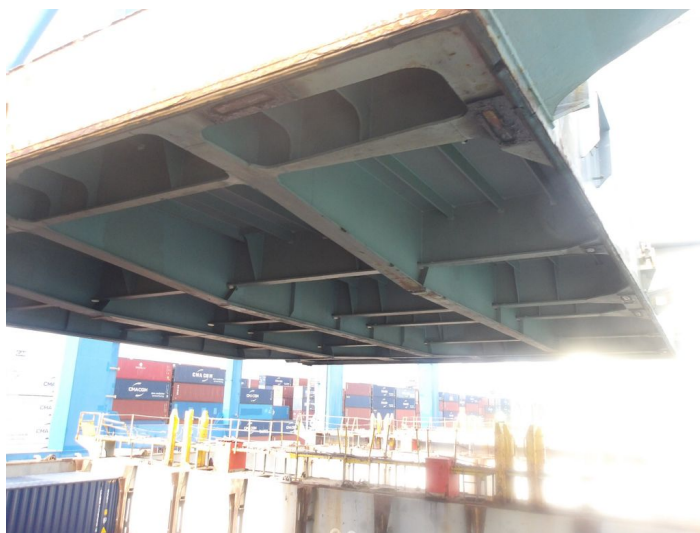
Defect ID: 474-189-828

Signs of wear were seen on the hatch coaming landing pads, and hatch cover support pads.

Maintenance should be carried out to improve the condition of the landing pads and support pads.

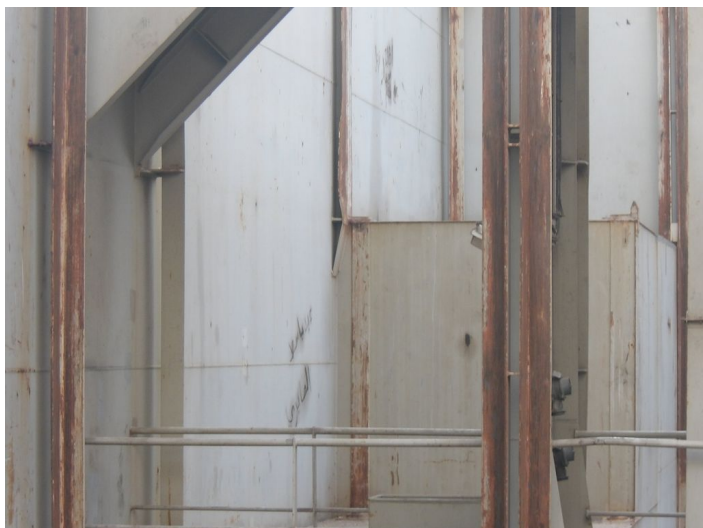
One of the vertical guides on the port bulkhead of cargo hold No.2 was found to have minor deformation. Based on the provided cargo hold photographs, minor deformation was pictured on one of the cell guides of bay 26.

For information.

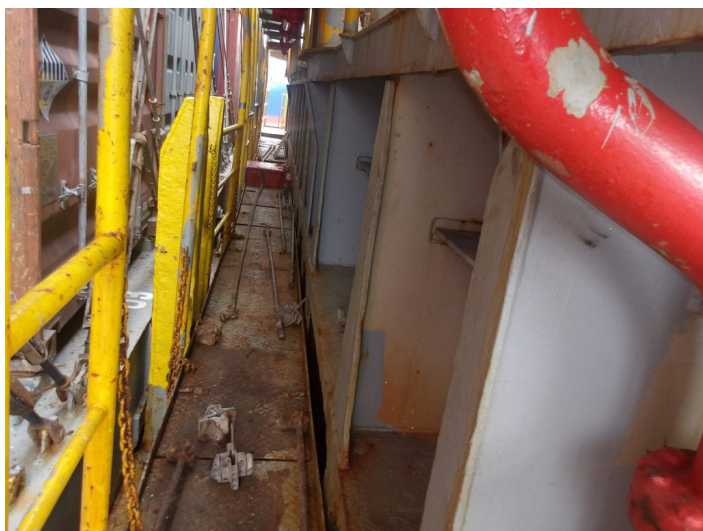
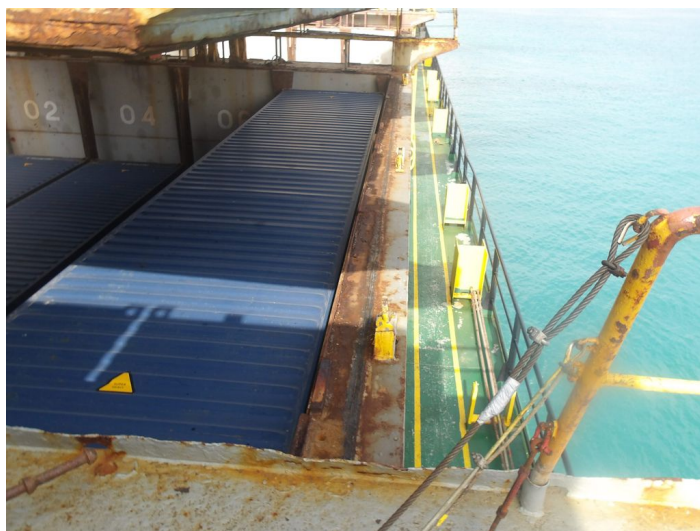
Signs of wastage and developing corrosion were seen on some areas of the coamings' cross deck walkways.

Maintenance and repairs are to be carried out to improve the condition of the cross deck walkways.

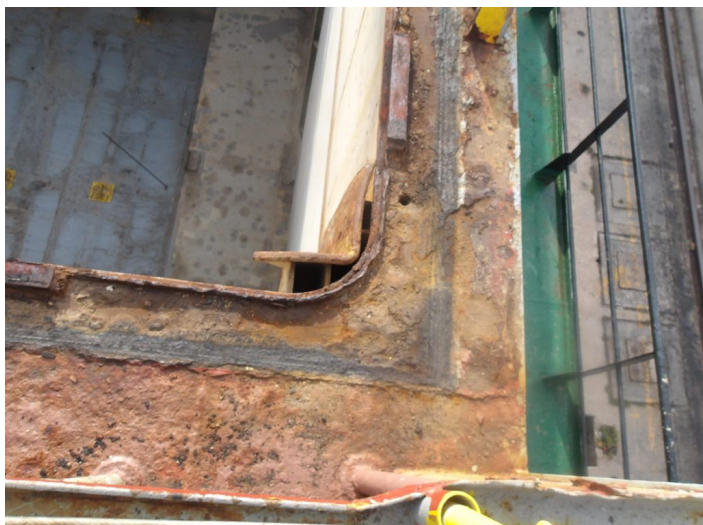
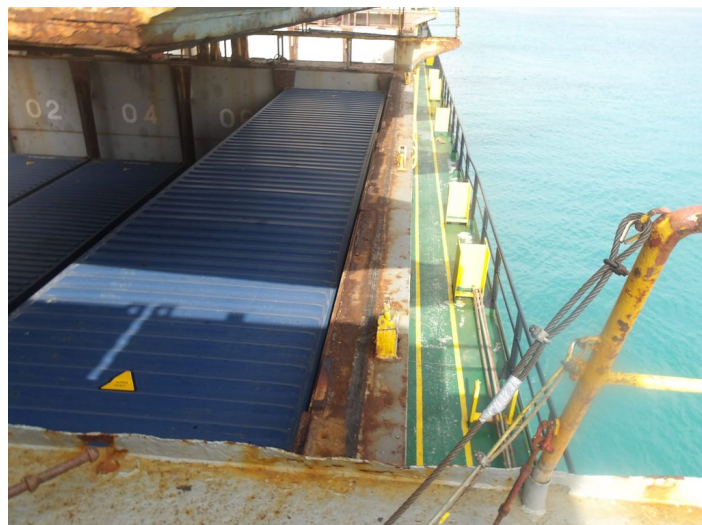
Hatch coamings were found to have minor to moderate localised scaling and spot corrosion, up to approximately 10% of the surface area, mainly located on the coaming table and free edges.

Maintenance should be carried out to improve the condition of the hatch coamings.

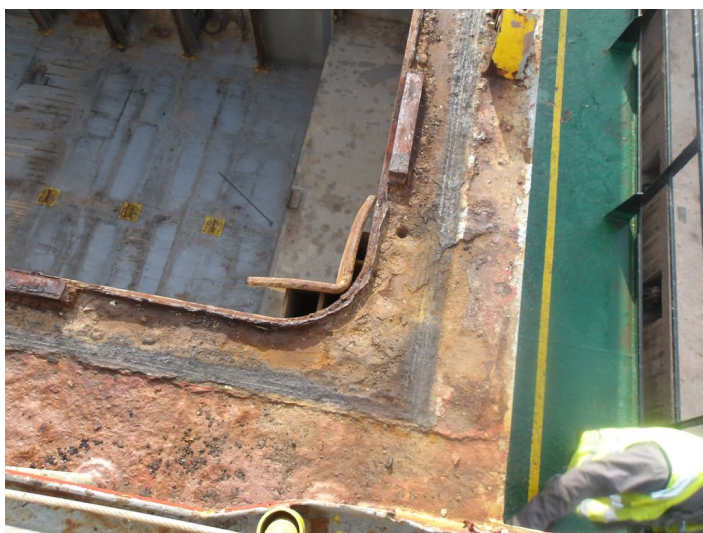
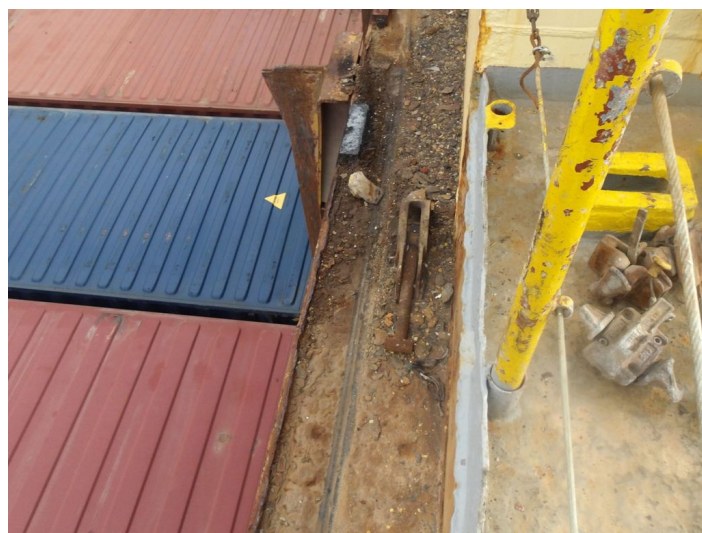
Defect ID: 474-214-407

Some sections of the hatch sills were found to have damage and prominent levels of corrosion.

Maintenance and repairs are to be carried out to improve the condition of the hatch sills.

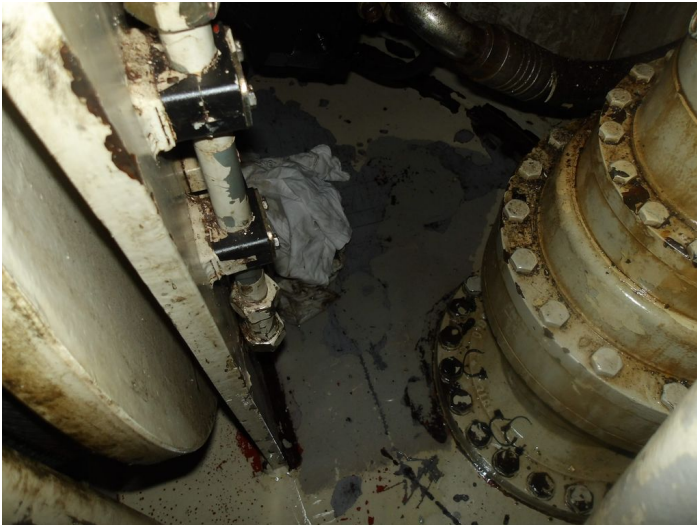
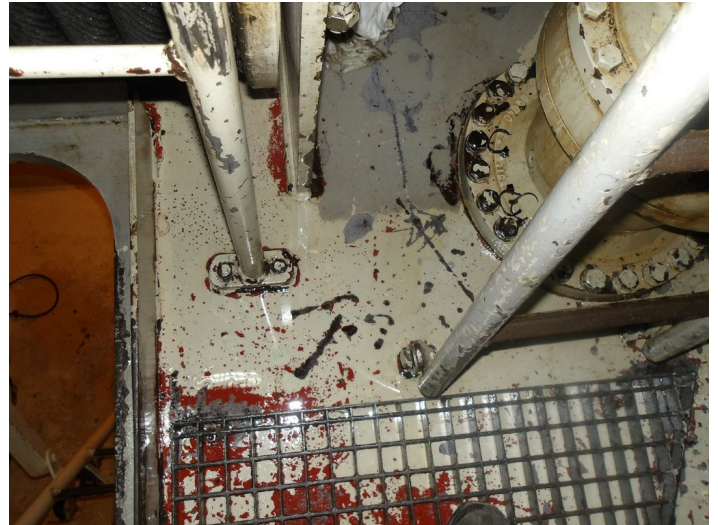
Defect ID: 58-744-847

Hydraulic oil leakages were seen on the motor and hydraulic platform of cargo crane No.2.

Further investigation is recommended to determine the cause of the leakage and carry out corrective actions to rectify the leakage.
