# ID CONDITION REPORT

## ATLANTIC PIONEER

IMO 9388417

Date of inspection:  
**December 01 2025**

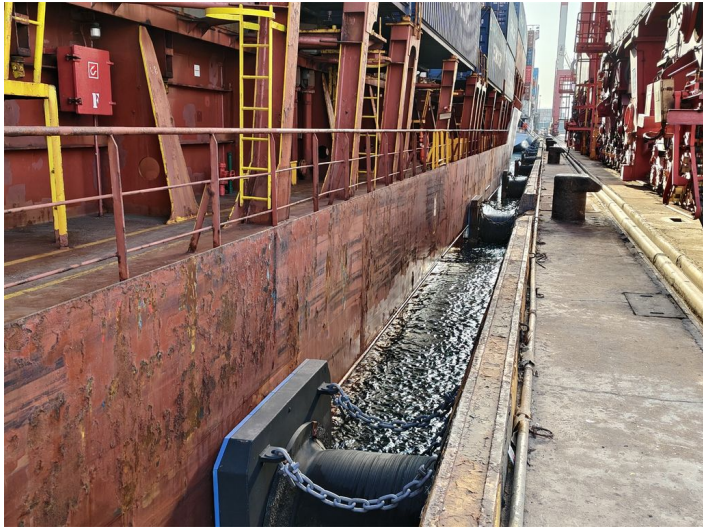
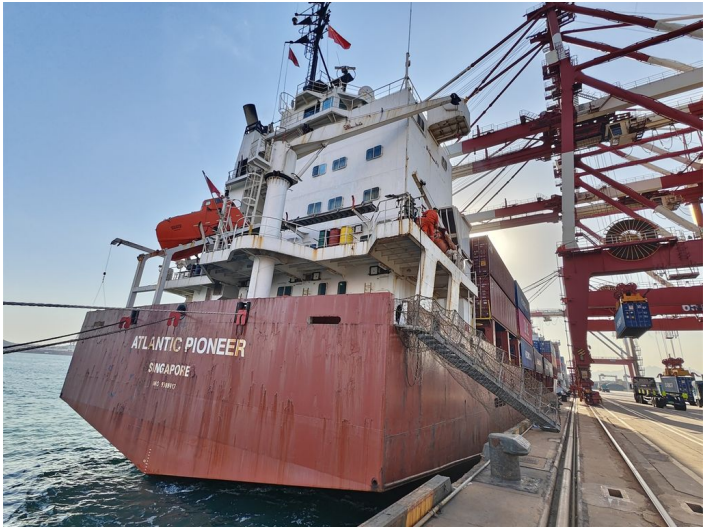
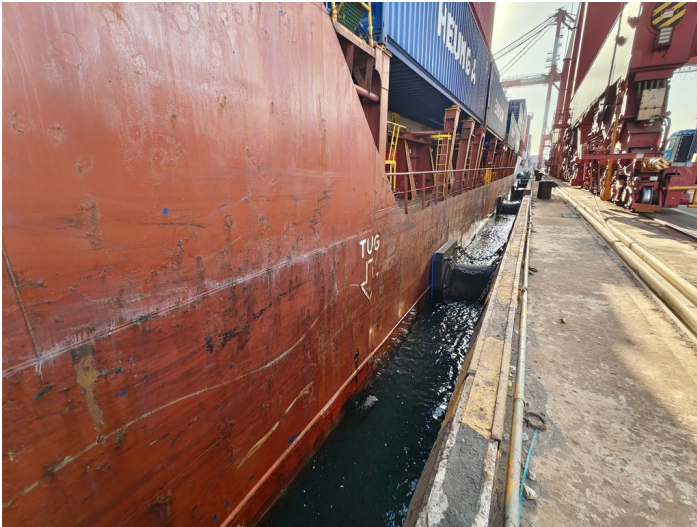
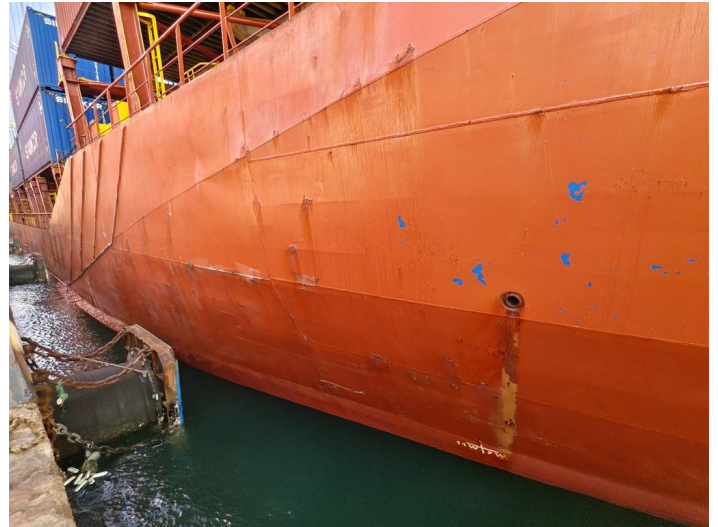
| Priority | Description | Recommendations |
|---|---|---|
| | <p>Defect ID: 2-319-507-456</p> <p>Coating breakdown and corrosion on the hull was seen to be moderate, notably on the top side and vertical side aft and at midships.</p> | <p>Areas of coating breakdown and corrosion should be addressed when possible.</p> |

| What was the level of Hull coating breakdown and corrosion? | Moderate |
| Coating breakdown and corrosion was mainly located in the following areas: | corrosion was observed mainly located in the top side aft and at midship area. coating breakdown observed on the vertical side |

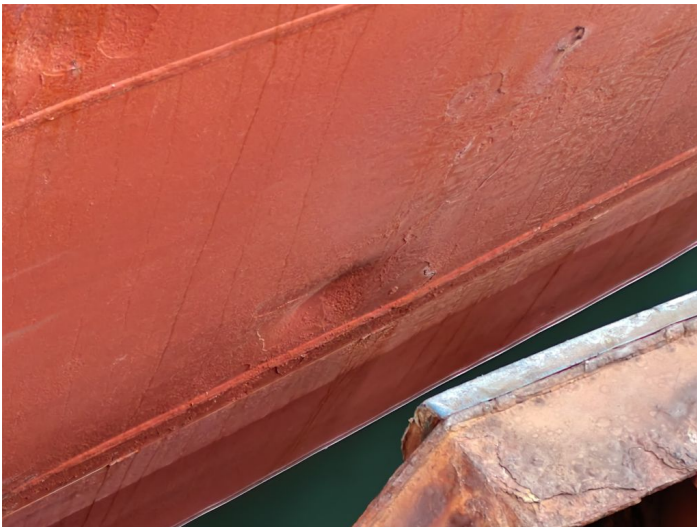
Defect ID: 2-243-952-640

Minor indentation was observed on the forward section on the starboard side of the hull. Diameter approximately 150mm, and depth approximately 20-30mm.

The areas of damage should be promptly inspected and monitored, and reported to class where required.

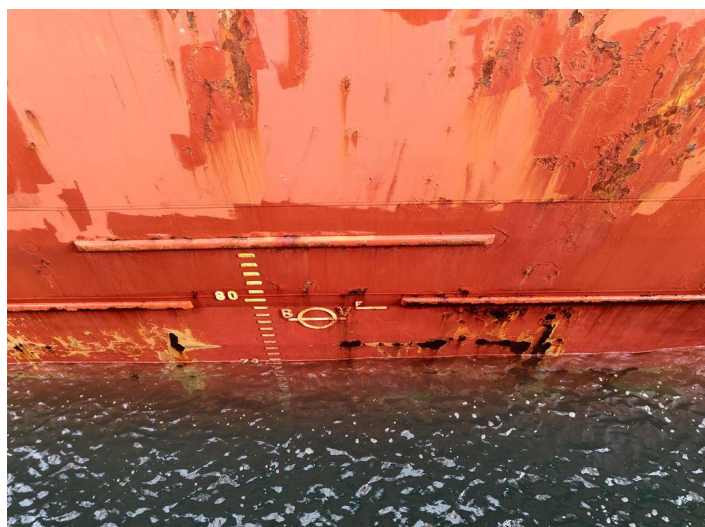
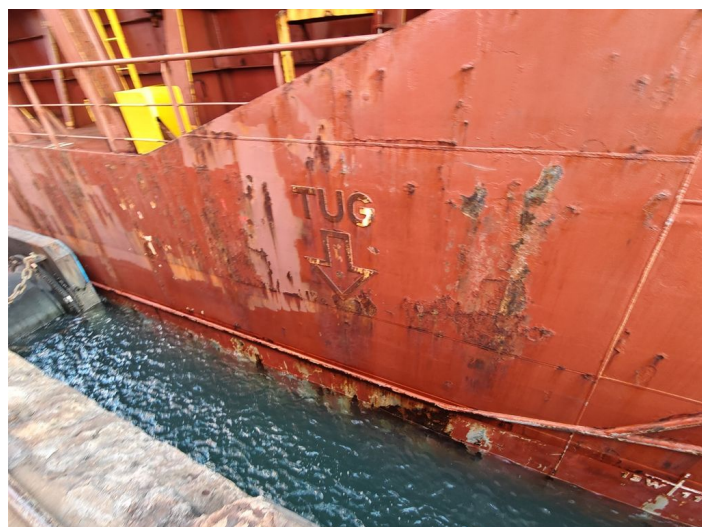
Defect ID: 2-319-470-593

Hull markings were seen to be partly obscured, notably the plimsoll marking and tug markings.

Touch up of hull markings should be considered at the earliest opportunity to ensure legibility.

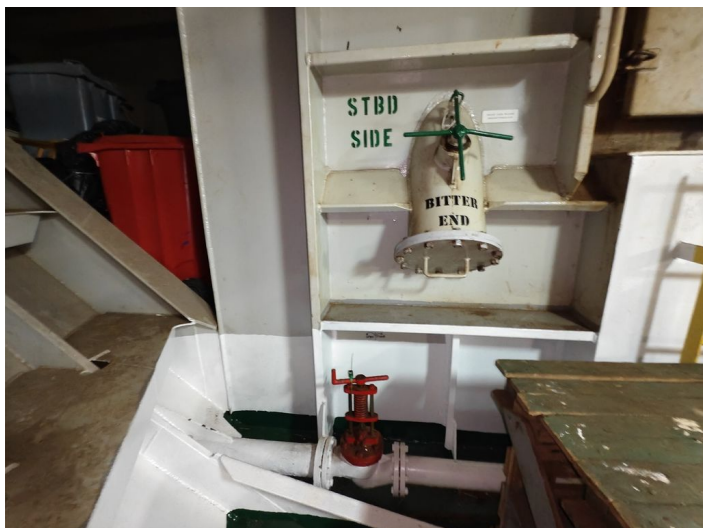
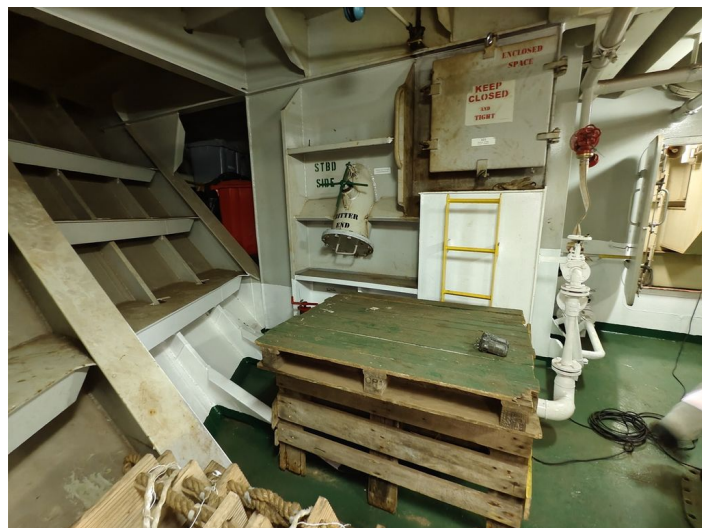
| Priority | Description | Recommendations |
|---|---|---|
| | Defect ID: 2-319-552-516<br>Bitter end release arrangements for the starboard anchor were obstructed. | Ensure easy access is provided to bitter end release arrangements. |

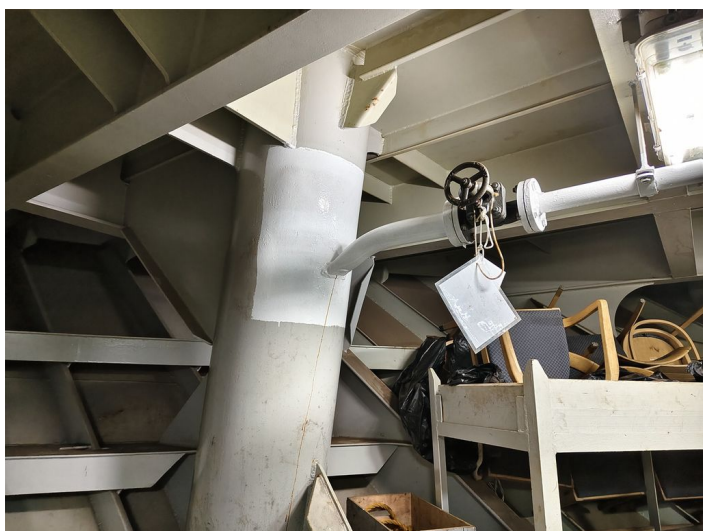
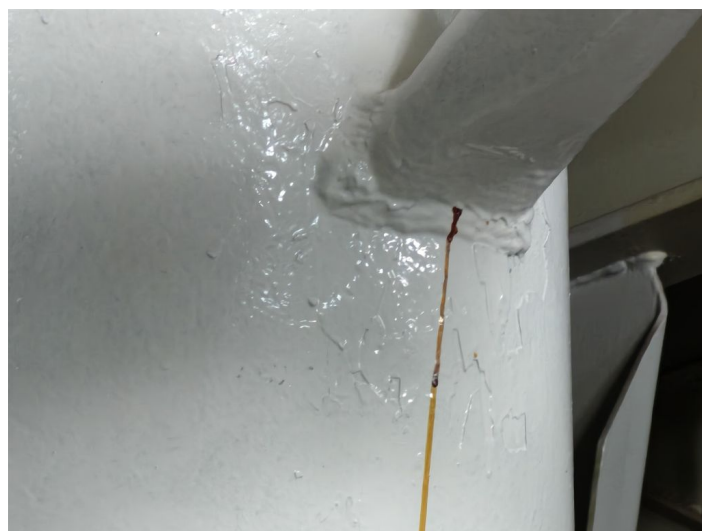
Defect ID: 2-319-556-630

A minor leak was observed from the port side anchor wash piping.

Remedial repairs to be carried out at the earliest opportunity.

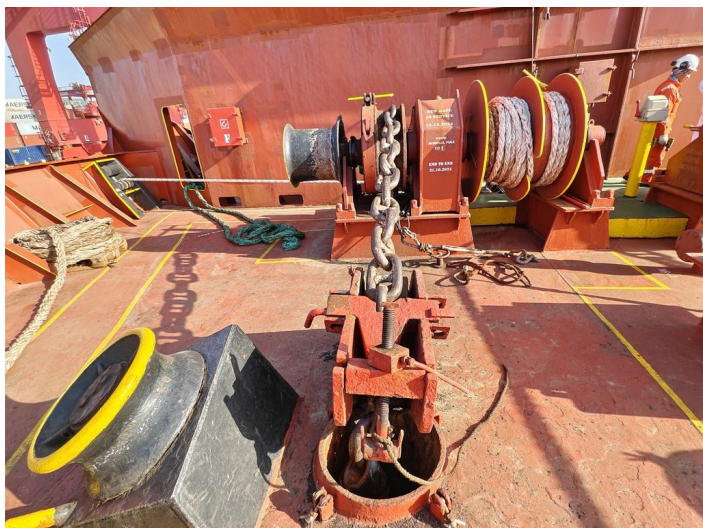
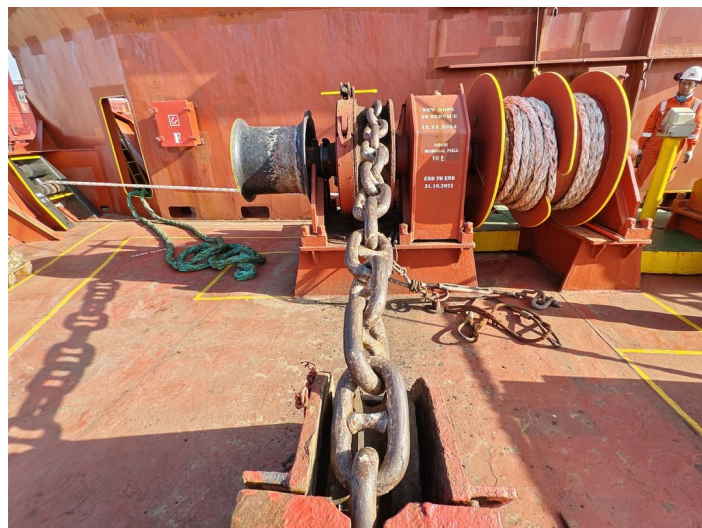
Defect ID: 2-319-486-999

The starboard anchor chain was noted to be twisted.

To be rectified at the next opportunity.

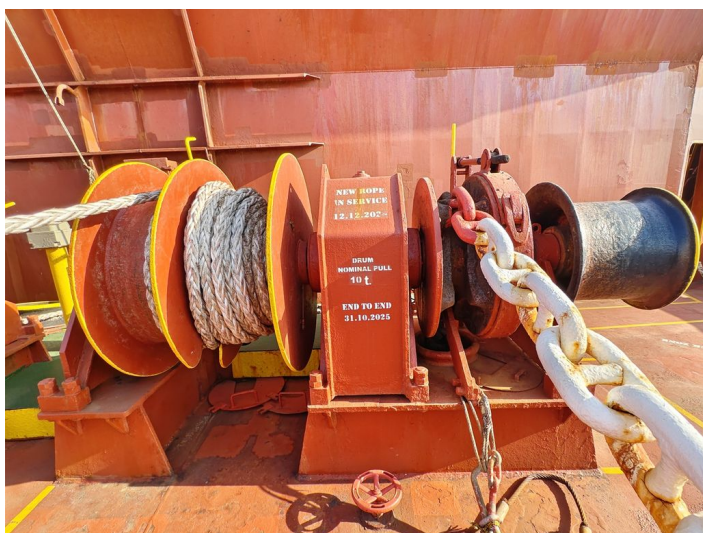
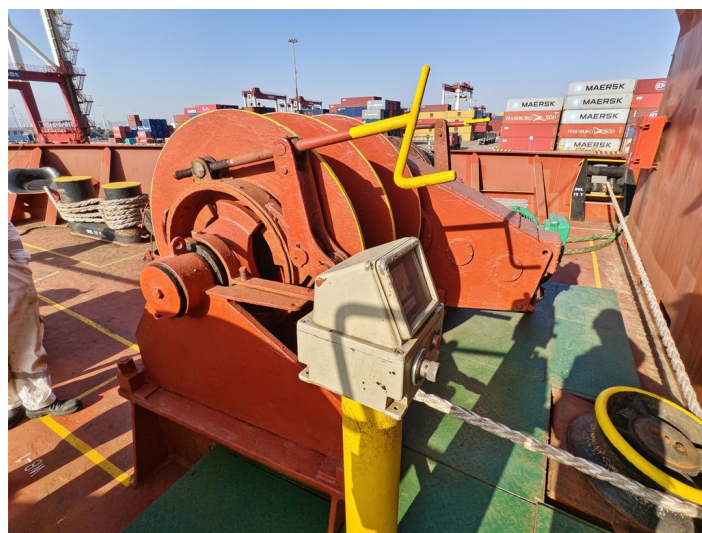
Defect ID: 2-319-536-131

The last brake test was not seen to be stencilled on the mooring winches.

The date of the last brake test should be stencilled on the mooring winches when possible.

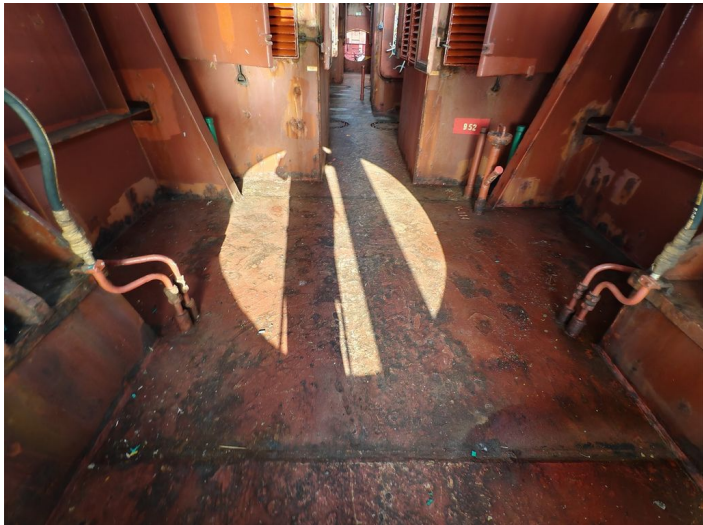
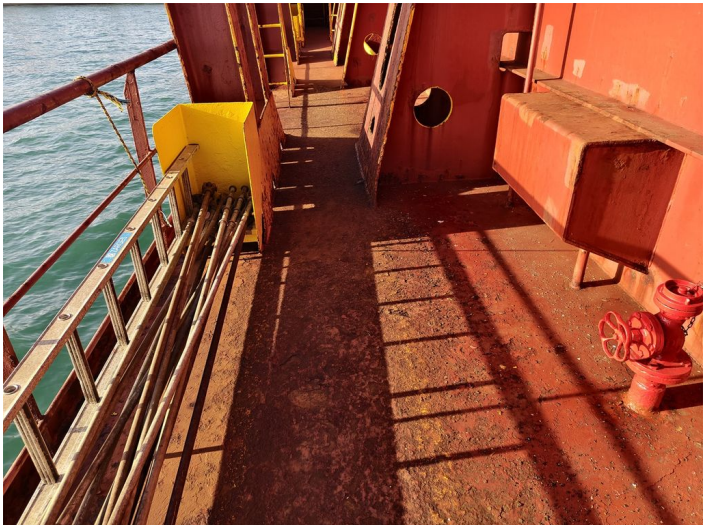
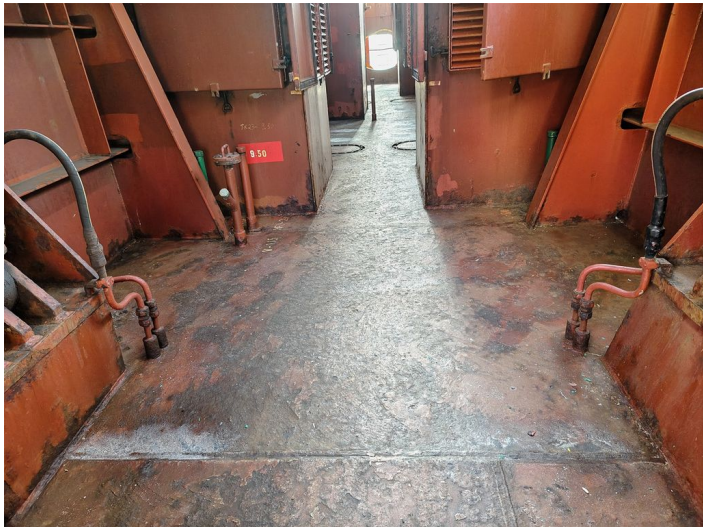
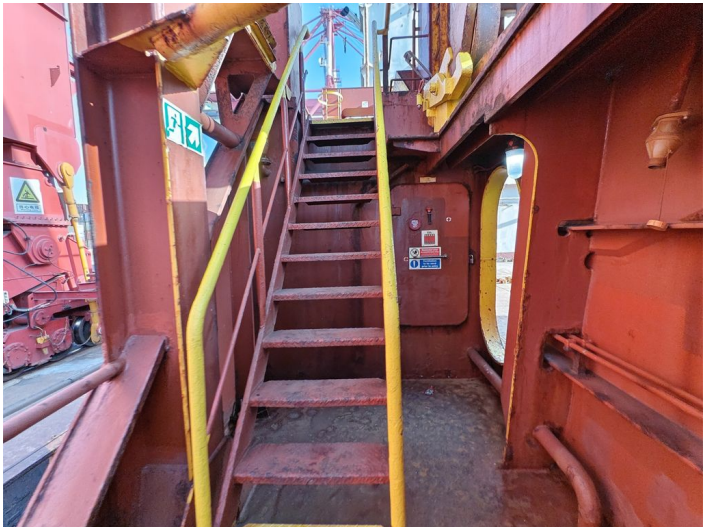
| Priority | Description | Recommendations |
|---|---|---|
| | <p>Defect ID: 2-319-618-067</p> <p>Coating breakdown and corrosion on the main deck was seen to be moderate, notably on the cross deck areas and the walkways on port and starboard.</p> | <p>Areas of coating breakdown and corrosion should be addressed when possible.</p> |

| Coating breakdown and corrosion was mainly located in the following areas: | Corrosion was observed mainly located on the main deck and cross deck areas |

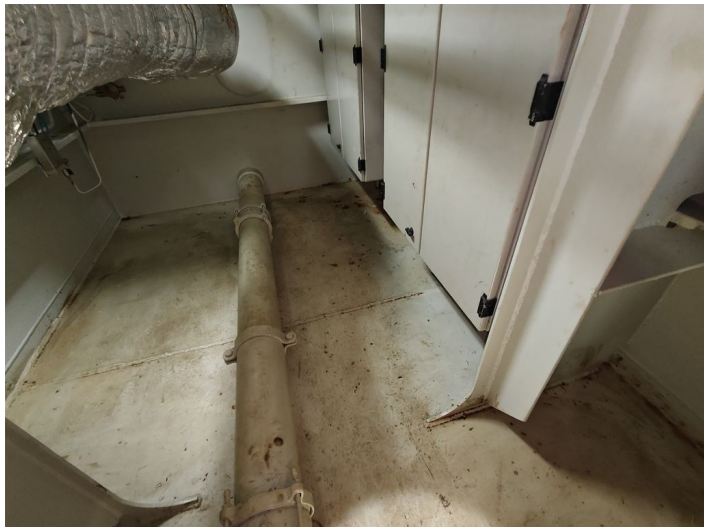
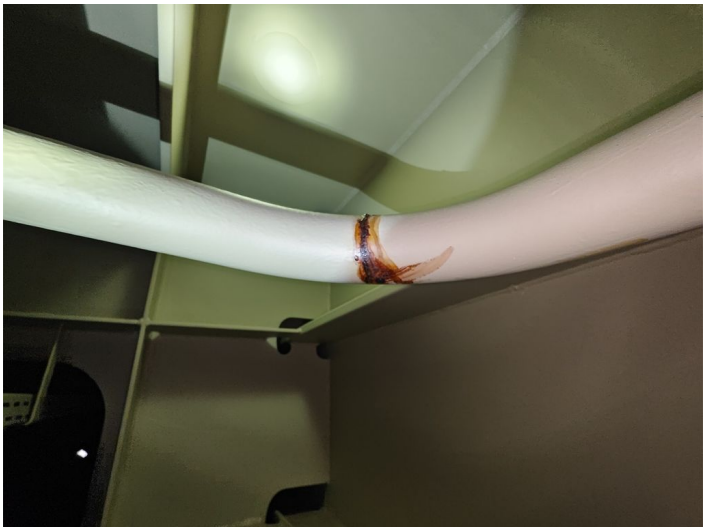
Defect ID: 2-831-187-968  
Evidence of a leakage observed from the drainage pipe in the passage way for the port side bunker station.

Chief officer will arrange to check and repair the leakage drainage pipe in due course

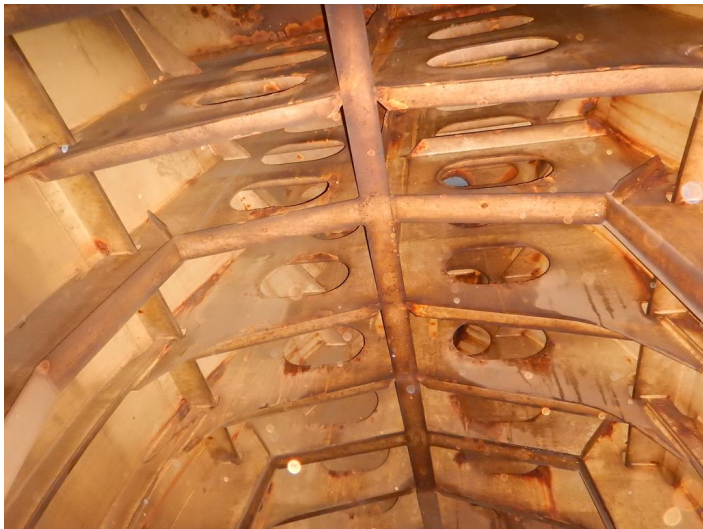
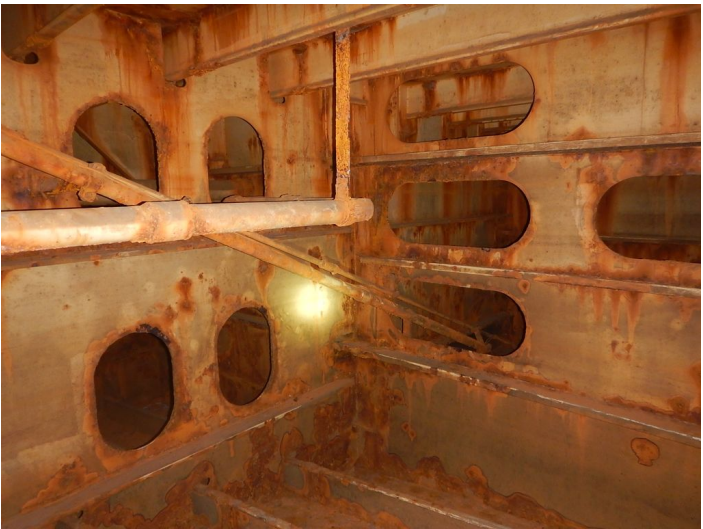
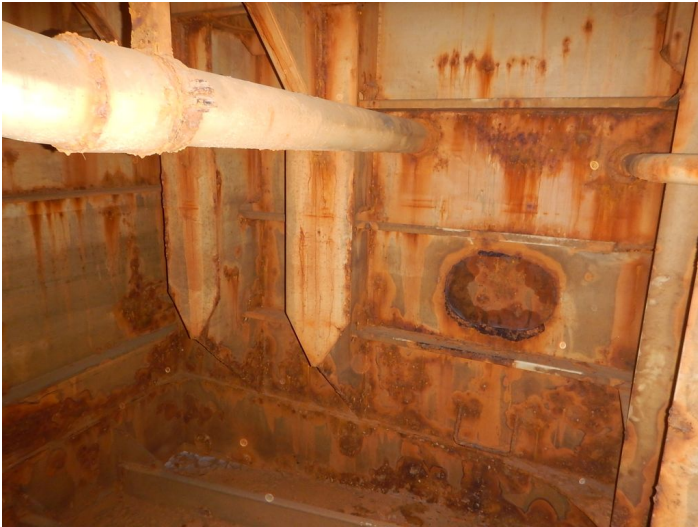
| Priority | Description | Recommendations |
|---|---|---|
| | <p>Defect ID: 2-319-515-653</p> <p>Coating breakdown and corrosion within the inspected ballast tanks was seen to be moderate, notably on the bulkheads, plating, free edges, longitudinals and stiffener plate.</p> | <p>Areas of coating breakdown and corrosion should be addressed when possible.</p> |

| Coating breakdown and corrosion was mainly located in the following areas: | mainly located in the tank frame, free edge, stiffener plate etc area. |

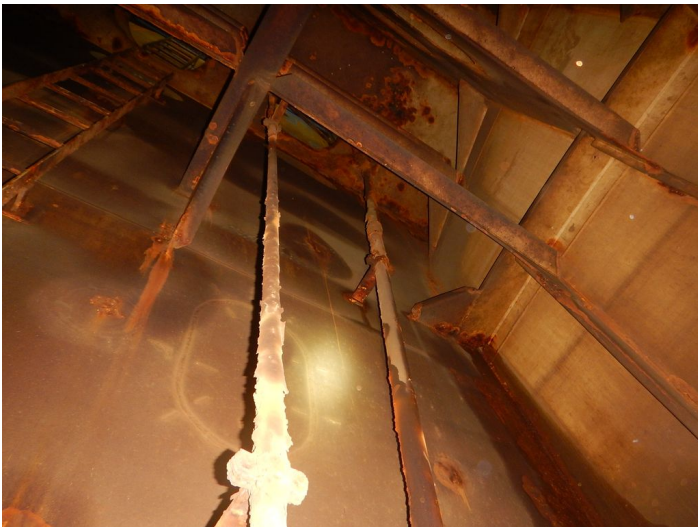
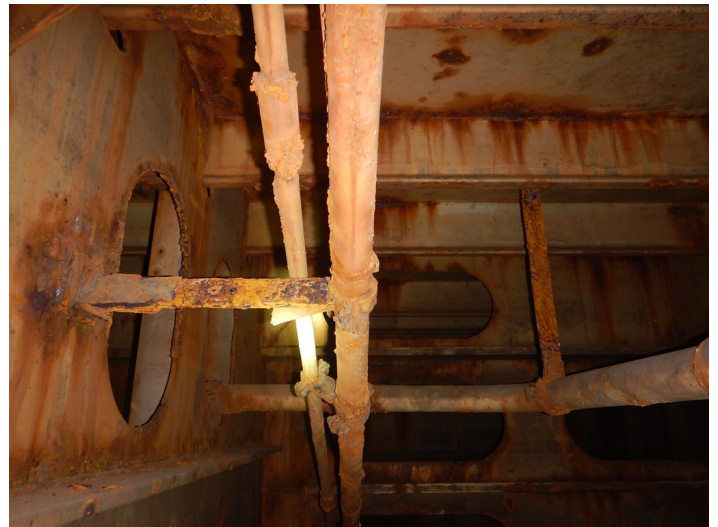
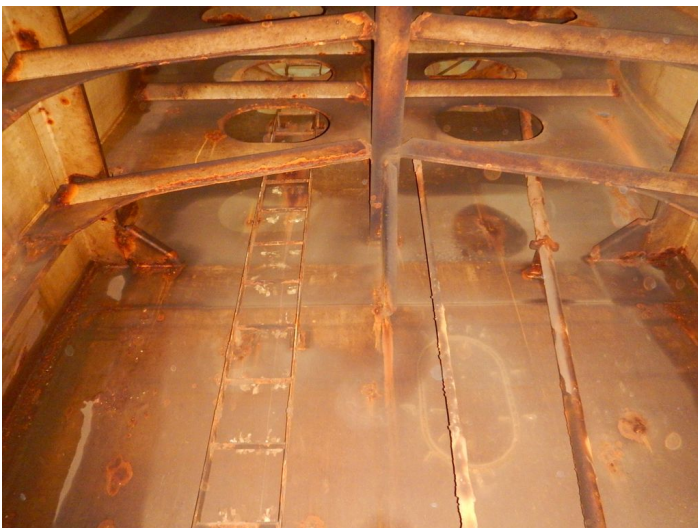
Defect ID: 2-319-671-302

Ballast tank fittings were found in a fair condition due to moderate coating breakdown and corrosion observed on the pipework, supporting brackets and ladders.

Areas of coating breakdown and corrosion should be addressed when possible.

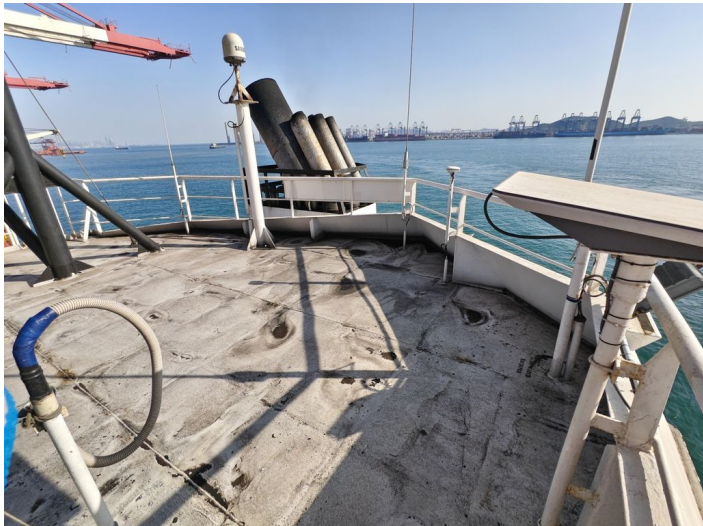
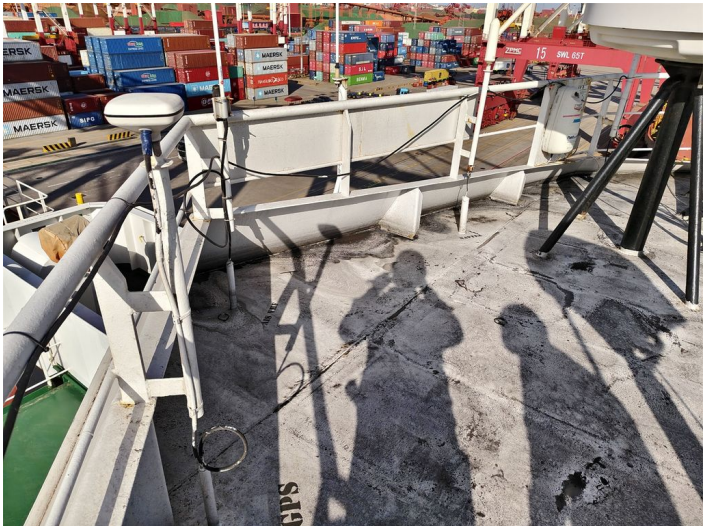
Defect ID: 2-319-667-210  
The monkey island was observed with deposits of soot on the deck plating.

Crew maintenance to be carried out when possible.

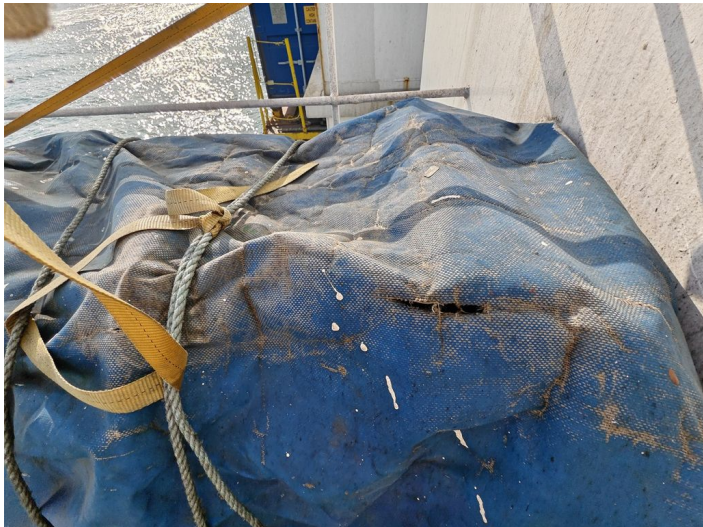
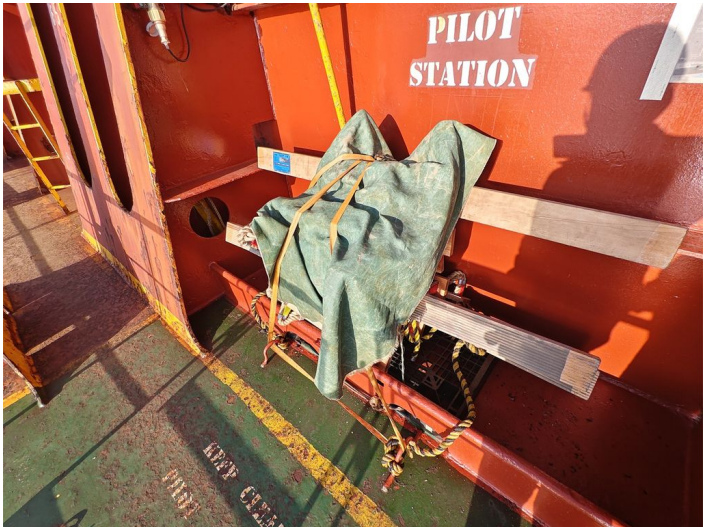
Defect ID: 2-319-581-197  
The covers of the embarkation ladders located on port and starboard were noted to be holed; additionally, the covers of the pilot ladders were notably small.

Remedial repairs to be carried out at the earliest opportunity.

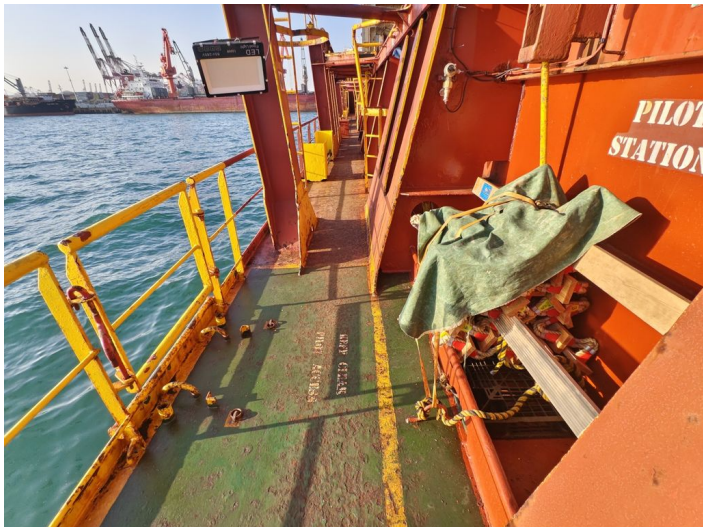
| Priority | Description | Recommendations |
|---|---|---|
| | <p>Defect ID: 2-319-704-078</p> <p>It was noted that the main deck was not applied with a suitable anti-slip coating.</p> | <p>Anti-slip coating to be reapplied as soon as possible.</p> |

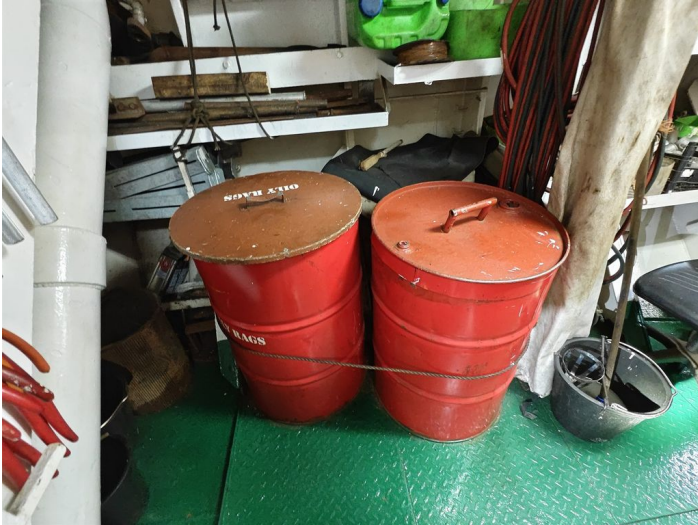
| Priority | Description | Recommendations |
|---|---|---|
| | Defect ID: 2-319-699-985<br>The lid on the garbage container for oily rags was not an approved material. | Arrange the supply of a suitable garbage container and lid made of a non-combustible material. |
