# A fast on-site measure-analyze-suppress response to control vortex-induced-vibration of a long-span bridge

## ABSTRACT

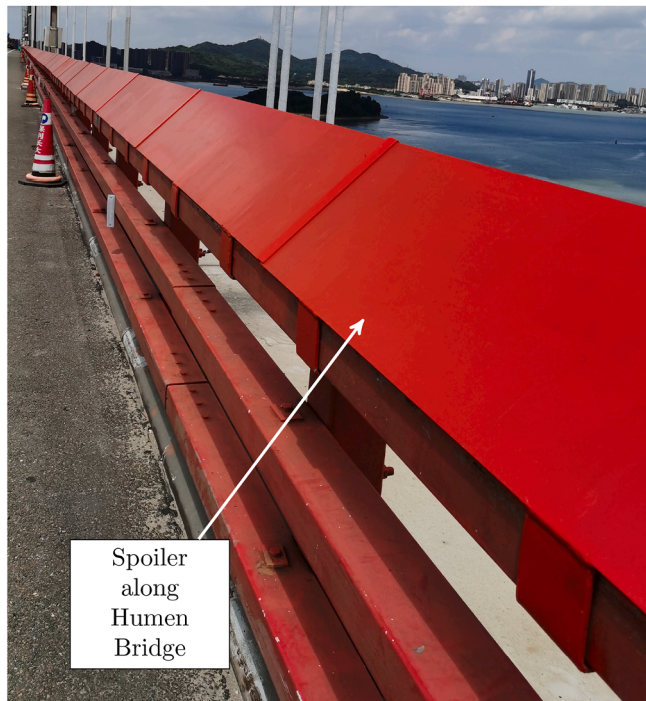
Fig. 13. Installation of spoiler on Humen Bridge.

On May 13 6 PM, 2020, when wind speeds were around 7 m/s, and wind direction was perpendicular to the bridge span. VIV happened again but at a much smaller amplitude, and, the recorded vortex at the wake was plotted in Fig. 14. It clearly shows that the major frequency of major vortex had been transferred to 0.05 Hz, which is far away from the fundamental frequency. However, there are several small peaks at different frequencies, which indicate that VIV is still possible, but the excitation forces are at a smaller range. If the Strouhal number is assumed as a constant value, the wind speeds should reach 21 m/s to excite the bridge to vibrate at considerable amplitude, which is very rare during monsoon season. The wind flow detected by LiDAE during non-VIV events at a smaller wind speed is also plotted in Fig. 15 which shows that the spectrum peak is at a even smaller frequency, which has a different characteristic comparing with the spectrum during VIV events.

Considering the feasibility of construction materials, a 40 cm width timber plates inclined 45° outward were suggested to be installed on the surface on the handrail along two sides of Humen Bridge, but initially, only about 120 m spoiler was installed at the middle of the bridge to testify its feasibility.

The sectional view and photos of the spoiler are illustrated in Fig. 13. In the meantime, the Doppler LiDAR was also deployed to detect the vortex feature.

After the verification, the spoiler was extended to the full span of Humen Bridge.
