# Bearing damage and failure analysis

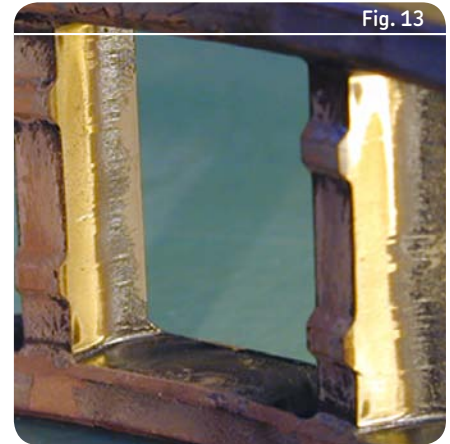
Fig. 13

The cage is a critical part of the bearing. Rings and rolling elements are hardened to approximately 60 HRC. Most metal cages are unhardened (sheet metal or brass). Under poor lubrication conditions, the cage may be the first component to wear. **Fig. 13** shows pocket wear in a solid brass cage.

*Abrasive wear on the cage bars of a cylindrical roller bearing*

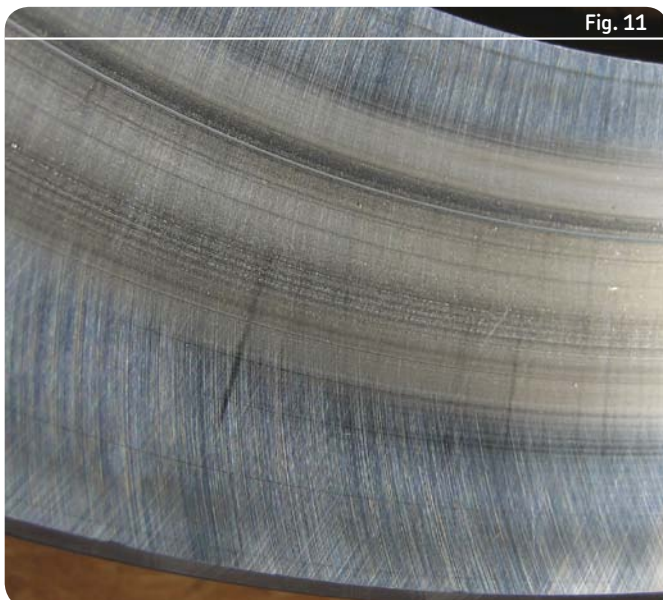
Fig. 11

*Light abrasive wear on the outer ring of a spherical roller thrust bearing*

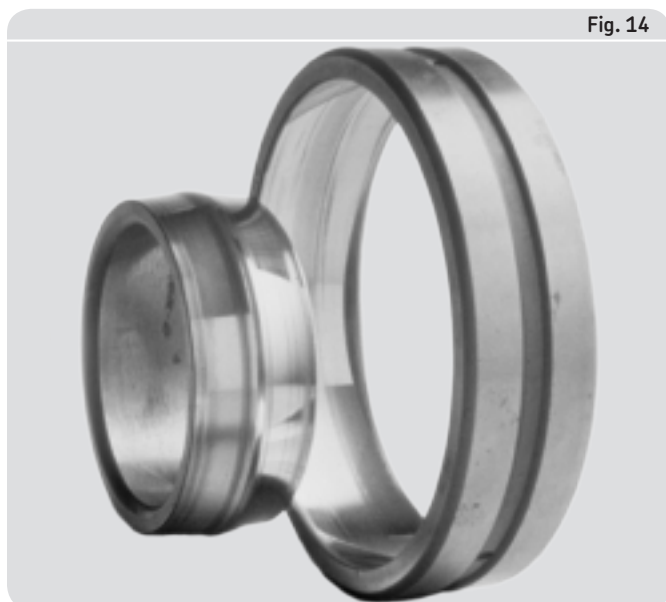
**Fig. 14**

*Polishing wear (mirror-like raceway surfaces) on the inner and outer rings of a spherical roller bearing*

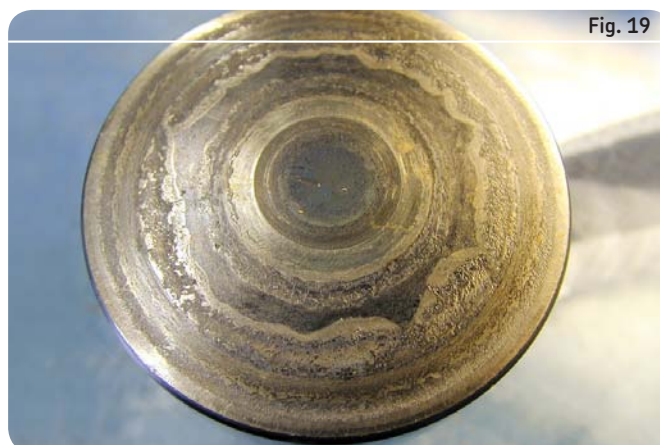
Fig. 19

Smearing can also occur between the cage and its contact surface and between the roller ends and guide flanges. **Fig. 19** shows a roller from a spherical roller thrust bearing that was riding against the guide flange. The roller end has smearing damage caused by inadequate lubrication.

*Smearing on a roller thrust face of a spherical roller thrust bearing*

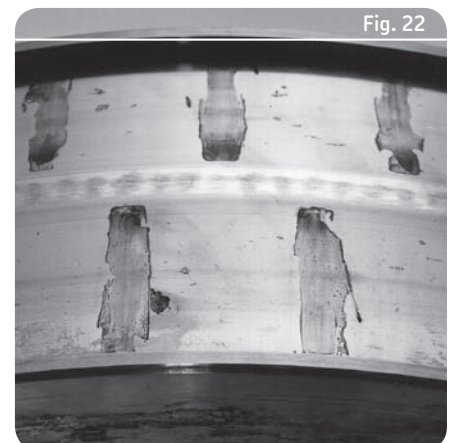
Fig. 22

*Initial patches of etching at rolling element pitch on the inner ring raceways of a spherical roller bearing*

Etching usually leads to premature, extended spalling as the material is subjected to a structural change and the surfaces in the load zone are reduced to such an extent that overloading occurs. The best way to avoid corrosion is to keep the lubricant free from water and aggressive liquids by adequately sealing the application. Using a lubricant with good rust-inhibiting properties also helps.

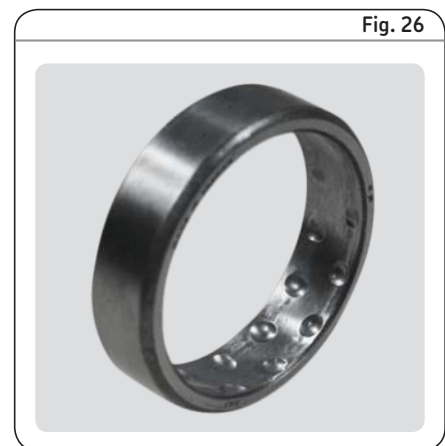
**Fig. 26** shows severe false brinelling damage caused to the outer ring of a self-aligning ball bearing at standstill.

**Fig. 26**  
*Severe false brinelling on the outer ring raceway of a self-aligning ball bearing*

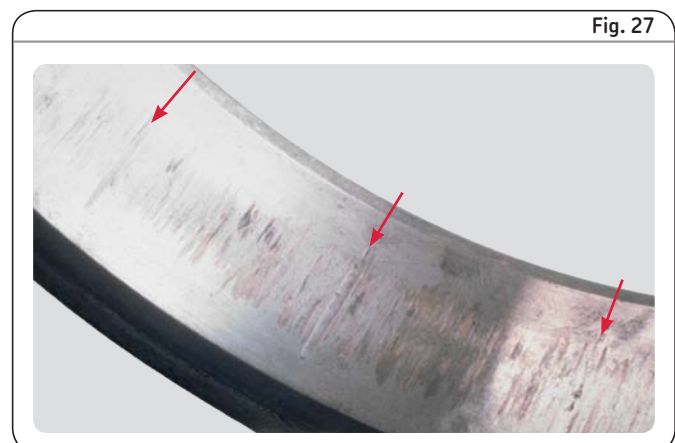
**Fig. 27** shows false brinelling damage on the outer ring of a cylindrical roller bearing. The root cause is vibration during standstill. The bearing was mounted in auxiliary equipment, with long standstill periods. Several sets of “flutes” can be observed at roller pitch, each set resulting from a period of standstill. The magnitude of damage depends on the level of vibration, frequency of vibration, and length of standstill.

*False brinelling (“flutes”) on the outer ring raceway of a cylindrical roller bearing*

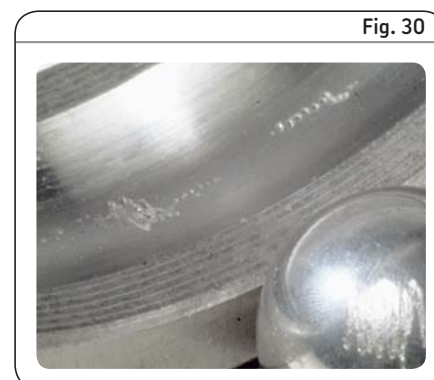
**Fig. 30** shows damage caused by excessive electrical current in a deep groove ball bearing, both on the outer ring raceway and ball. Notice the zigzag burns.

#### Excessive current erosion on the outer ring raceway and ball of a deep groove ball bearing

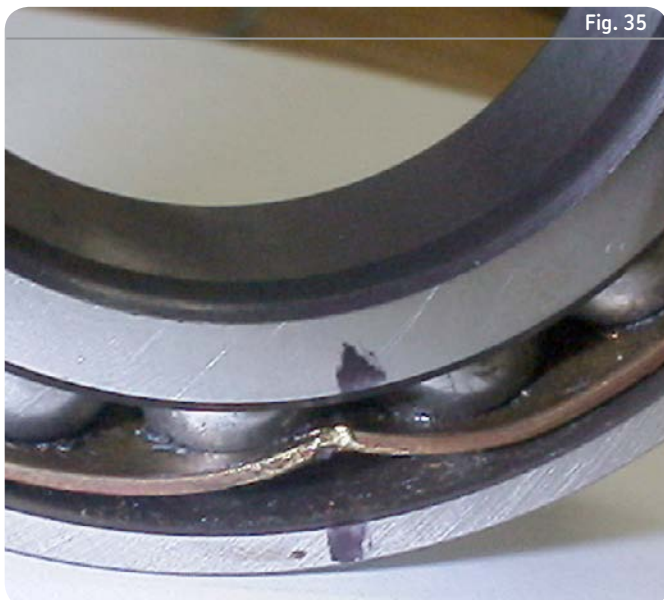
**Fig. 35** shows a case where a cage was hit directly, causing it to deform. If this bearing were put into operation, high noise and vibration levels would result.

*Plastic deformation on the cage of an angular contact ball bearing resulting from poor handling*

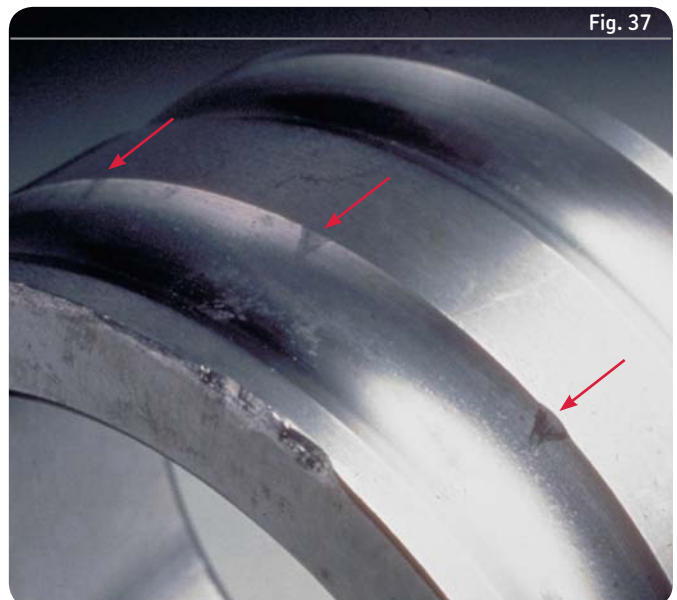
**Fig. 37**

Raceways and rolling elements may become dented if the mounting force is applied through the rolling elements (→ **fig. 36**), or if the bearing is subjected to abnormal loading while stationary. The distance between the indentations is at rolling element pitch (→ **fig. 37**).

*Indentations at ball pitch on the raceway of a double row angular contact ball bearing resulting from incorrect mounting*

The solution: always use the correct mounting tools and methods (→ **fig. 38**).

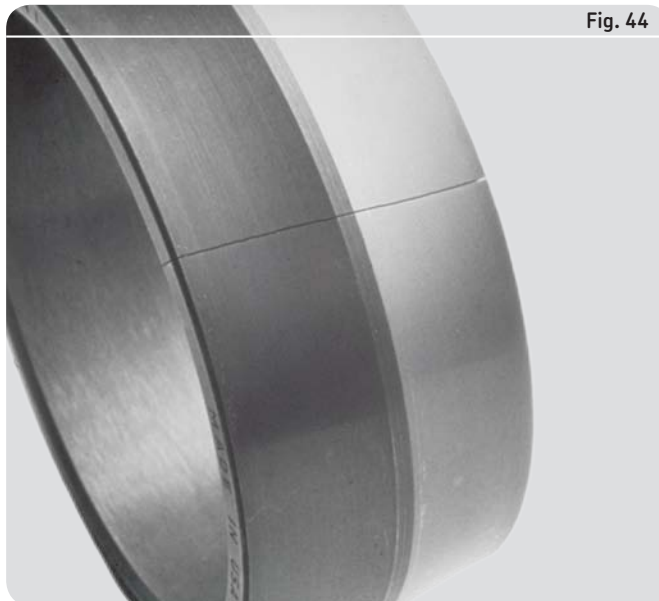
Fig. 44

Excessive drive-up (→ **fig. 44**) on a tapered seat can cause an inner ring to fracture. The hoop (tensile) stresses, arising in the ring as a result of excessive drive-up, cause the ring to crack through in service. Martensite hardened rings are more sensitive to this than bainite hardened rings.

*Fractured inner ring of a spherical roller bearing with a tapered bore resulting from excessive drive-up*

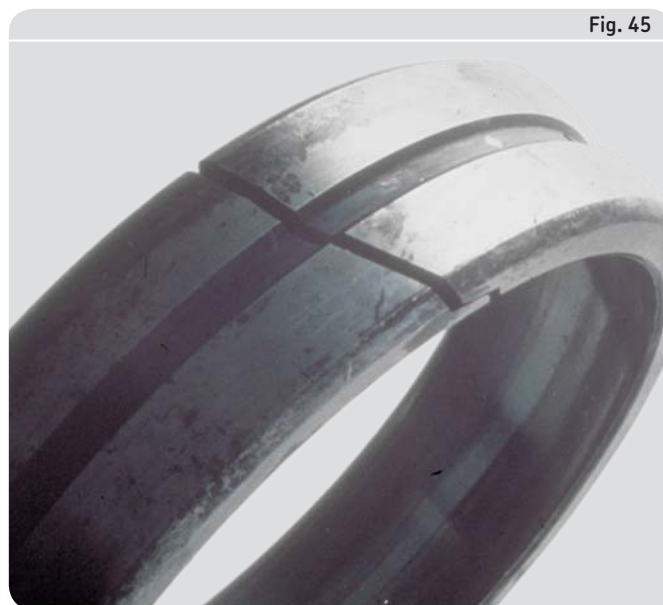
**Fig. 45**

*Fatigue fracture of an outer ring of a spherical roller bearing*

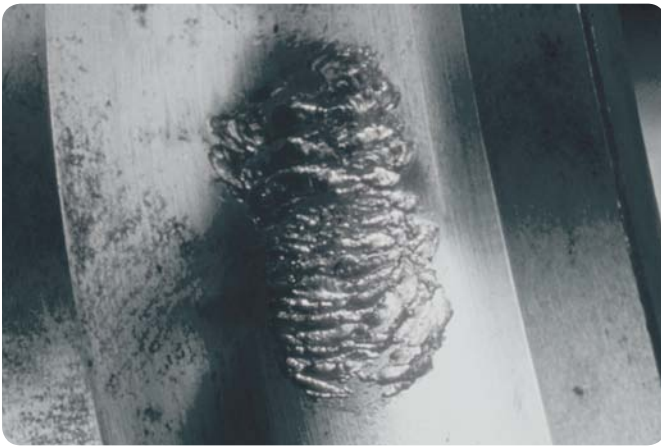
**Deep groove ball bearing inner ring**  
Material fatigue

- Make sure you have the right bearing for the actual application conditions and their variations (load, temperature, speed, misalignment, mounting, etc.)
- Use modern, state-of-the-art quality bearings
- If available, use SKF Explorer performance class bearings, which provide extended life
- Make sure adjacent components are properly designed and manufactured
- Mount correctly

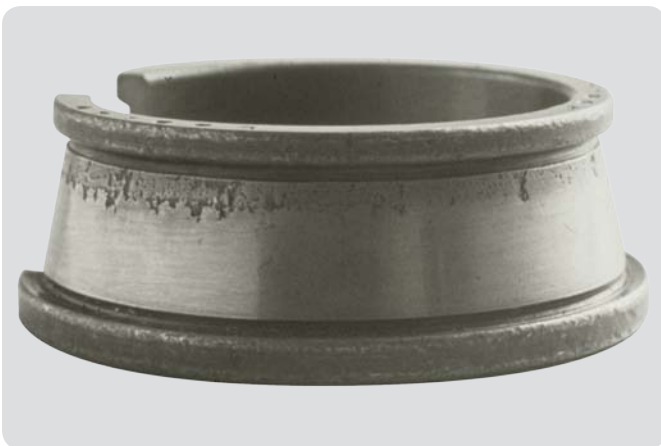
**Tapered roller bearing inner ring**  
Spalling on one side of the raceway only, resulting from misalignment and consequent edge loading, leading to higher stress and failure

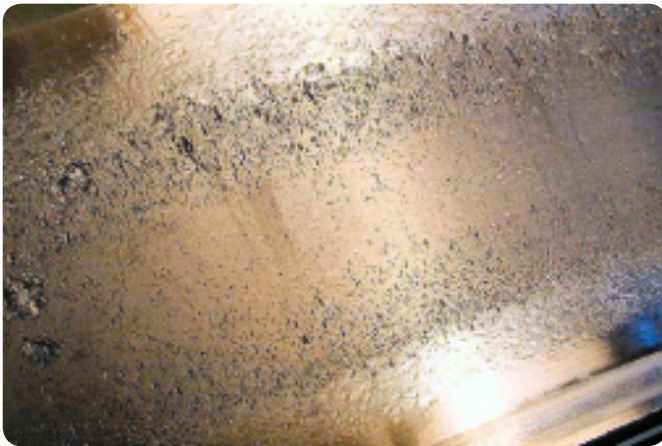
**Spherical roller bearing inner ring**  
*Inadequate lubrication, surface distress with incipient spalling*

- Make sure you have the right bearing for the actual application conditions and their variations (load, temperature, speed, misalignment, mounting, etc.)
- Make sure the lubrication is adequate: right lubricant, right quantity, right time
- Improve the surface separation capability of the lubricant (lubricant viscosity, additives, grease formulation)
- Check the lubricant quality at regular intervals
- Reduce the contamination (improved sealing, oil filtration)

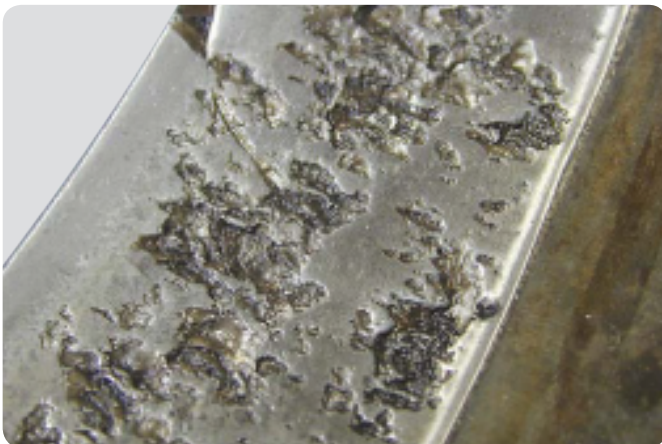
**Spherical roller bearing outer ring**  
*Initially, abrasive wear due to contamination, developed into surface distress and advanced spalling*

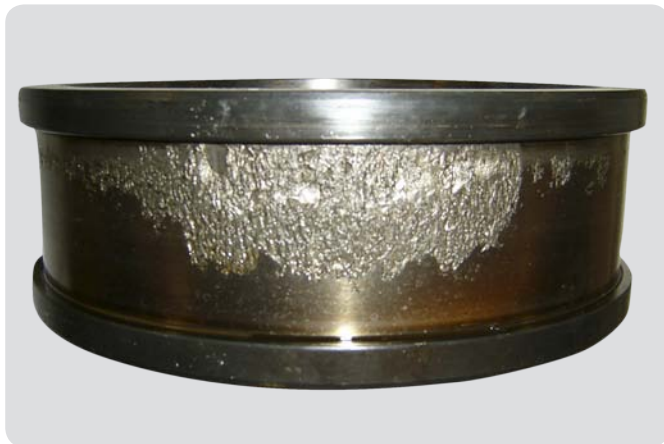
**Cylindrical roller bearing inner ring**  
Inadequate lubricant film, excessive misalignment, advanced surface distress

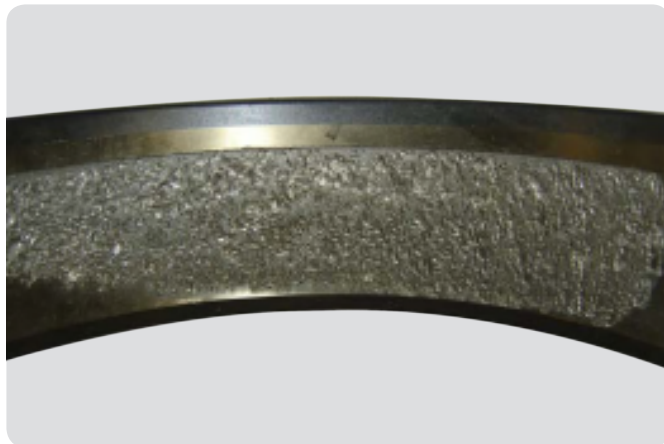
**Cylindrical roller bearing outer ring**  
Inadequate lubricant film, some misalignment, advanced surface distress

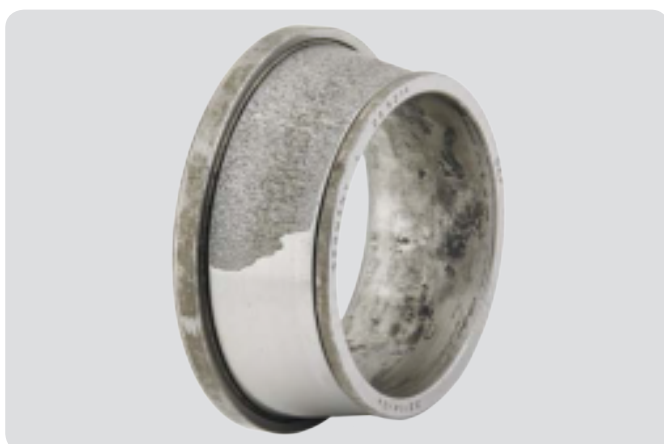
**Tapered roller bearing inner ring**  
Inadequate lubricant film, surface distress over a large area

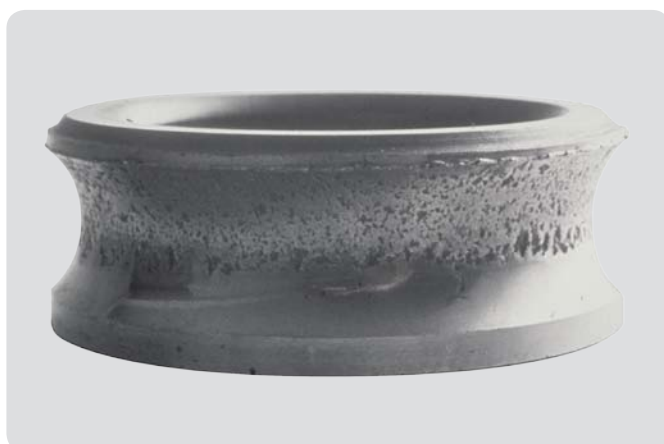
**Deep groove ball bearing inner ring**  
Excessive axial load, resulting in too thin lubricant film and surface distress

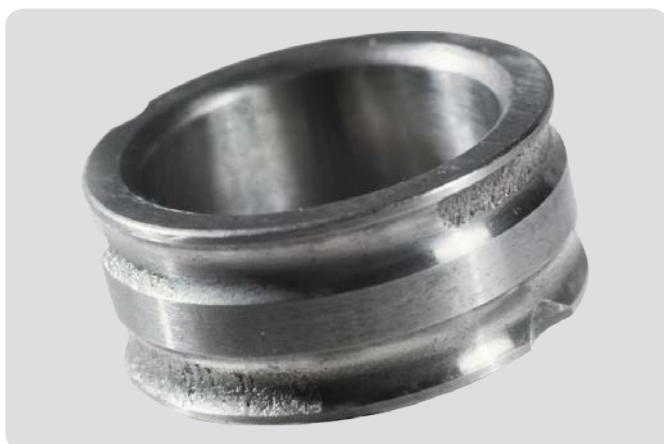
**Double row angular contact ball bearing inner ring**  
Excessive misalignment, resulting in excessive loads, with two load zones 180° apart.

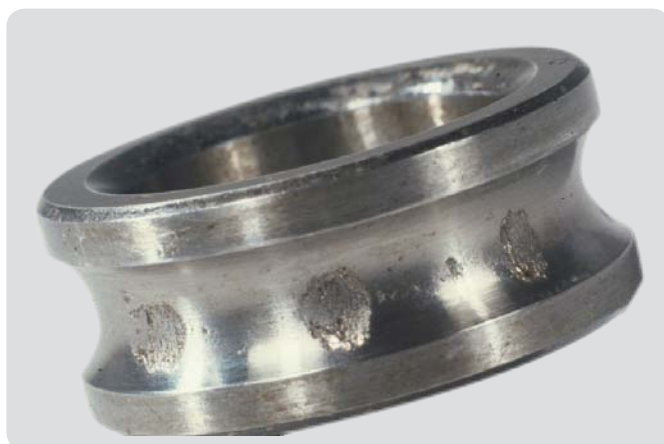
**Deep groove ball bearing inner ring**  
Impact during mounting, resulting in spalling at ball pitch

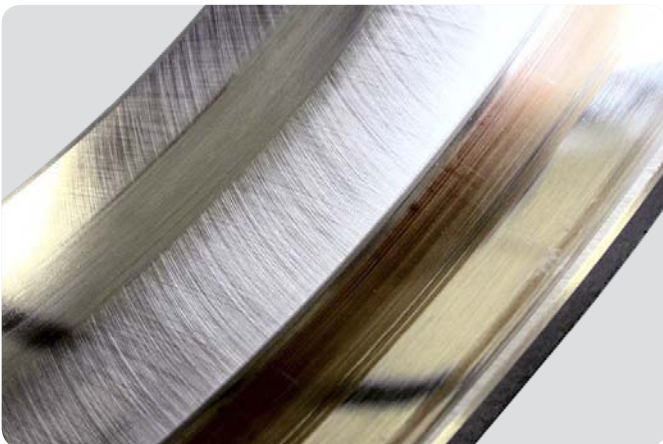
**Spherical roller bearing outer ring**

Abrasive wear of the raceway tracks. The axially loaded one also partly discolored indicating inadequate lubrication and heat generation. The other raceway track shows a narrower load pattern with a matt appearance.

- Make sure an adequate sealing arrangement is in place considering the operational conditions
- Make sure the lubrication is adequate: right lubricant, right quantity, right time
- Check the quality of the lubricant at regular intervals
- Check the quality of the sealing arrangement at regular intervals
- Make sure housing and shaft fits are adequate to avoid creep

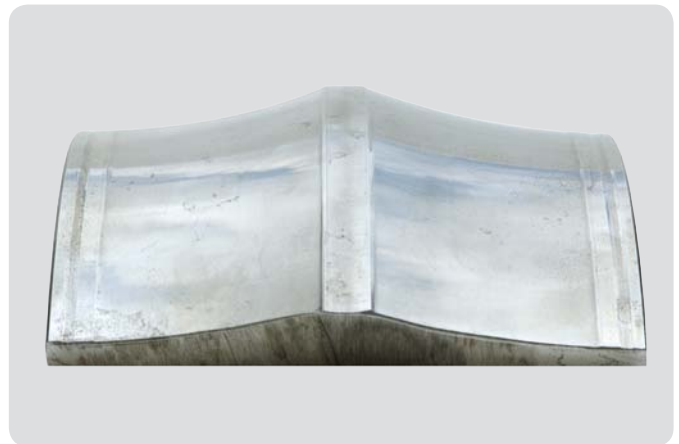
**Spherical roller bearing inner ring**

Contamination by fine particles – abrasive wear of the raceway tracks – rather shiny. Due to cage pocket wear, a groove has been cut by the cages on either side.

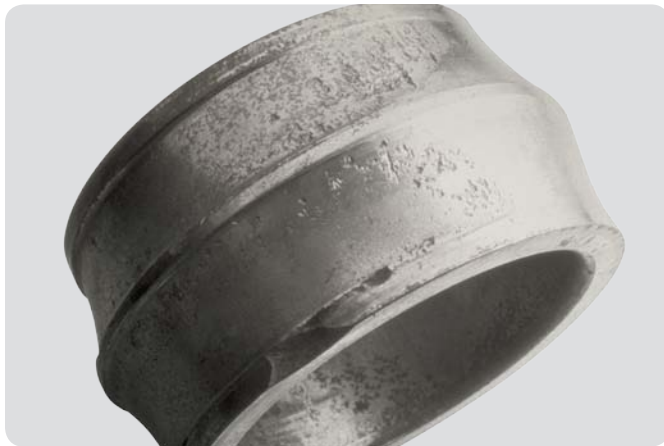
**Spherical roller bearing inner ring**

Contamination and resulting inadequate lubrication leading to abrasive wear of the raceway tracks – one raceway track more damaged due to axial load

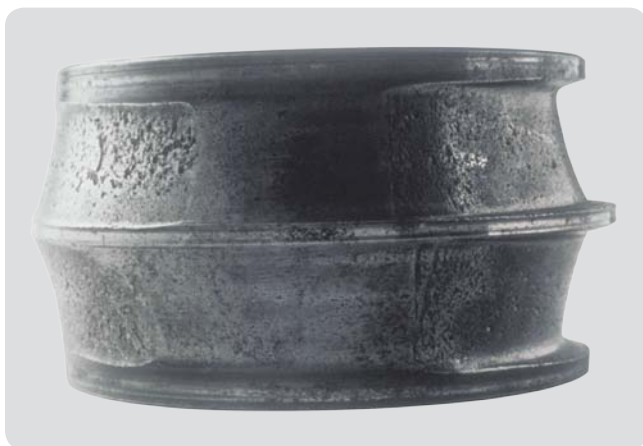
**Spherical roller bearing inner ring**

Inner ring stationary – heavy abrasive wear – two wear zones: one with heavy wear; then creep of the inner ring with subsequent second wear zone

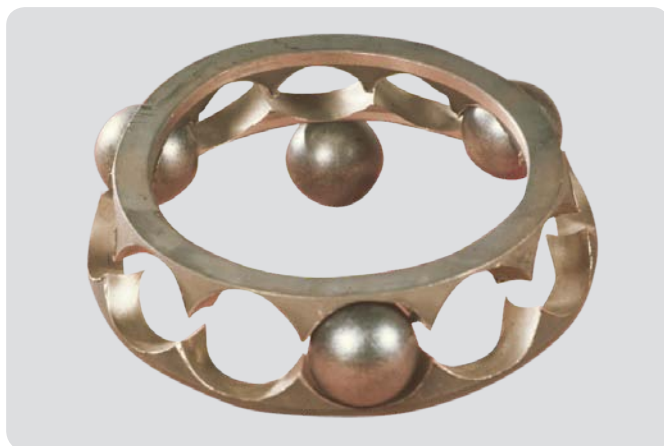
**Angular contact ball bearing cage**

Abrasive wear of the cage pockets due to inadequate lubrication and vibration. Cage bars worn away.

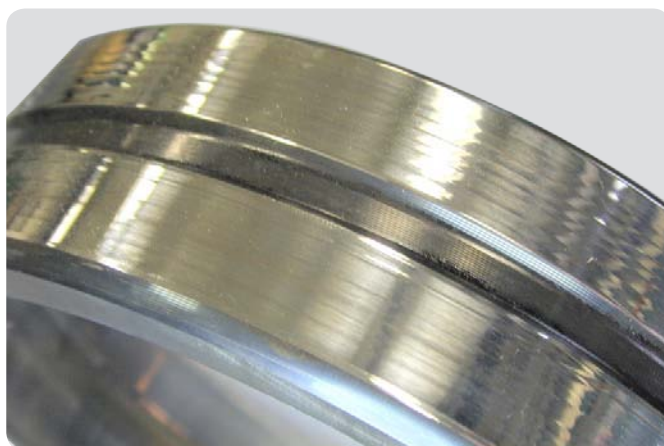
**Spherical roller bearing outer ring**

Ring creep in the housing from inadequate fit – polishing wear on the outside surface

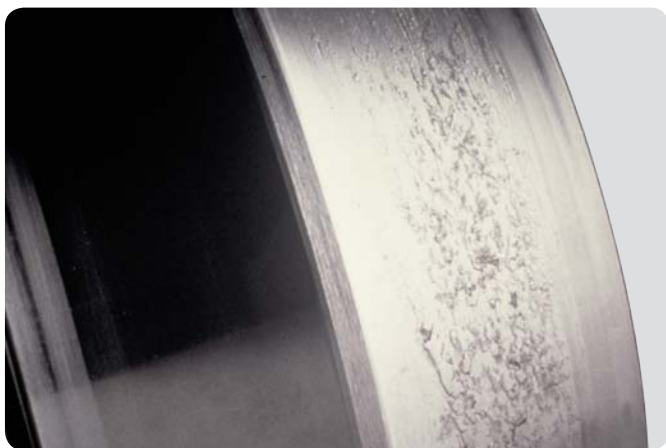
**Spherical roller bearing inner ring**  
*Too low load combined with inadequate lubrication*

- Make sure the bearing is adequately loaded
- Make sure the sealing arrangement is operating efficiently
- Consider bearing downsizing
- Verify lubricant selection (viscosity, AW and EP additives)
- Consider using coatings
- Consider using hybrid bearings

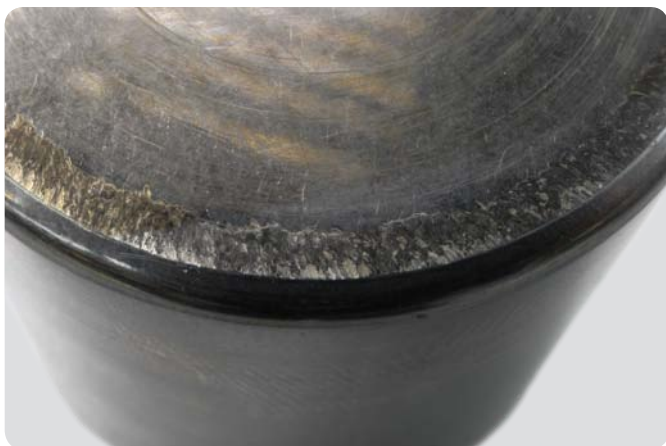
**Tapered roller bearing – roller**  
*Contamination and inadequate lubrication leading to adhesive wear marks on the large roller end face*

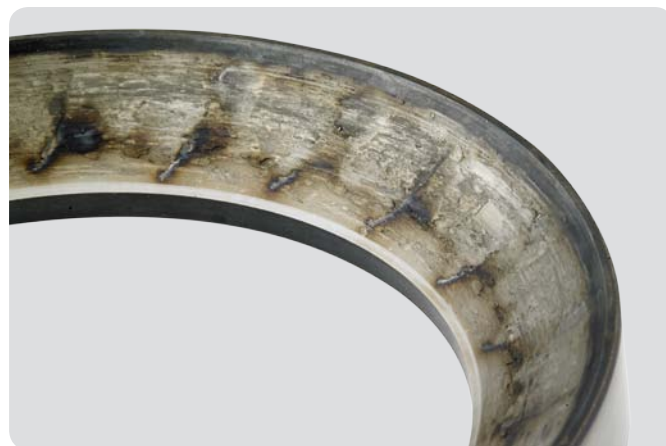
**Spherical roller thrust bearing outer ring**  
*Initially adhesive wear, then excessive heat generation, finally jamming*

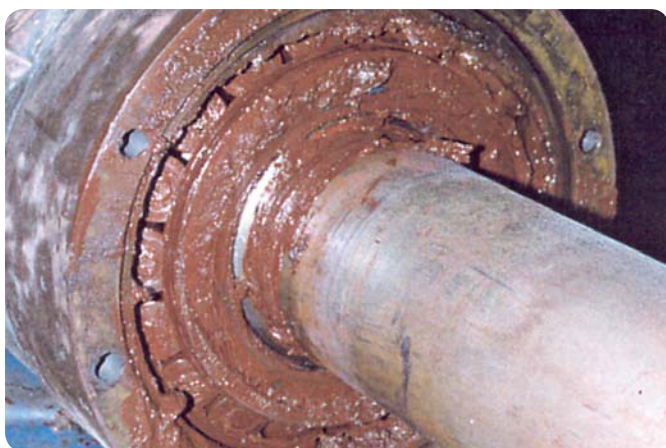
**Tapered roller bearing in a pump unit**  
 Seal failure, bearing corrosion and reddish discoloured grease

- Make sure the bearing arrangement is adequately protected
- Consider using sealed bearings in respect of the operating environment
- Make sure the lubrication is adequate: right lubricant, right quantity, right time
- Do not unpack bearings until mounting them
- Protect mounted bearings adequately

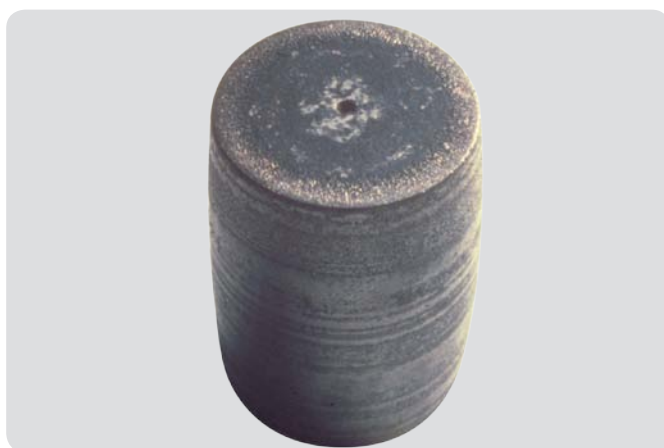
**Spherical roller bearing – roller**  
 Corroded roller due to severe water penetration into the bearing

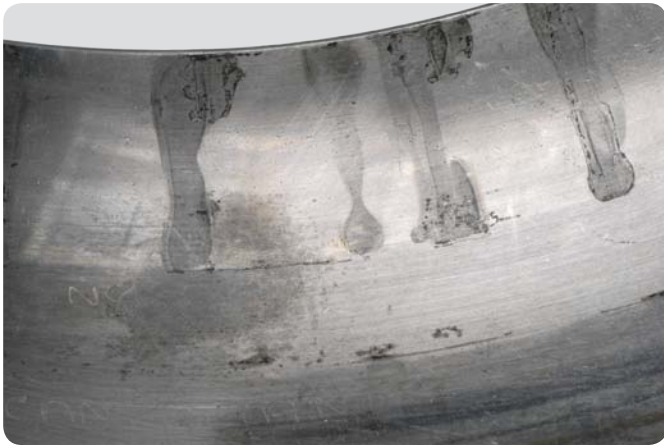
**Spherical roller bearing outer ring**

*Too high water content in lubricant, sets of etching marks at roller pitch at standstill*

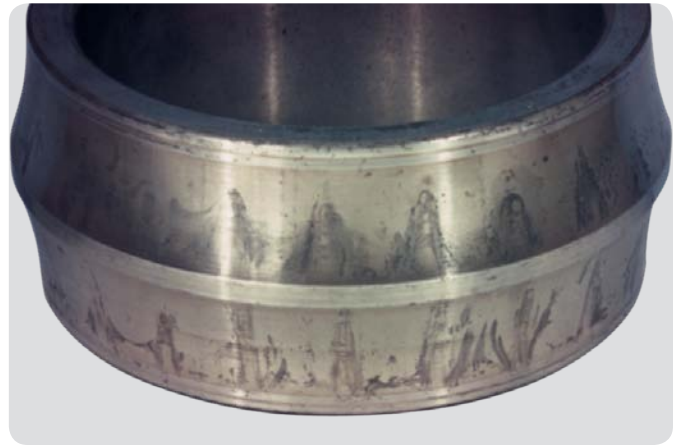
**Spherical roller bearing inner ring**

*Lubricant contaminated by water, etching marks at roller pitch at standstill*

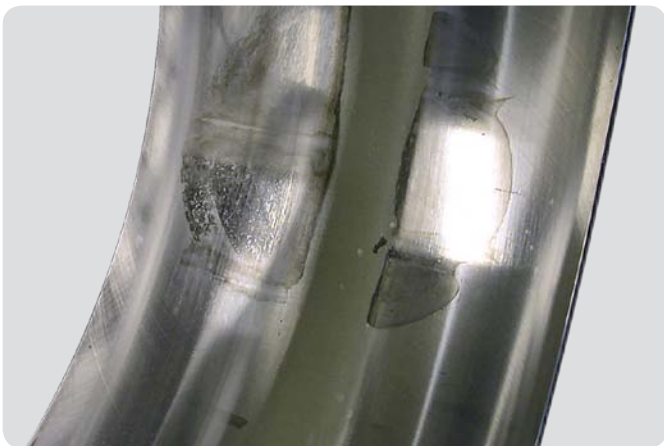
**Spherical roller bearing outer ring**

*Sealing arrangement failure, corrosion at standstill*

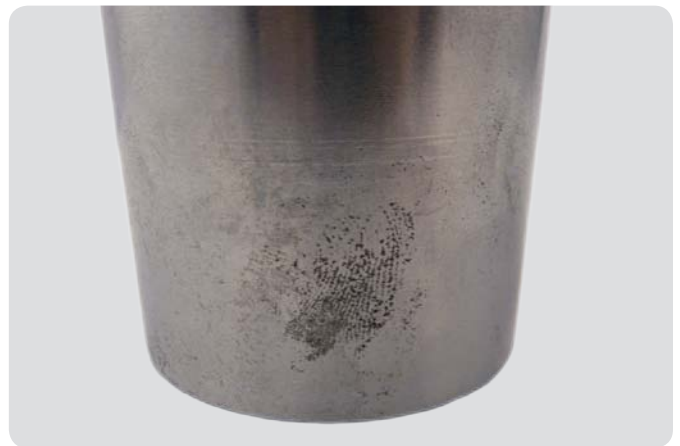
**Tapered roller bearing – roller**

*Rusty surface on raceway resulting from finger perspiration*

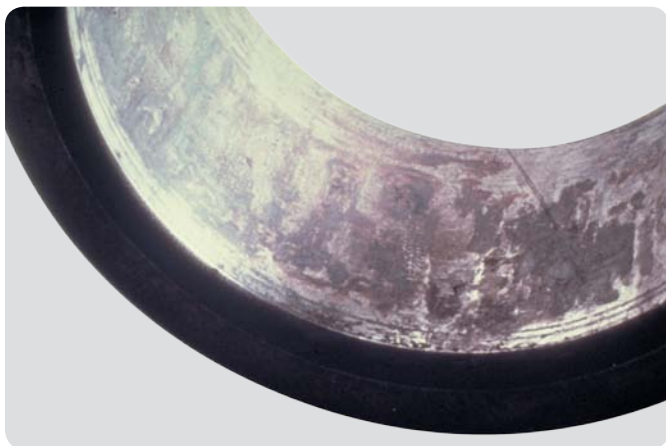
*Cylindrical roller bearing inner ring*  
Inappropriate shaft fit (too loose)

- Select appropriate fits
- Make sure the bearing seats are adequately machined
- Make sure the bearing seats conform to dimensional and geometrical specifications (even after overhaul of the machine)
- In the case of loose fits, consider applying an anti-fretting paste or coatings on one of the bearing surfaces

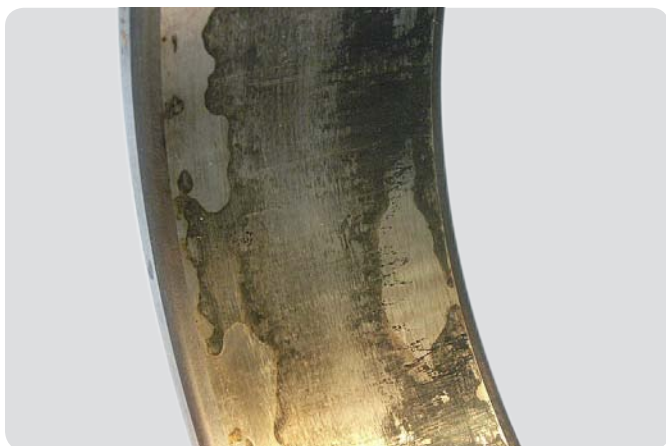
*Cylindrical roller bearing inner ring*  
Inappropriate shaft fit, uneven support

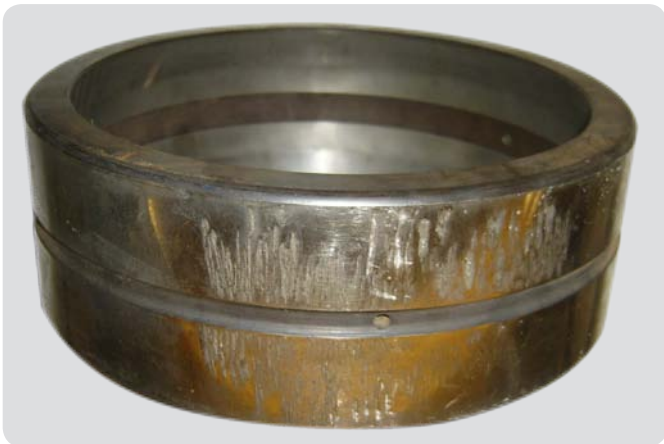
**Spherical roller bearing outer ring**  
Brown coloured fretting corrosion area from micromovements due to advanced raceway spalling, with scratches due to dismounting

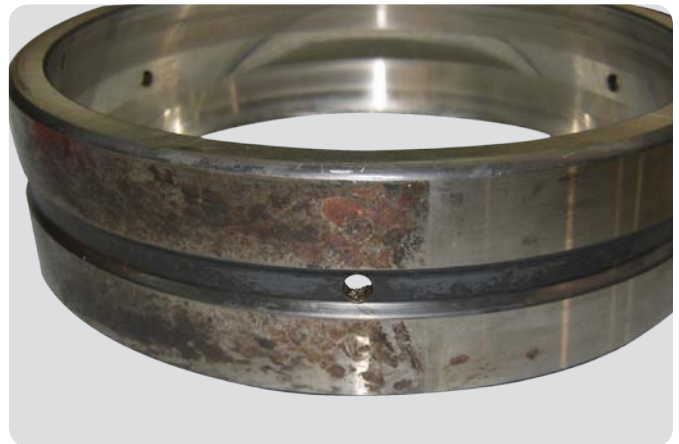
**Spherical roller bearing outer ring**  
Inadequately supported ring

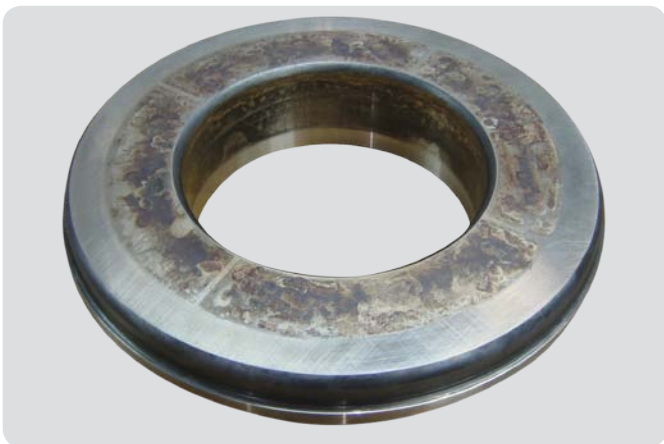
**Spherical roller thrust bearing shaft washer**  
Inadequate seat

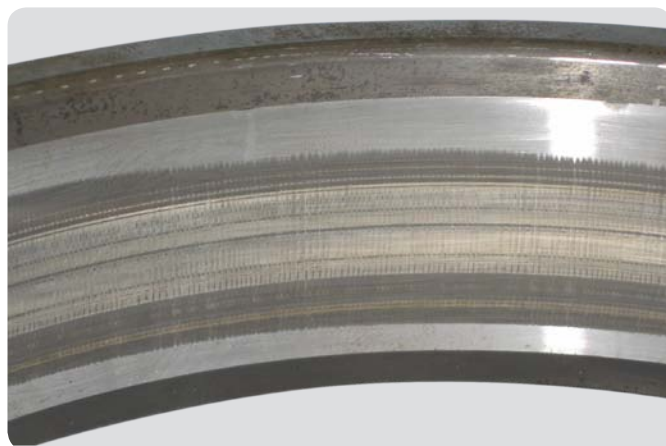
**Cylindrical roller bearing outer ring**  
Early stage of washboarding

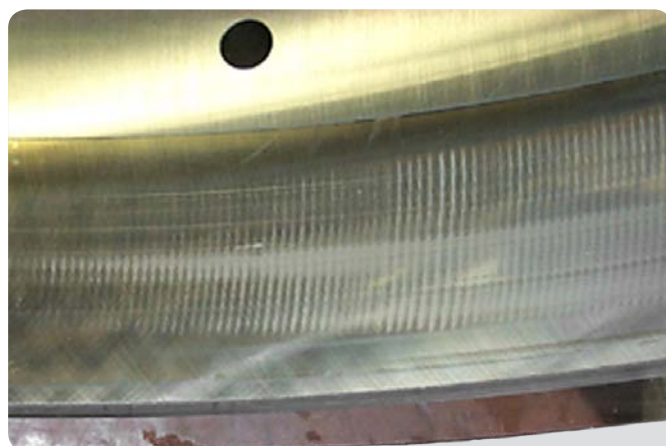
**Spherical roller bearing outer ring**  
Current leakage

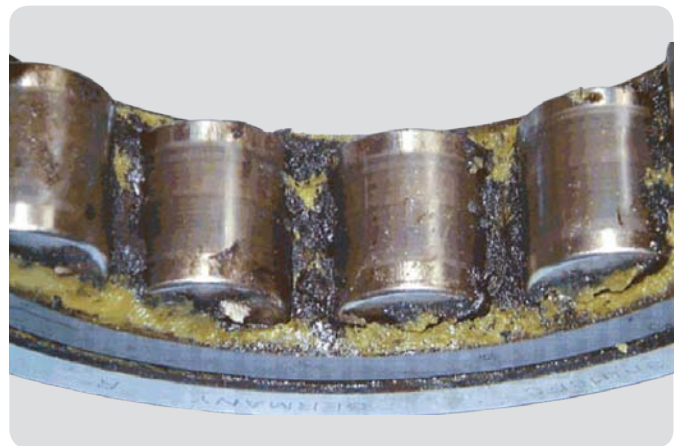
**Cylindrical roller bearing outer ring with cage, rollers and grease**  
Current leakage resulted in burnt grease (black) on the cage bars

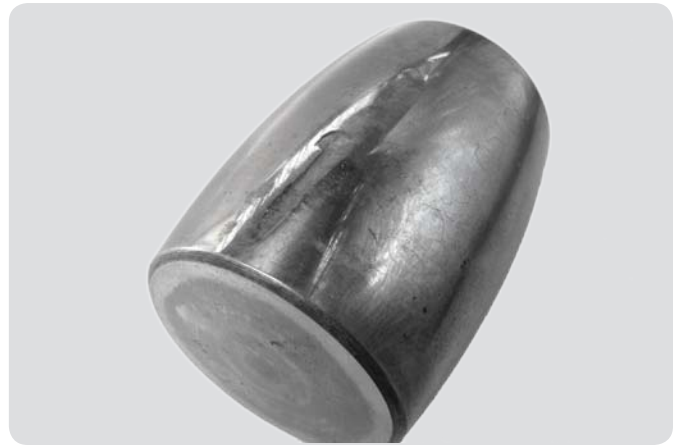
**Spherical roller thrust bearing – roller**  
Heavy impact, plastic deformation

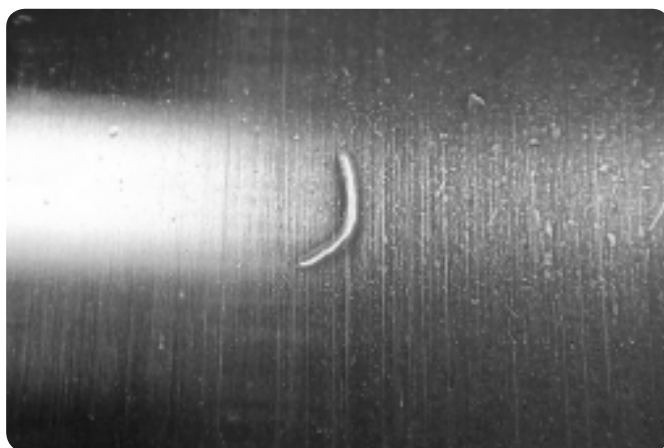
**Spherical roller bearing outer ring**  
Overrolled swarf/chip will lead to spalling

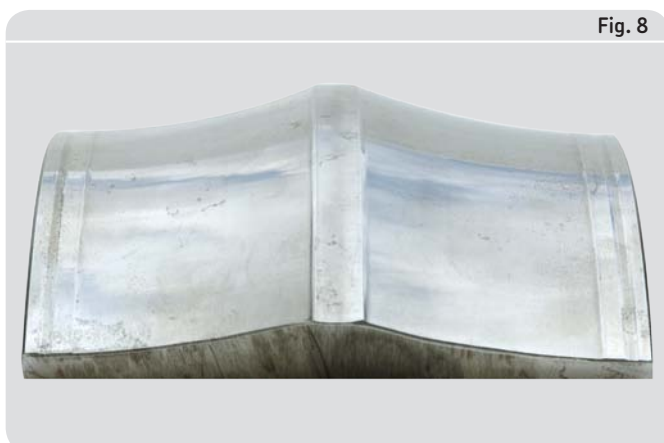
**Fig. 8**

The bore showed no signs of fretting corrosion and the side faces were undamaged. The raceways showed severe abrasive wear. On both raceways, the cages had cut a groove at the edge of the raceway, indicating that the cages were making contact with the raceways. The raceways were dull and grey in colour (→ fig. 8).

**Inner ring: Heavy abrasive wear on the raceways and a circumferential groove at both raceway edges**

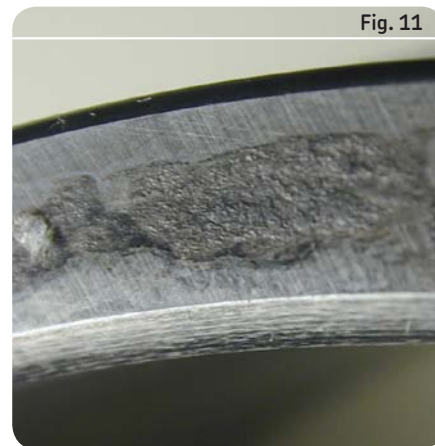
The side faces of the outer ring also showed fretting corrosion (→ fig. 11), which further confirms ring creep.

*Outer ring: Fretting corrosion on the side face*

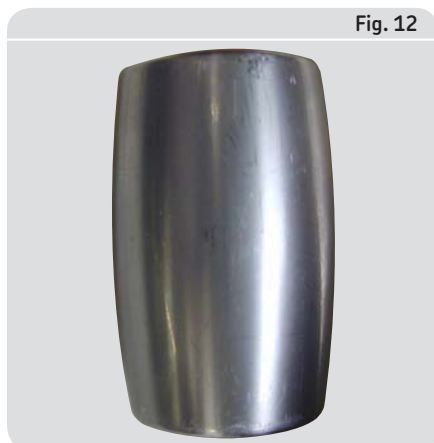
*Roller: Dull and grey colour*

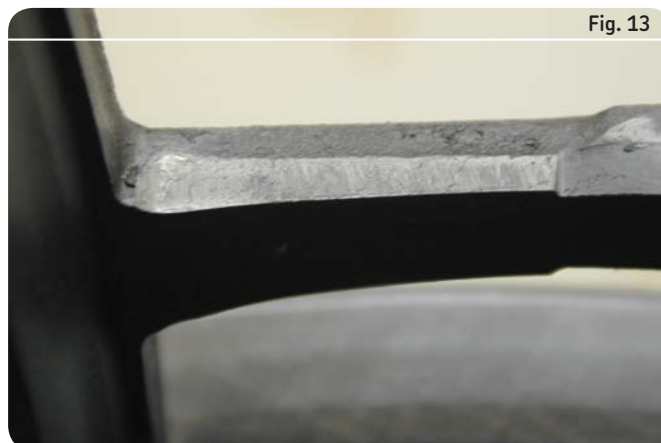
The pockets of the window-type cages exhibited abrasive wear. The cage bars were worn substantially (→ fig. 13).

*Cage: Pocket wear*

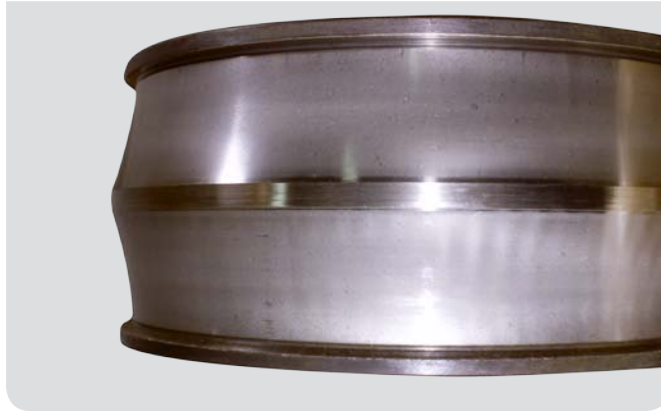
Fig. 17

There was heavy abrasive wear on the raceways (→ fig. 17). No other marks were visible.

The abrasive wear on the inner ring raceways was probably secondary damage due to the spalling, as the condition of the lubricant was found to be unacceptable.

*Inner ring: Abrasive wear on the raceways*

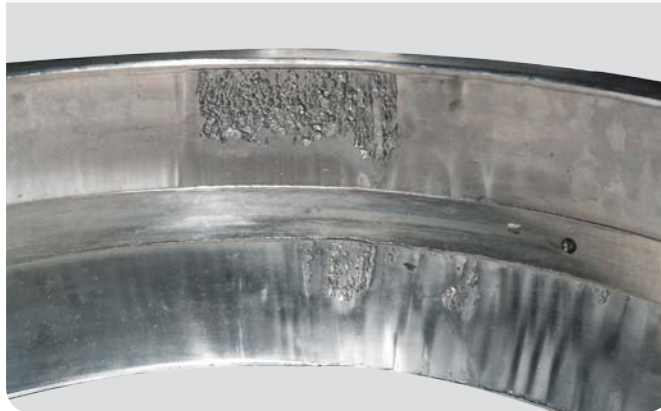
Fig. 18

There was heavy spalling on the raceways in a small area of the load zone. There were heavy vibration marks over a large part of the load zone (→ fig. 18).

- 2) The waviness on the outer ring raceways and the severe cage wear indicated a serious vibration problem during operation.

*Outer ring: Load zone spalls and vibration marks on the raceways, at the bottom of the ring*

- 1) Check the bearing seat in the housing. Repair if needed.
- 2) Locate the source/cause of vibration during operation.

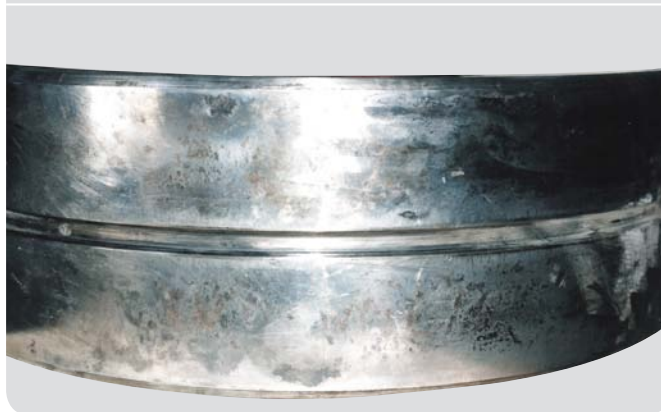
Fig. 19

There was heavy fretting corrosion on the outside surface corresponding to the load zone (→ fig. 19).

- 1) The outer ring showed damage in the same area of the load zone on both the outside surface (fretting corrosion) and the raceways (spalling), which indicated a problem with the bearing seat in the housing.

The cause of the failure appeared to be the fretting corrosion from a damaged outer ring seat (ISO 5.3.3.2).

*Outer ring: Heavy fretting corrosion in the load zone of the outside surface*

- 1) An inspection of the housing confirmed that the bearing seat had become worn and was no longer providing adequate support in the load zone. This caused severe fretting corrosion on the outside surface of the outer ring and subsequent distortion of the raceways in the load zone. The distortion caused premature spalling.
- 2) A thorough mechanical review of the application showed that material was not discharging adequately, which caused the crusher to “bottom out” and act as a compactor. This explained the excessive vibration and the heavy external loads that accelerated fretting corrosion and the waviness on the raceways.

During a planned shutdown, the bearing seat was repaired and the discharge end of the crusher redesigned. Since the modifications, no further problems have been reported.

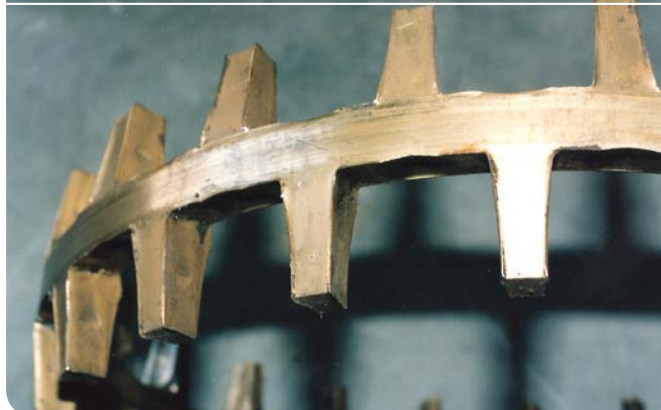
Fig. 20

The cage pockets exhibited heavy and irregular wear (→ fig. 20).

*Cage: Heavy pocket wear*
