INSPECTION AND REPAIR OF HORIZONTAL CENTRIFUGAL PUMPS

PUMP INSPECTION AND REPAIR HISTORY

DATA SHEET P-G-5S1

Unit: 50 Equipment No: 150-PC-014 A Date: 31.07.2024

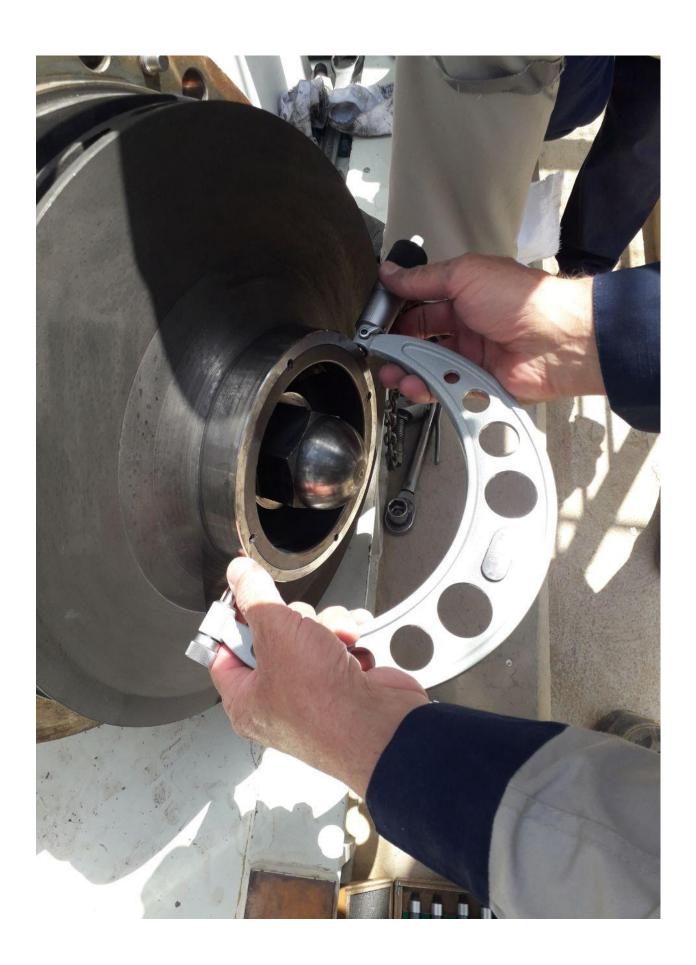
Name	Horizontal diameter	Vertical diameter
	(mm)	(mm)
Impeller wear ring outside diameter	173.49	173.47
Casing wear ring inside diameter	174.05	173.98
Wear ring tolerance	0.56	0.51
