## Crane Splice

### Inspection Report:

Product Name: Fabricated lifting plate: a flat plate with 4 nos. of 20 mm drilled hole and complete with a bend rod welded on top

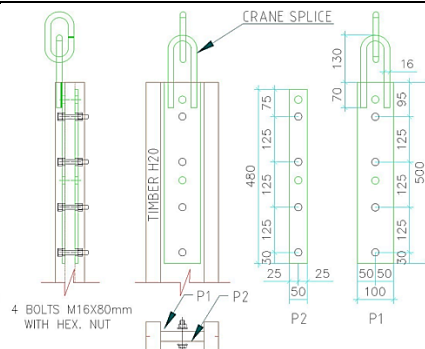
### Enclosures:

FROM THE ABOVE OBSERVATION, THE FAILURE POINT OF THE FABRICATED LIFTING PLATE WAS FOUND TO BE 6.51 TONNE .
