# Crane Splice

## Inspection Report:

Product Name: Fabricated lifting plate: a flat plate with 4 nos. of 20 mm drilled hole and complete with a bend rod welded on top

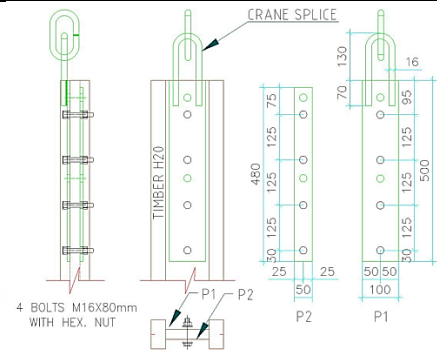
| No | Inspection Item | | Samples |
|---|---|---|---|
| 3 | Loading Test Results | | The Fabricated lifting plate loaded till 6.51 tons |
| <u>Conclusion</u> | | | <u>The Fabricated lifting plate safe working load is 0.90 ton</u><br>Factor of safety = 7.23 |

**FROM THE ABOVE OBSERVATION, THE FAILURE POINT OF THE FABRICATED LIFTING PLATE WAS FOUND TO BE 6.51 TONNE .**
