# SERVICE BULLETIN

## LANDING GEAR - MAIN LANDING GEAR COMPLETE - INTRODUCTION OF A NEW CAP

Aircraft affected: Airbus A350-900

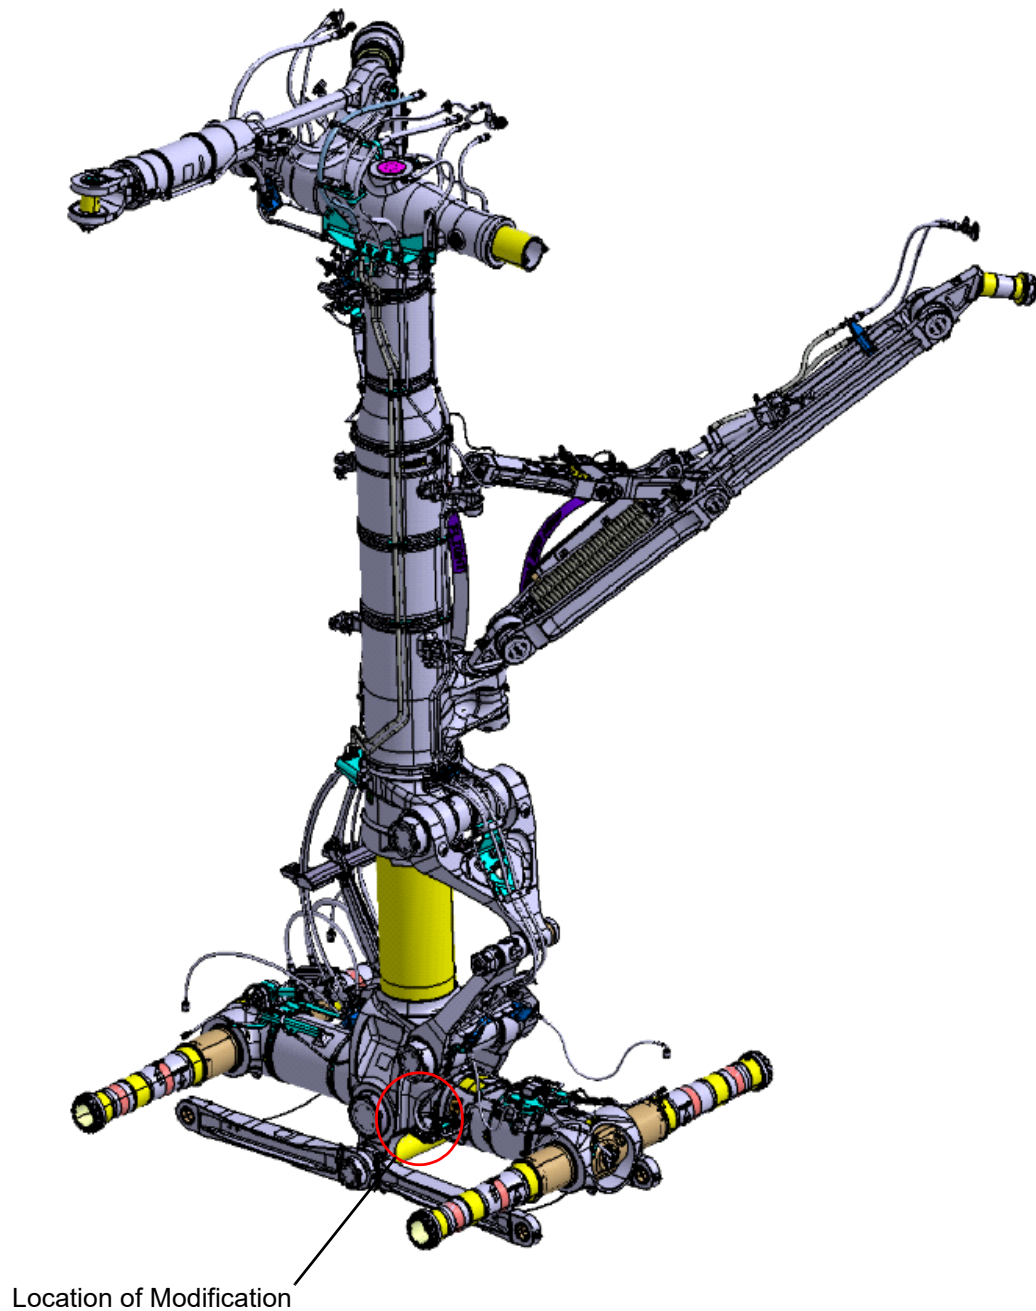
Figure 1

LH Main Landing Gear View from Outboard - Location of Modification

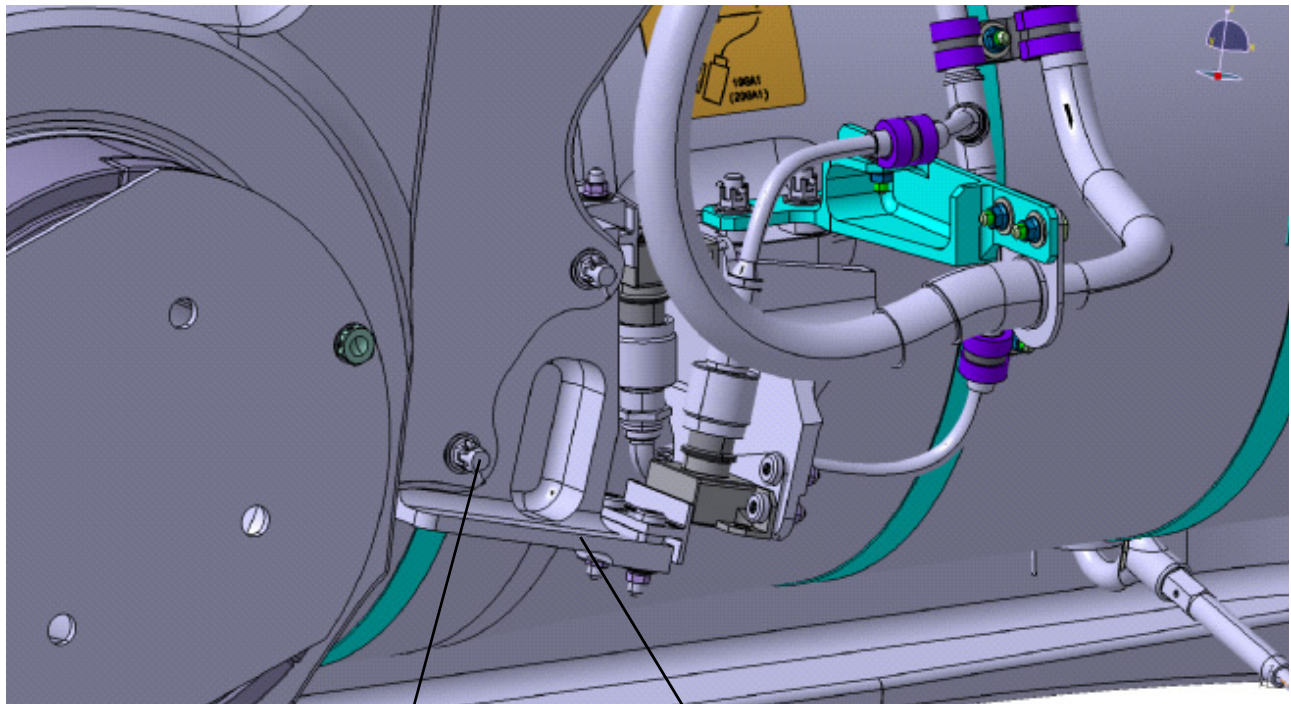
Before Modification  
Figure 2

- (1) Safran Landing Systems tells operators that a new cap is introduced to prevent contact between the 1M strut harness and a bolt in the location of the sliding piston fork.
- (2) Safran Landing Systems recommend that you do this Service Bulletin on main landing gears on which:
- the strike number 10 has not been cancelled on the 10-357303 LH Series and 10-357403 RH Series shock strut dressings nameplate and looks like this 10.
