Study of PF-ring Infrastructure Improvements Using Temperature Measurements in the Ring Tunnel

N. Nakamura, M. Tadano, T. Nogami, K. Haga
High Energy Accelerator Research Organization (KEK)

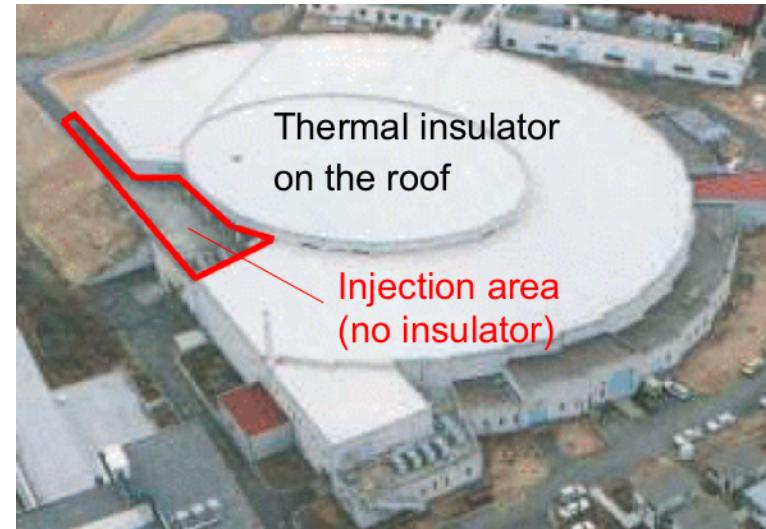
PF Building with the white thermal insulator on the roof.
A red frame part has no thermal insulator for a carry-in route.

(2) Thermal shielding of the injection area

- Heat-shield painting of the outside roof and wall of the injection area
- Heat-insulation by glass-wool boards on the inside roof and wall of the injection area

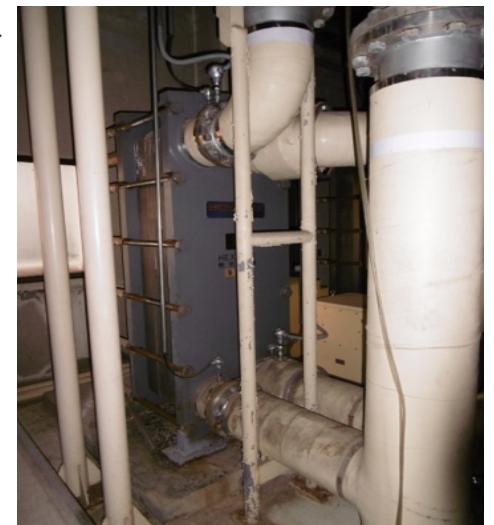
Schematic view of the cooling-water system(left) and the plate heat exchanger (right) for the PF ring.

- 5) Temperatures of the cooling systems B and C significantly varied and correlated with the outside air temperature in July 2018, because the cooling-water systems B and C became insufficient in cooling power.

(1) Upgrade of plate heat exchangers in the cooling-water systems

- Sizes of cooling water ducts increased at the same time
