# Study of the radiation damage on a scintillating fibers based beam profile monitor

E. Rojatti\*, G. Calvi, L. Lanzavecchia, A. Parravicini, C. Viviani, CNAO, Pavia, Italy \* corresponding author e-mail: elisa.rojatti@cnao.it

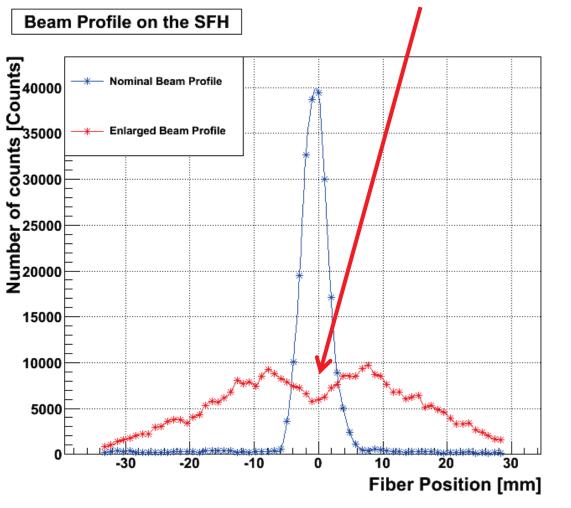
#### 1. Reduction of fibers light production power involving central fibers (mainly hit by the beam)

Nominal (blue line) and enlarged (red line) beam profiles reconstructed on the horizontal plane from one SFH measurement.

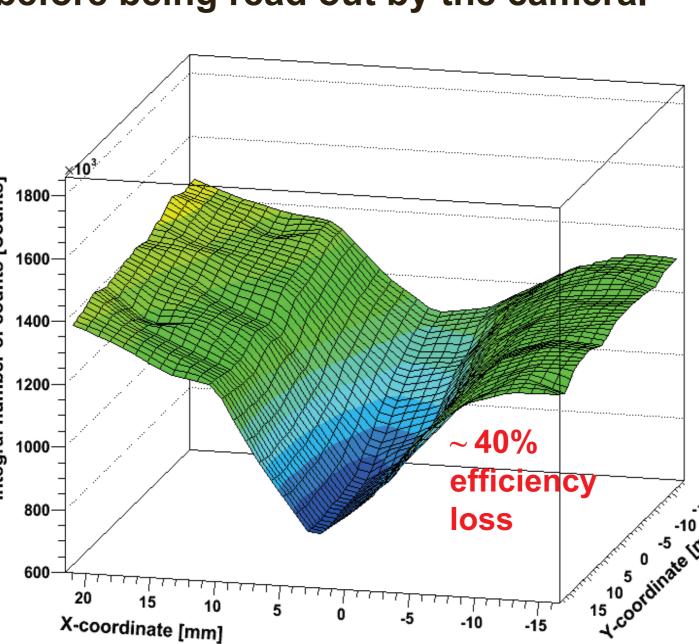
2. Fibers transparency loss: due to the detector geometry the light produced on the positive region of the vertical plane has to cross the more damaged area (about the active area center) before being read out by the camera.

SFH response on the horizontal plane (i.e. integral number of counts in function of beam barycenter position) to a **Proton beam with 8E+08** particles per spill, 10 mm FWHM, 60 MeV kinetic energy, moved up to 121 different positions equally spaced on the detector active area.

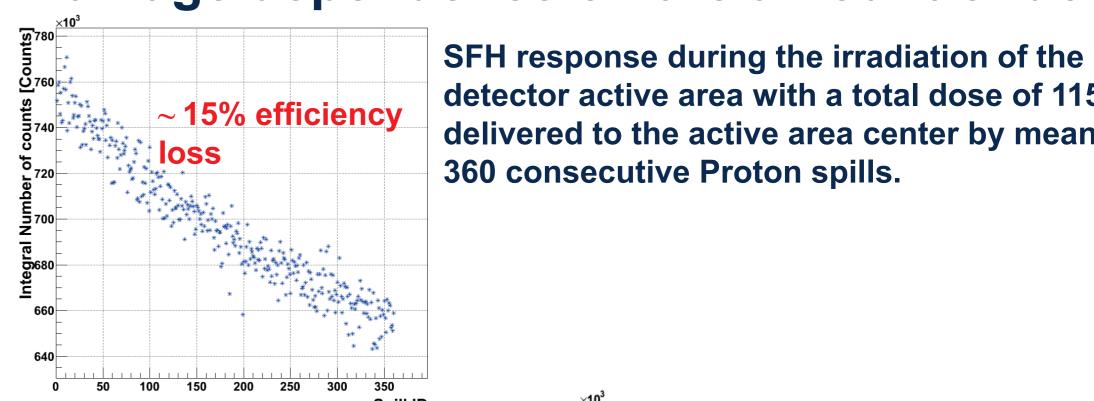
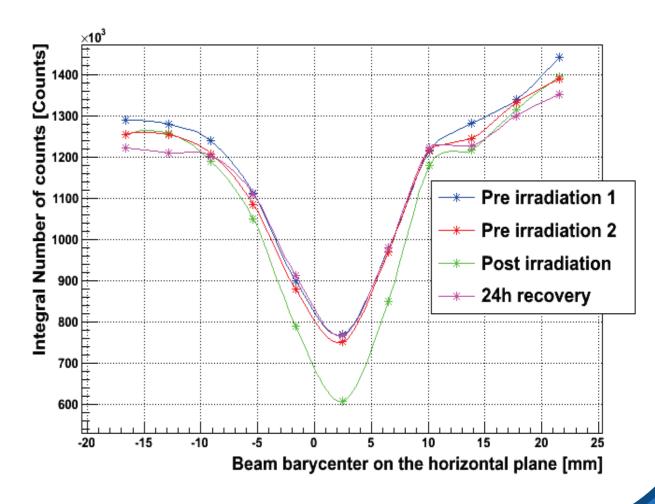
detector active area with a total dose of 115 Gy delivered to the active area center by means of 360 consecutive Proton spills.

SFH response on the horizontal plane at fixed coordinate on the vertical plane (Y = 0 mm) to a **Proton beam with fixed** parameters (8E+08 particles per spill, 10 mm FWHM, 60 MeV kinetic energy) before and after (immediately after and 24 hours after) the irradiation with 115Gy total dose.

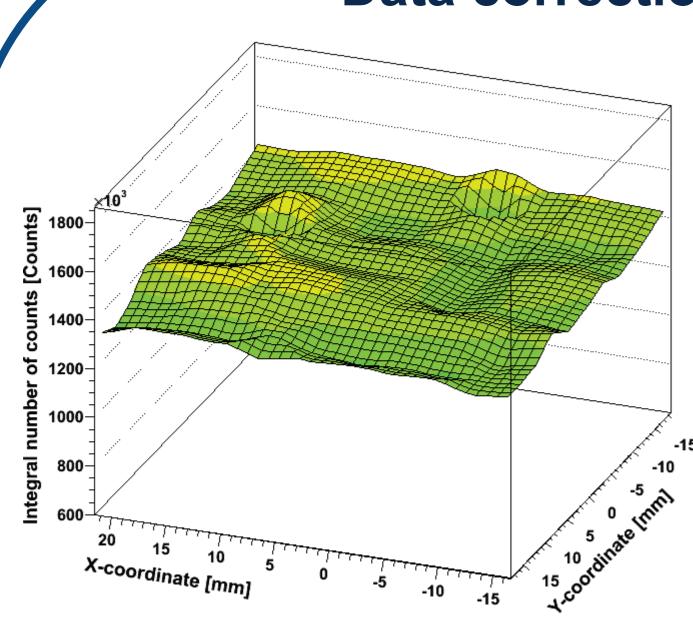
SFH intensity map, on the horizontal plane, extracted after the application, to raw data, of the correction factors 2D map.

1. Elaboration of a 2D map of correction factors per each plane, extracted from data manipulation, and depending on beam barycenter position on the horizontal/vertical plane of the detector active area. Detector response correction from radiation damage effects by means of correction factors application on raw data after a rough beam barycenter estimation. Robust and reliable procedure, but demanding and time consuming, implying the SFH dismantlement from the beam line.

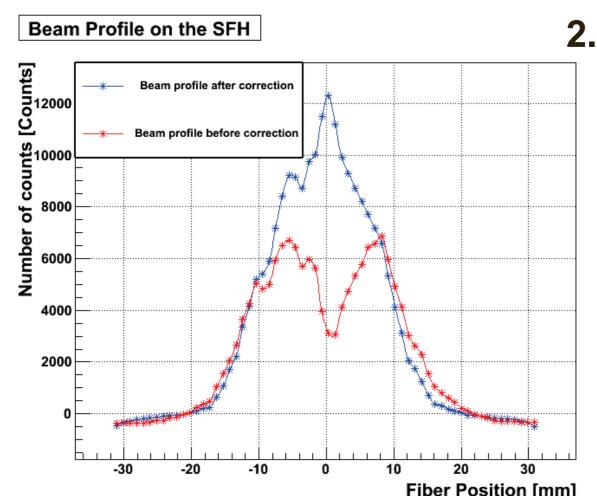
Horizontal beam profiles acquired before and after the 1D set of correction factors application to profiles reconstruction parameters.

2. Elaboration on 1D set of correction factors involving 4-5 central fibers for each plane. Correction factors used to modify profiles reconstruction parameters for damaged fibers response equalization. Not very rigorous procedure and usable only for a beam centered on the detector active area. At the same time quick and easy to apply to all the installed SFH detectors.

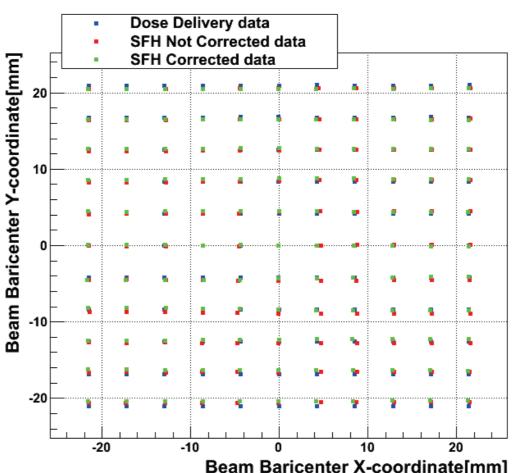
Beam barycenter values on the horizontal and vertical plane extracted from one SFH measurement before and after data correction (with the 2D correction factors map application) and compared to reference values acquired with the Dose Delivery, a ionization monitor installed at the end of the extraction line.

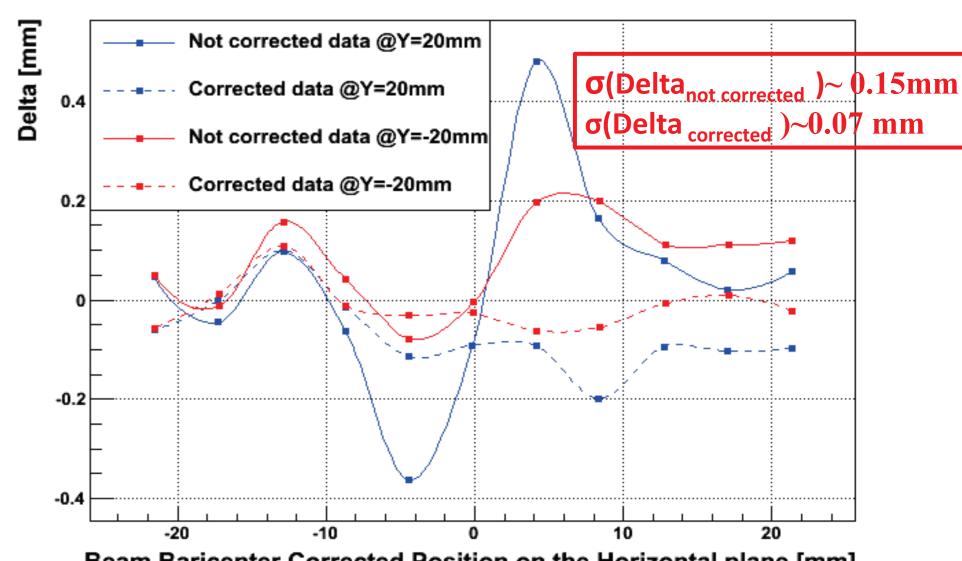
Beam Baricenter Corrected Position on the Horizontal plane [mm] Differences (Delta[mm]) on the horizontal plane between reference barycenter values (from Dose Delivery measurement) and barycenter values from one SFH measurement before (solid line) and after (dashed line) data correction (with the 2D correction factors map application) for the two outer positions on the vertical plane (Y = -20 mm and Y = 20 mm
