**HIAT2015, RIKEN, Yokohama**

# **Ultra high impedance diagnostics of electrostatic accelerators with improved resolution**

**N. R. Lobanov, P. Linardakis, D. Tsifakis and T.Tunningley**

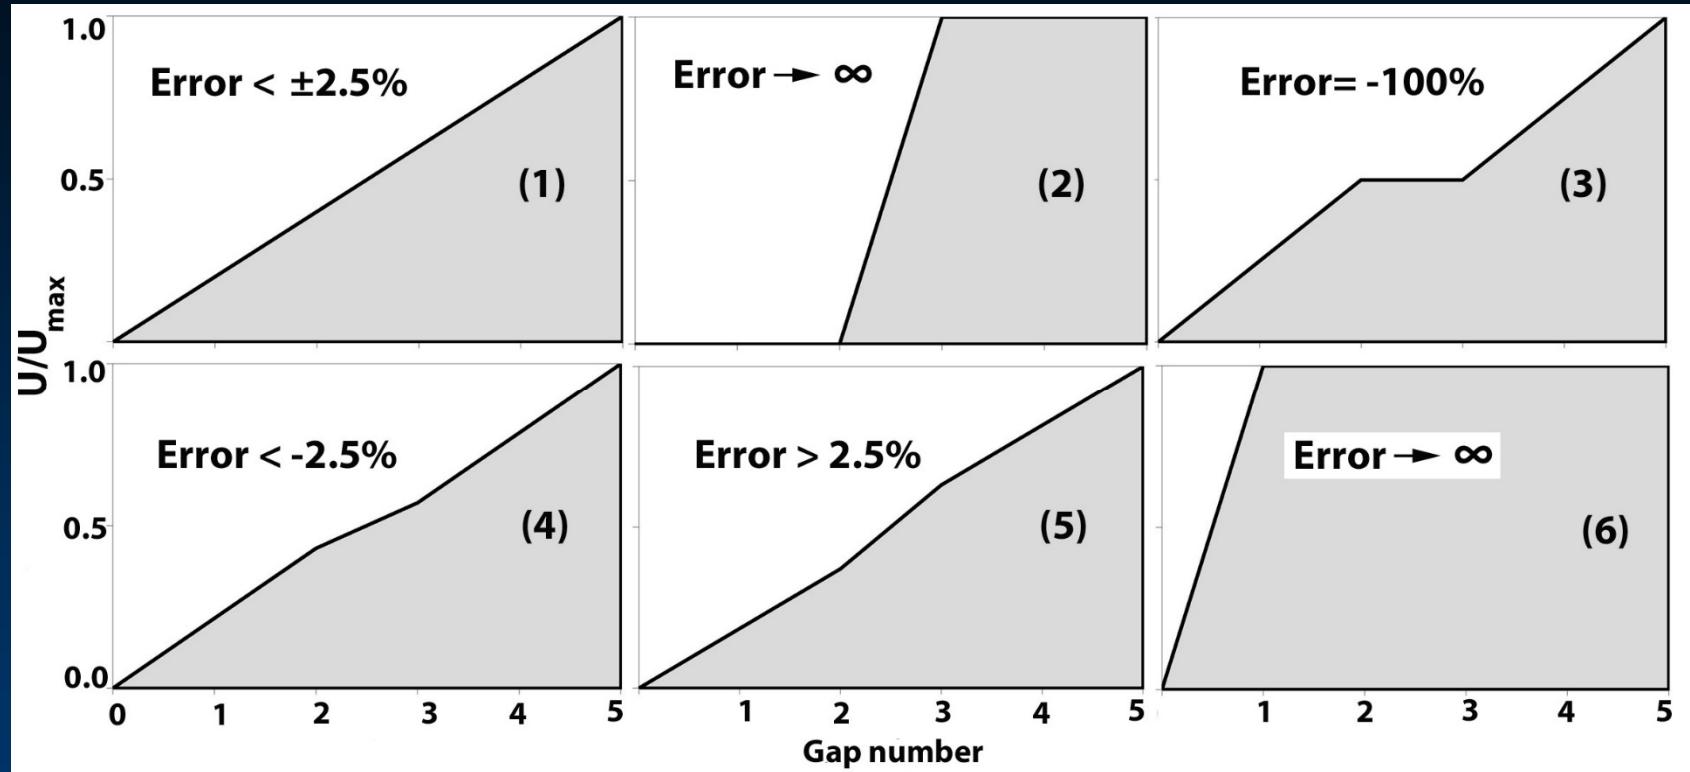
# Troubleshooting chart for express identification of faults

The vertical axis for all graphs is the normalised voltage distribution across five gaps corresponding to different fault conditions such as: (1) fault free system; (2) open circuit in gap 3; (3) short circuit in gap 3; (4) lower resistance in gap 3; (5) higher resistance in gap 3 and (6) open circuit in gap 1.

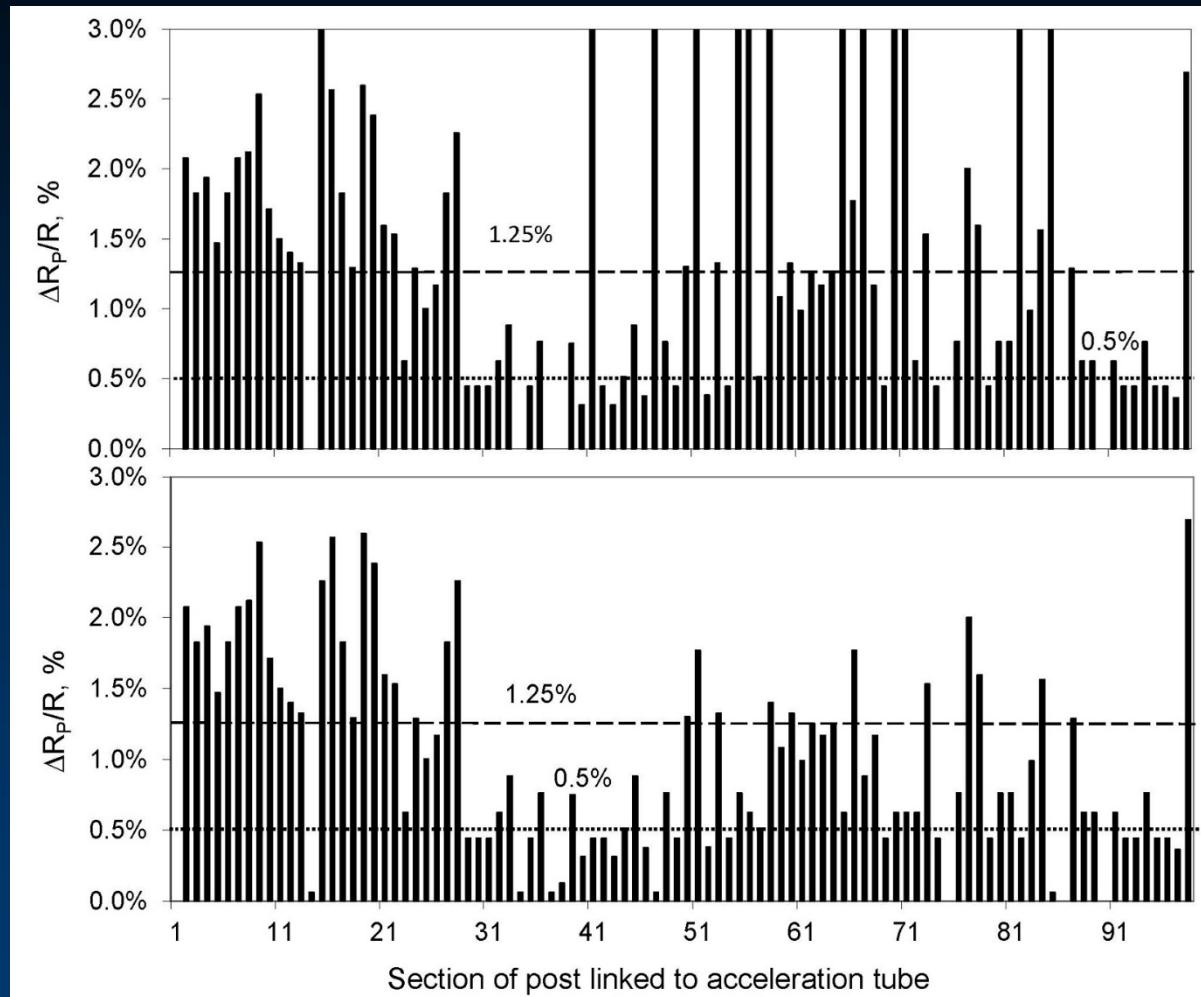
$|\langle \Delta R_p/R \rangle_{\text{max}}|$  in the posts. Top chart is the compilation of entry test distributions The bottom chart is the exit distribution collected in the end of TO #123. Dashed line is 1.25% resolution at 40 V. Dotted line corresponds to 0.5% resolution if testing at 100 V.

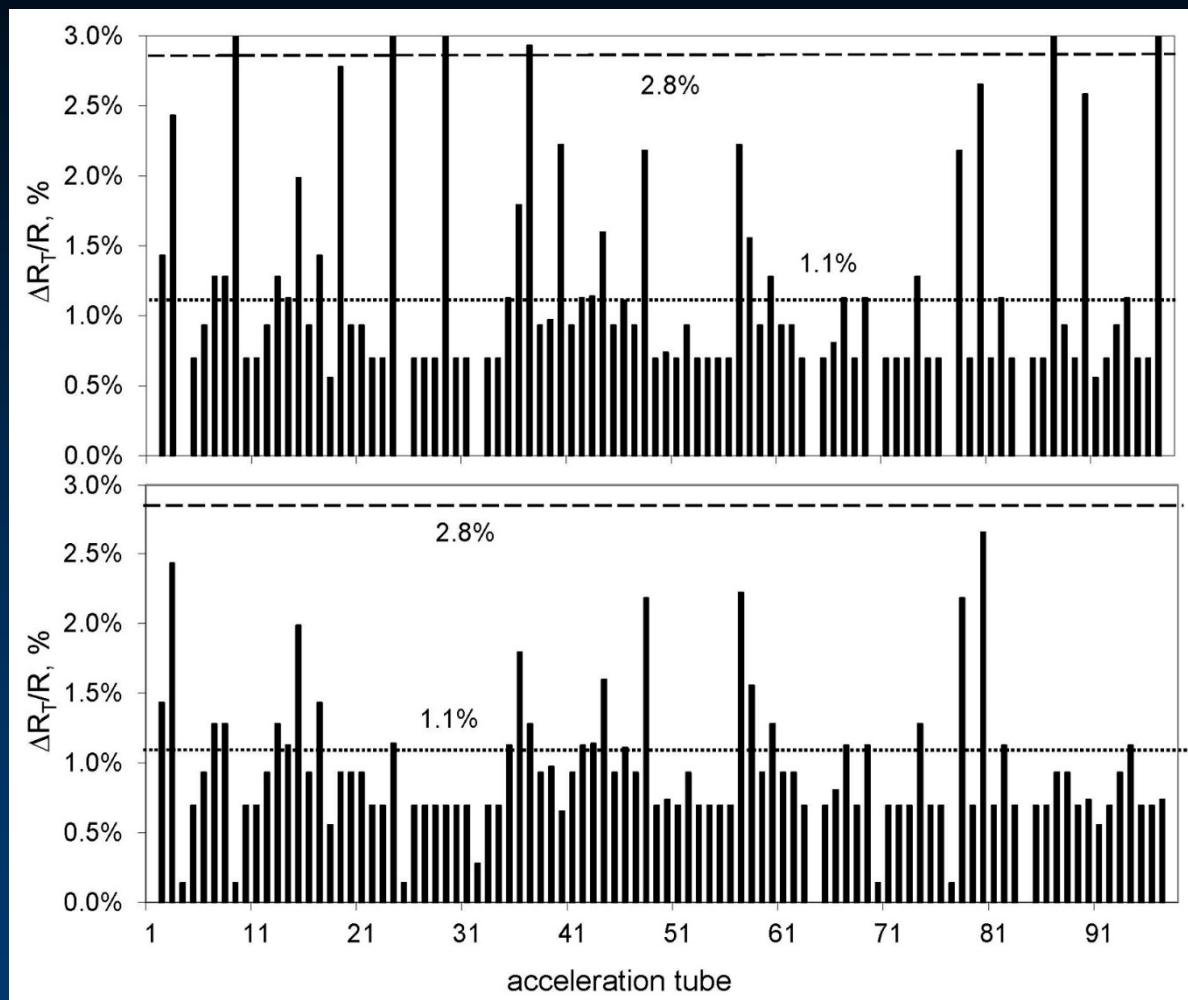
$|\langle \Delta R_p / R \rangle_{\max}|$  in the tubes. Top chart is the compilation of entry test distributions. The bottom chart is the exit distribution collected in the end of TO #123. Dashed line is 2.8% resolution at 40 V. Dotted line corresponds to 1.1% resolution if testing at 100 V.

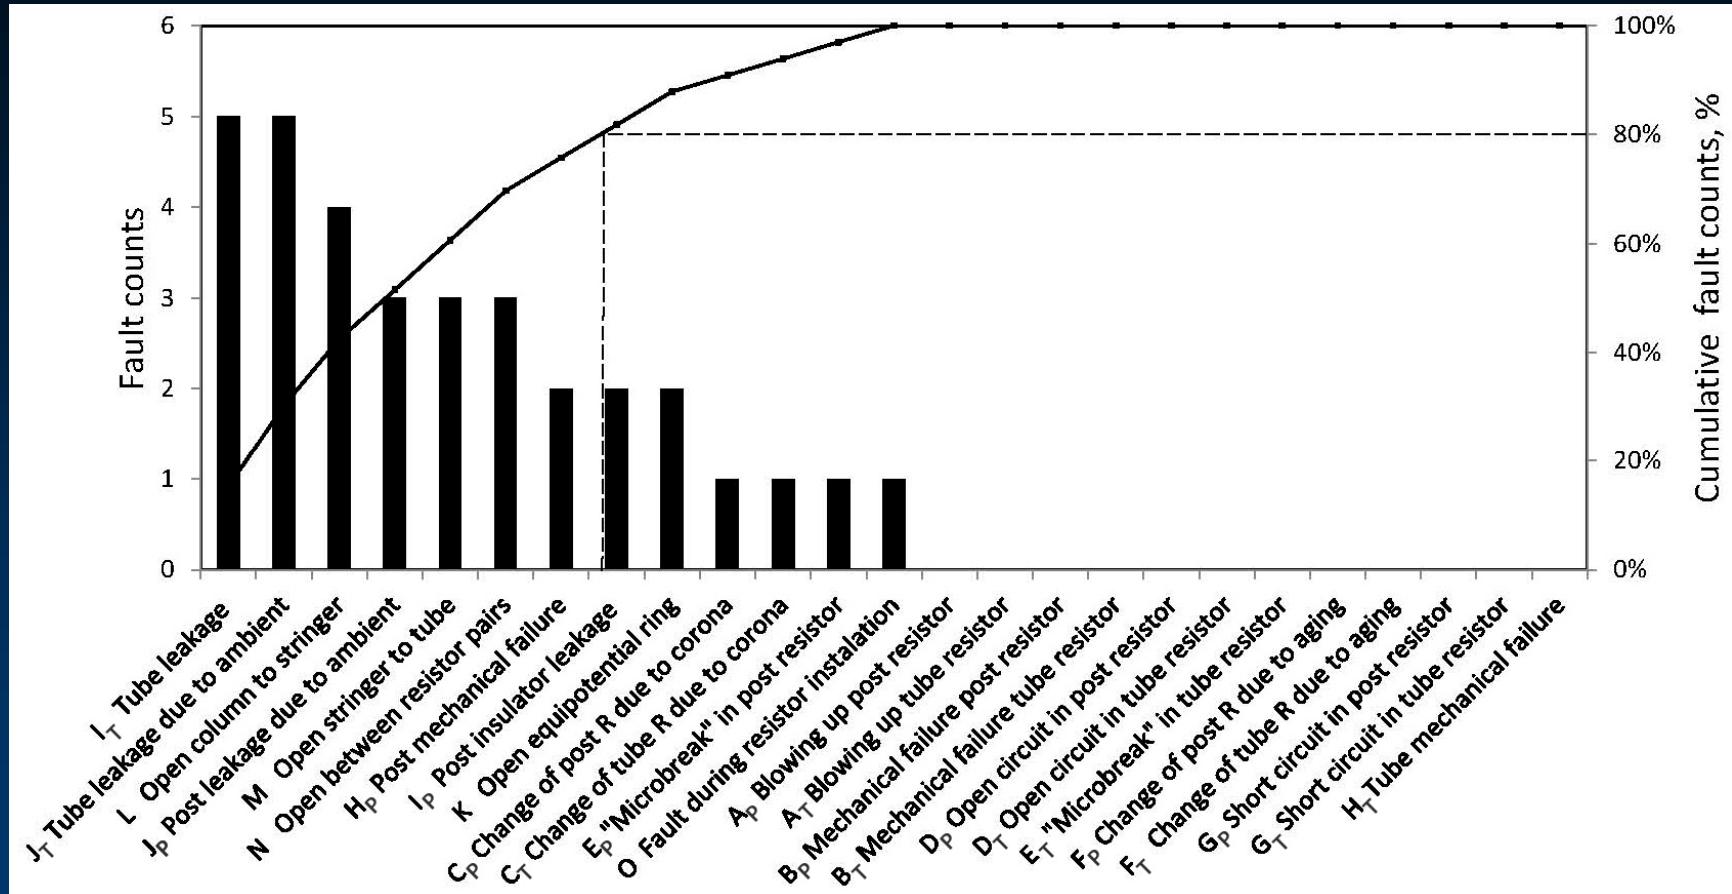
the most common failure modes are tube insulator leakage and tube insulator current developed after being exposed to ambient environment (any gap that exhibits current leakage has at least a hairline crack in the insulator); next fault category is poor electrical connection between post/tube electrode and stringer; next is the open circuit or poor continuity between pairs of resistors etc

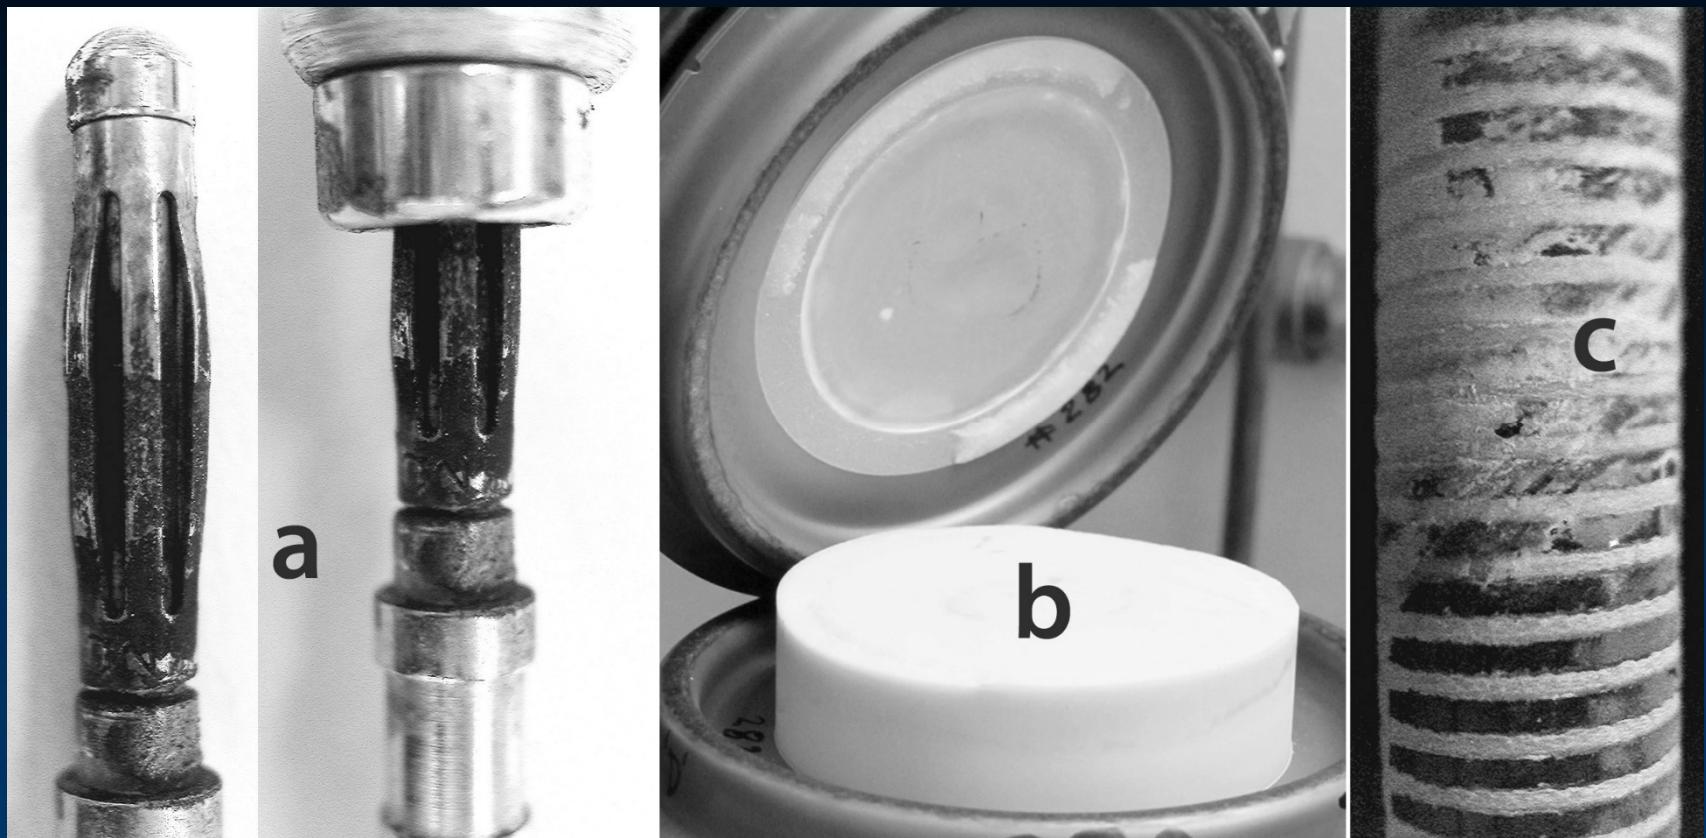
- (a) spark-eroded resistor plug connecting flexible lead to resistor circuit and the same plug inserted partially into resistor receptacle;
- (b) (b) the complete separation of the bond between the post ceramic and titanium electrode;
- (c) (c) the erosion of conductive layer of post resistor due to exposure to corona discharge.

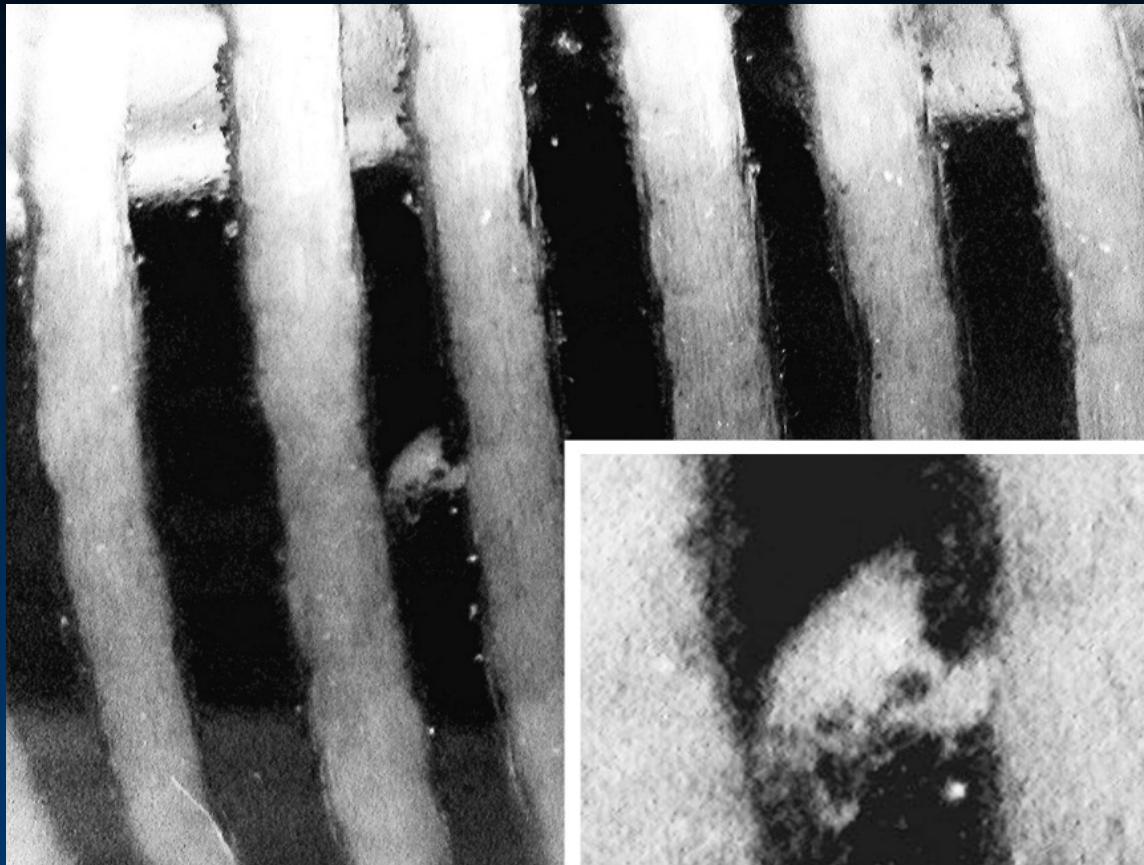
“microbreak” on a Welwyn  $982\text{ M}\Omega$  post resistor. Rounded edges of the film suggest possible localised vaporization of the film due to high instantaneous voltage.

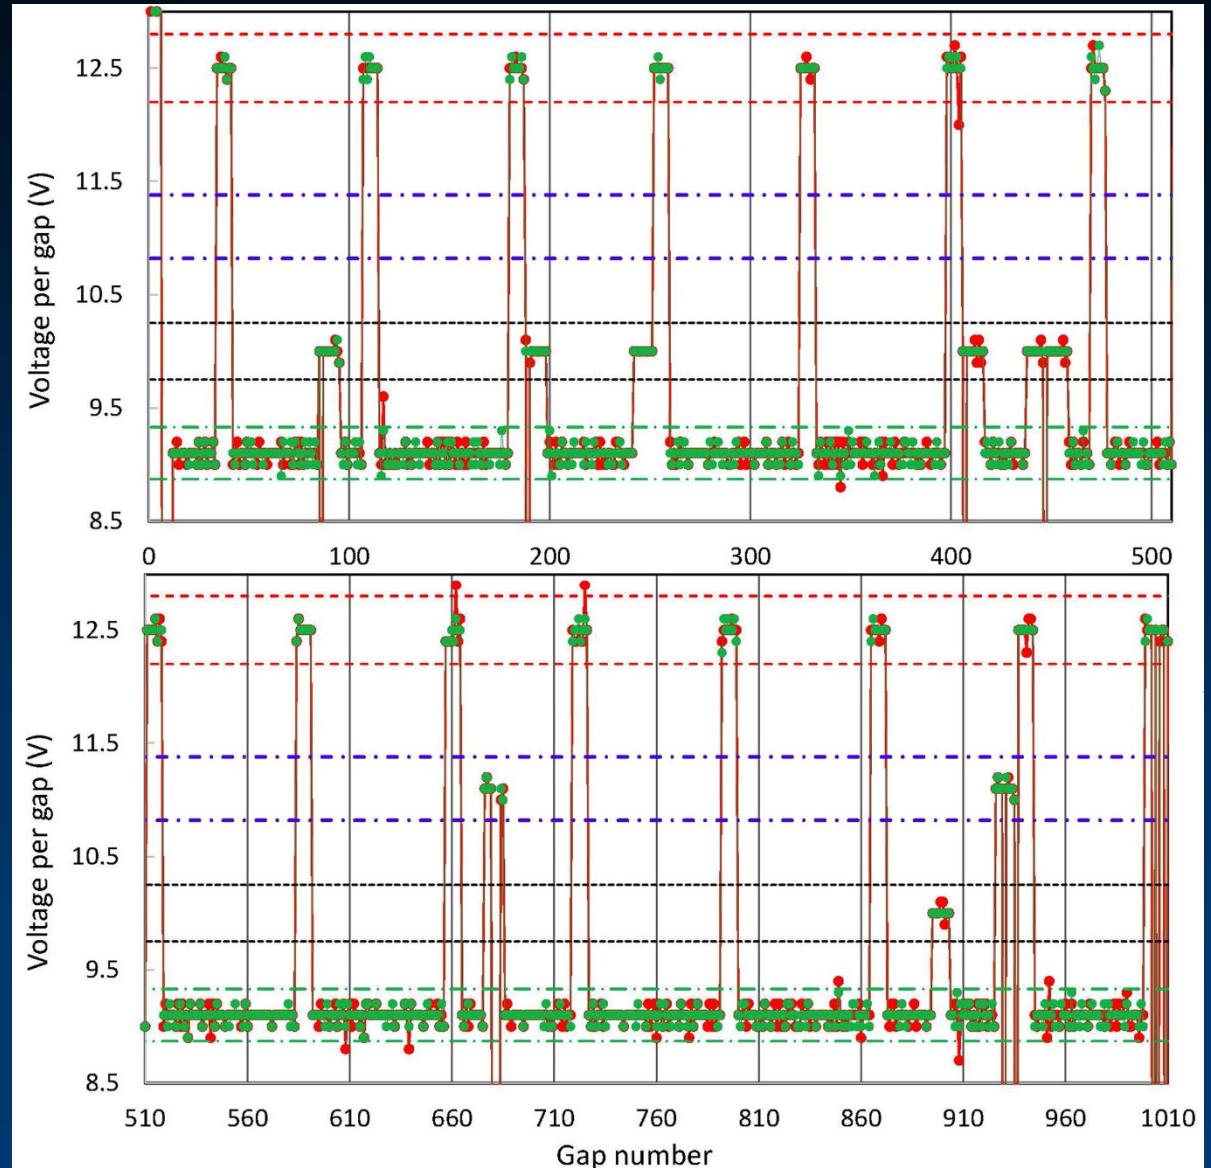
Distribution of gap voltage in tubes.

The red series is the entry test.

The green series is the exit distribution.

Dashed lines displays  $\pm 2.5\%$  acceptance margin at different gap voltages.

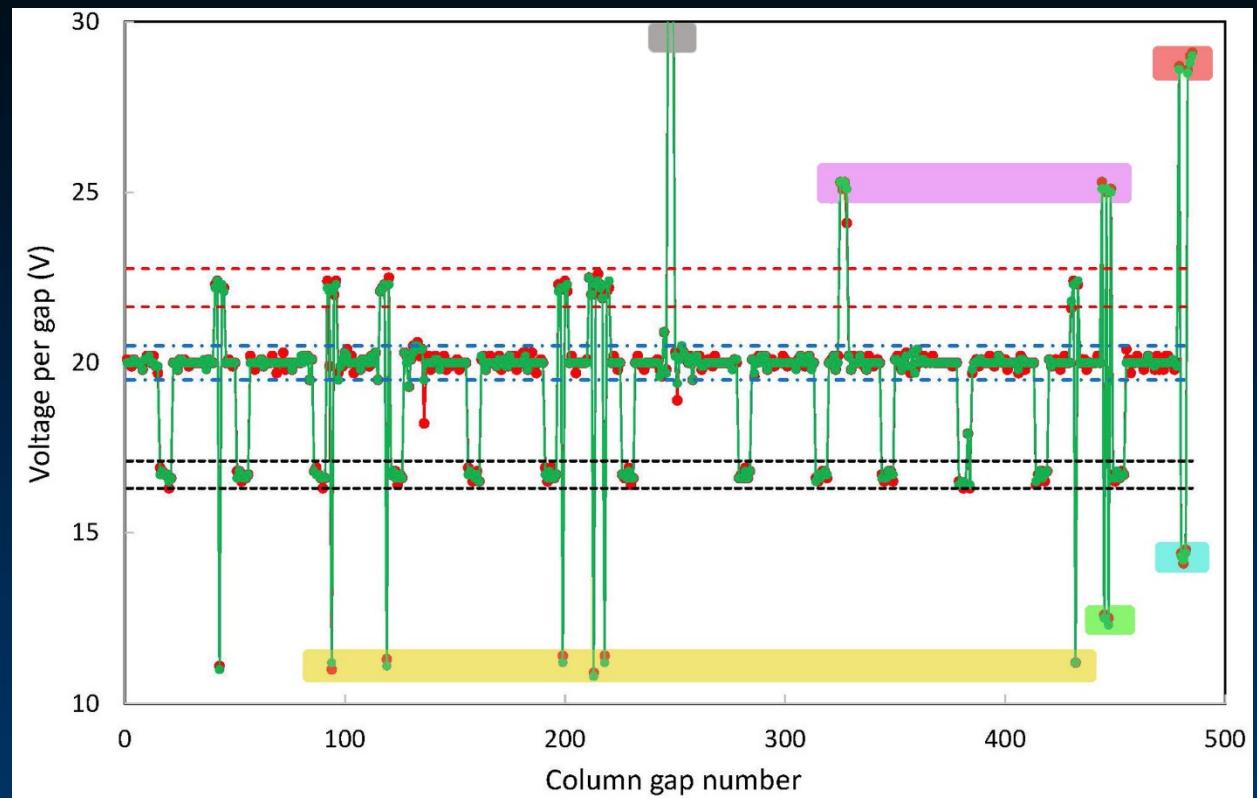
Distribution of gap voltage in column posts.

The red series is the entry test.

The green series is the exit distribution.

Dashed lines displays  $\pm 2.5\%$  acceptance margin at different gap voltages.
