European XFEL High-Power RF System – The First 4 Years of Operation

Abstract

This report describes the operation experience and improvements of the high-power RF stations during the first 4 years of operation.

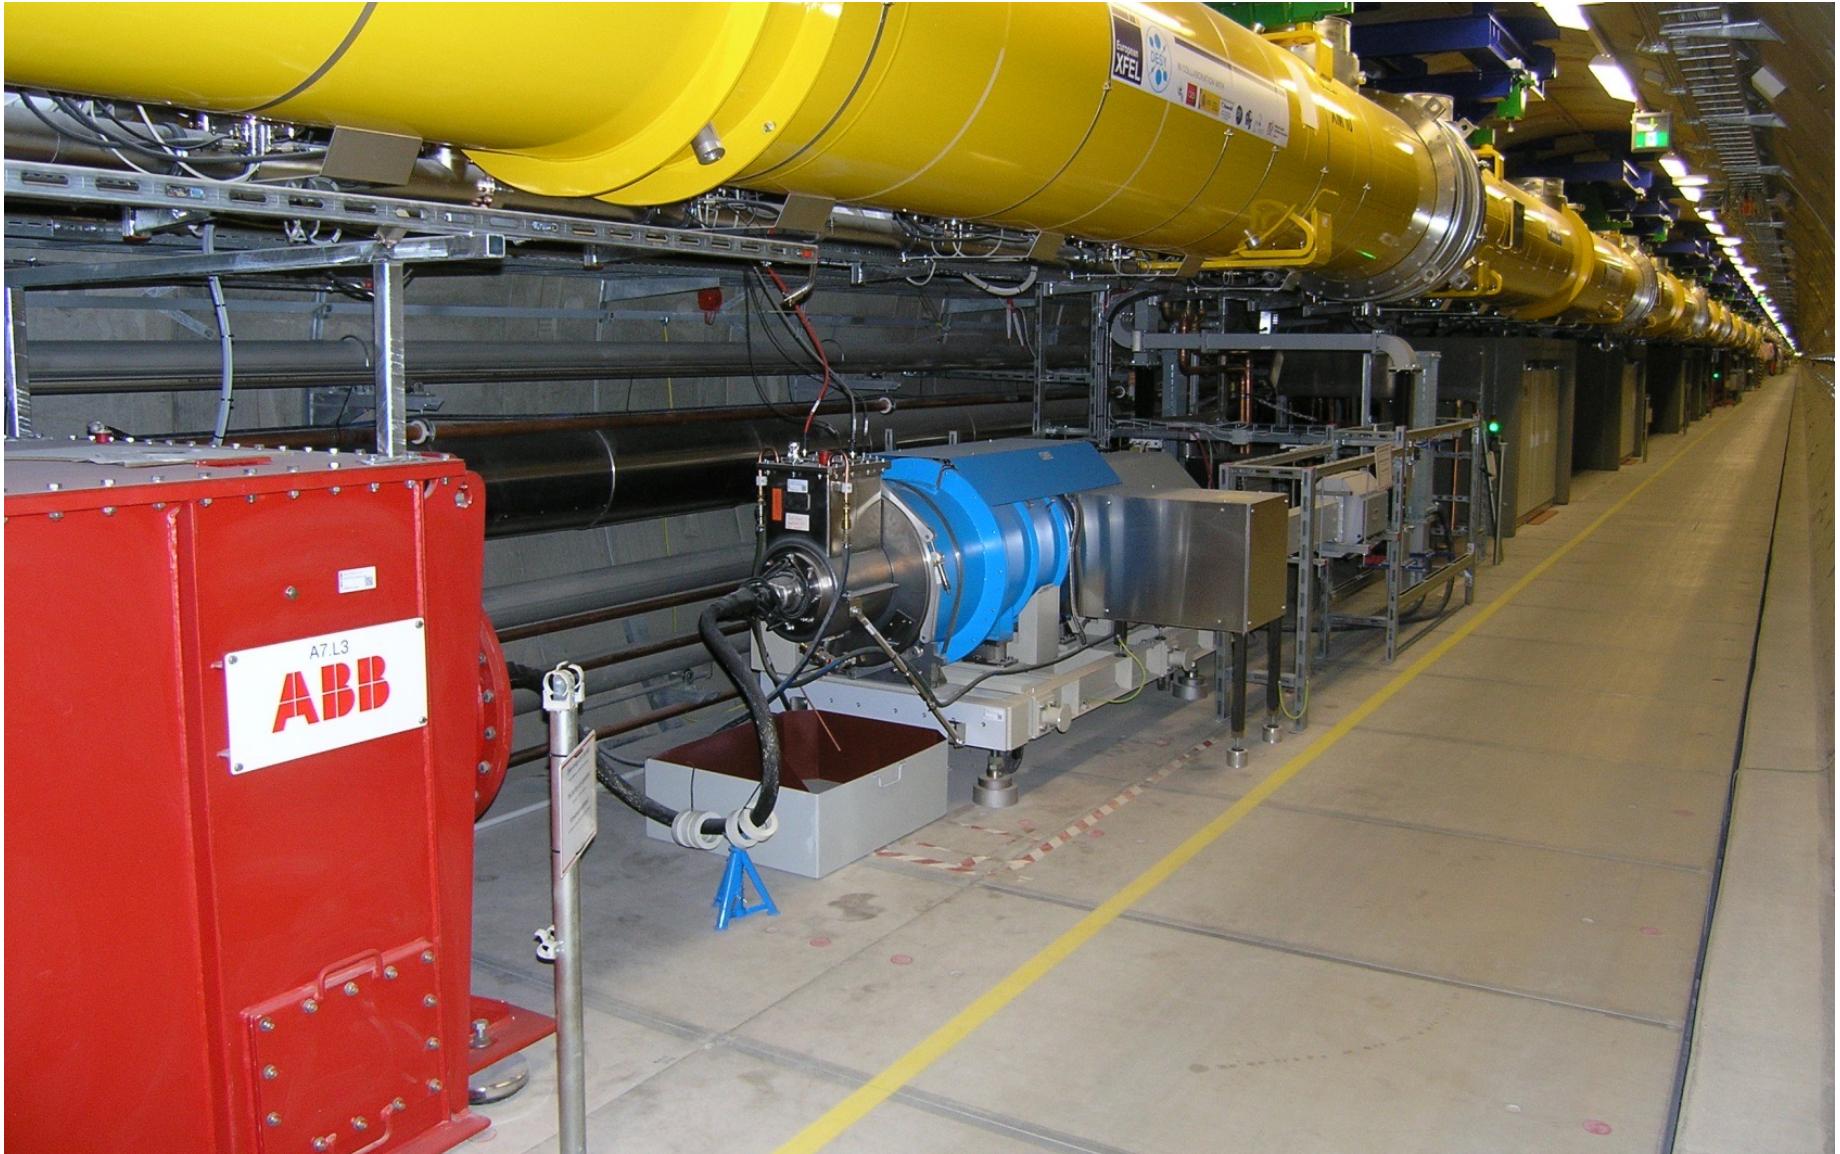
One RF station in the accelerator tunnel.

The klystrons are located below the accelerator modules.

Therefore replacing a klystron in the XFEL is more complicated than in other accelerator facilities.
