# TEST RESULTS OF PLASMA IN-SITU CLEANING ON LOW BETA HWR CAVITY

**ID: TUPO036**

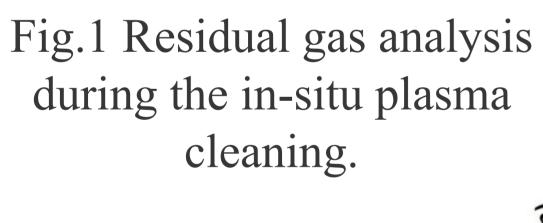
Fig.2 Results of CH<sub>4</sub> adsorption on HWR and performance recovery by thermal cycle.

- ➤ Performance degraded by carbon cryogenic adsorption, FE onset and quench point decreased by 12% and 18%.
- The carbon contamination from the cryogenic adsorption can be removed by warming to room temperature.

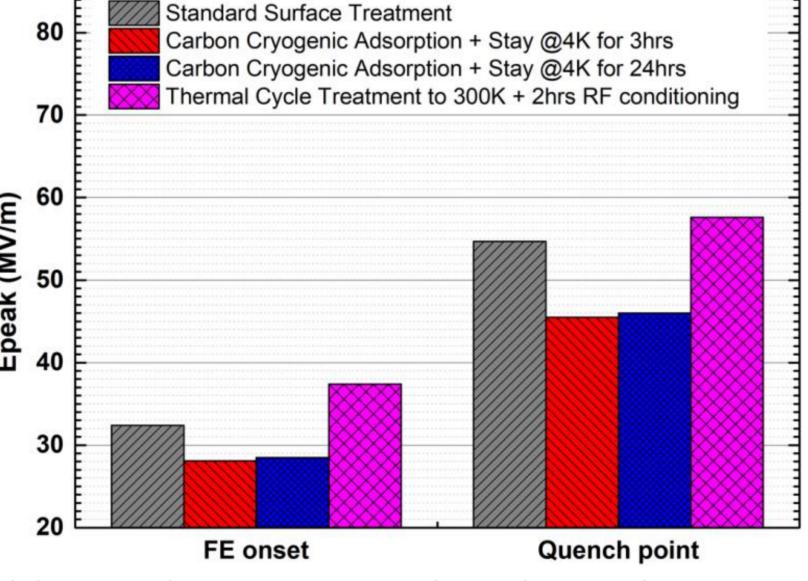
Ar/O2 (28.6%)
  170 W
  1.70 W
  1.70
- Fig.3 Ar/O2 mixed RF plasma ignition on HWR cavity.

- Plasma discharge was concentrated in the middle of cavity.
- The lower gas

pressure and smaller

oxygen volume ratio

has stronger

luminance of the

plasma light and a

more uniform

distribution of

discharge will be

achieved in the cavity.

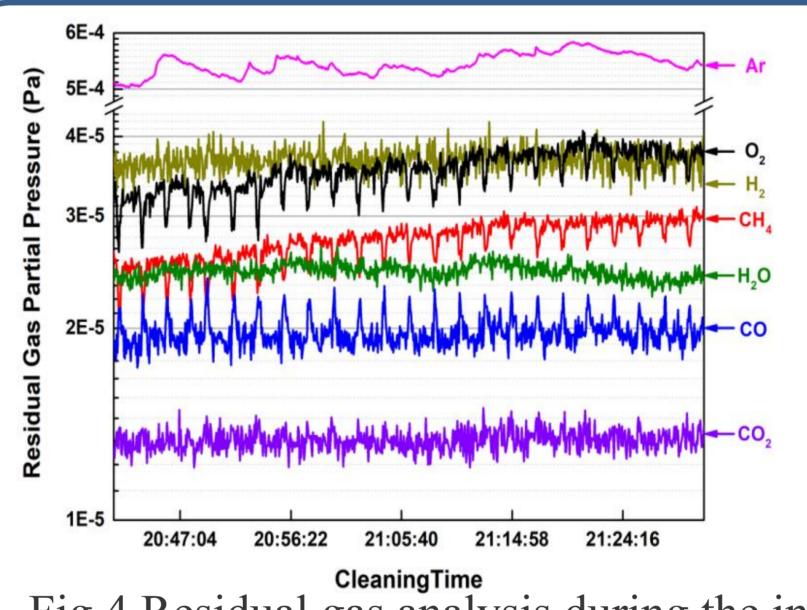
Fig.4 Residual gas analysis during the insitu plasma cleaning.

- Dobviously peaks of the partial pressures appeared when the plasma pulse turning on.
- ➤ Oxygen was consumed as the oxidant for burning the carbon contaminants.
- CO is more readily produced that CO2 on the oxidizing of carbon contaminants under the plasma condition of this work..

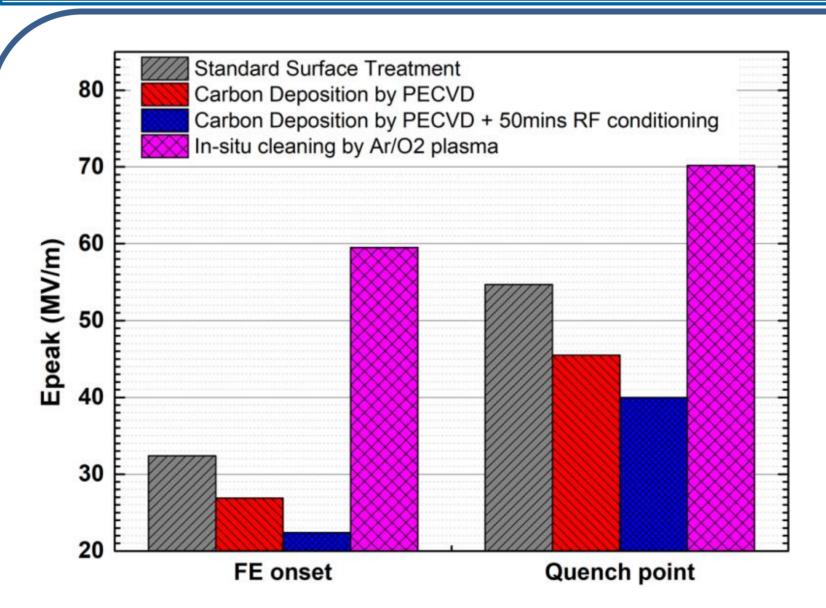
Fig.5 Results of carbon deposition and in-situ plasma cleaning.

- The performance was deteriorated after the carbon deposition due to the increasing of FE, and the MP was appeared at 16-19 MV/m.
- Additional RF conditioning was conducted to mitigate the multipacting and FE, but the performance decreased further due to that the carbon contaminants was translated to the electric field stronger region.
- Carbon deposited contamination was removed by oxygen active plasma, and the x-ray dose was significantly decreased.

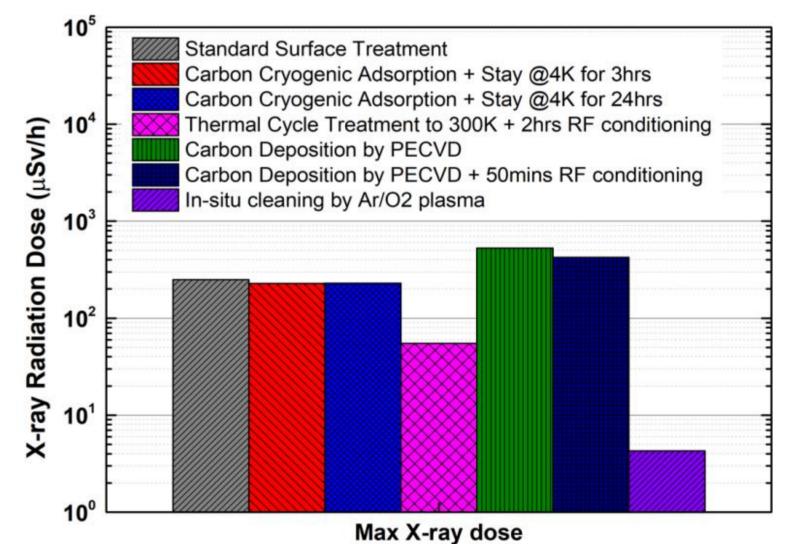
Fig.6 X-ray of HWR under different treatments.
