# RAPID DEVELOPMENT AND IMPLEMENTATION OF A CUSTOM PHOTON STOP AT THE ADVANCED LIGHT SOURCE: FROM FAILURE ANALYSIS TO PREDICTIVE MAINTENANCE

W. Hutcheson, N. Wenner, G. Cutler, L. Kistulentz, S. Morton, T. Swain  
Lawrence Berkeley National Laboratory, Berkeley, USA

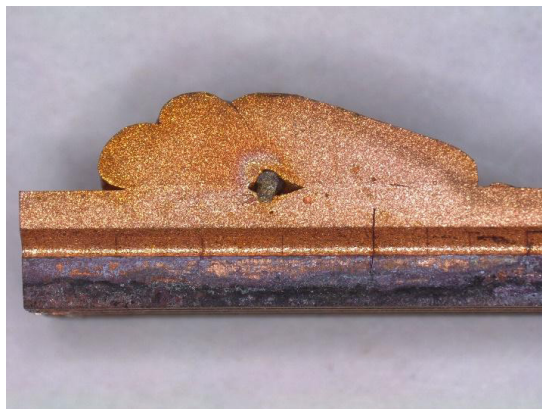
Lack of coolant flow in blocked channels appears to have created conditions of thermally induced fatigue, resulting in cracking of the face near the area of highest

beam power, with one particularly large crack being visible at the site of failure (Fig. 4).

Figure 4: A vertical slice through the hot-wall of the original photon stop, showing cracking at the site of failure. Artifacts of the welded repair can be seen at top.
