LESSONS LEARNED ASSEMBLING THE SSR1 CAVITIES STRING FOR PIP-II*

D. Passarelli[†], D. Bice, M. Parise, T. Ring, G. Wu, Fermilab, [60510] Batavia, IL, USA
Stéphane Berry, CEA, [91190] Saclay, France

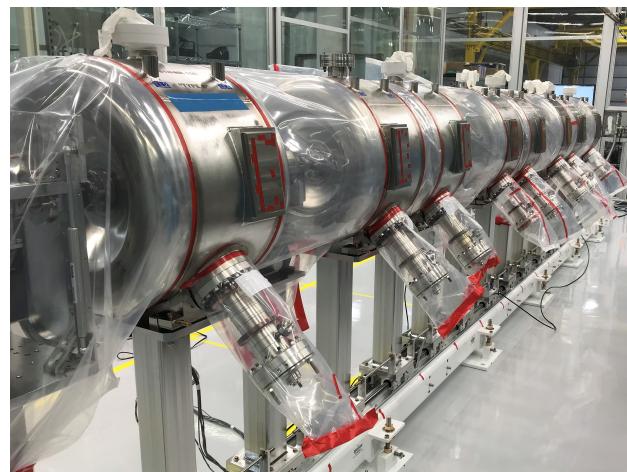
Figure 8: Final leak check of the full assembly.

During first leak check cycle, two ceramics of the vacuum-end coupler mounted on cavities S109 and S111 were found leaking at $4.6 \cdot 10^{-8}$ mbar·L/s and $2.5 \cdot 10^{-8}$ mbar·L/s respectively. It was decided to slowly venting the entire string beamline (at 250 sccm) and replace the two vacuum-end couplers.

Leak check procedure was repeated again and no leak was found above $2 \cdot 10^{-10}$ mbar·L/s (specification). The string assembly base pressure was $2.3 \cdot 10^{-7}$ Torr at the final leak check. The helium background was at $2.7 \cdot 10^{-10}$ mbar·L/s.

The nature of failure that led to open a leak in the ceramic of the vacuum-end coupler is unknown but it most likely due to mishandling during testing and/or inter-facilities transportation. However, an explicit leak check should be performed on all cavities prior to venting them to atmospheric pressure to verify their leak tightness with a minimum detectable leak rate of $2 \cdot 10^{-10}$ mbar·L/s. Also, the design of such couplers should be made more robust to improve their reliability throughout the entire life cycle.
