INTEGRATED CIRCUITS

ERRATA SHEET

Date: 2008 Nov 07
Document Release: Version 1.3
Device Affected: P89LPC922

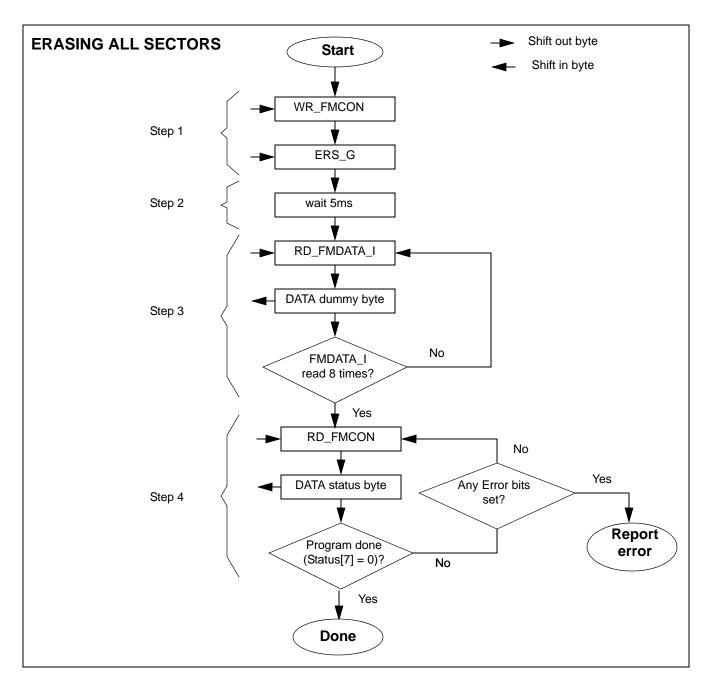
Figure 1: Flowchart ICP Global Erase

Problem: When giving the Erase Global command through the ICP interface the LPC922 will not clear the

busy flag and stay busy forever.

Workaround: The workaround can be done in 4 steps:

Step 1: Shift out the WR FMCON command followed by the Erase Global opcode.

Step 2: Wait 5ms.

Step 3: Do 8 dummy reads with the RD_FMDATA_I command.

Step 4: Read FMCON until the busy flag gets cleared.

Please also see figure 1 on the following page.
