Edgecumbe Performance Test Report

29/05/2024

DOCUMENT CONTROL							
PROJECT		Edgecumbe Solar Farm	REPORT TITLE Edgecumbe Performance Test Repo		Гest Report		
CLIENT		Lodestone	CLIENT CONTACT	Peter Apperley			
REV	DATE	REVISION DETAILS		PREPARED BY	REVIEWED BY	APPROVED BY	
0	28/05/2024	Issued to client		ZKD	DO	BP	
1	29/05/2024	Minor updates based on Lodestone comments		ZKD	DO	ВР	
CURRENT REVISION		1

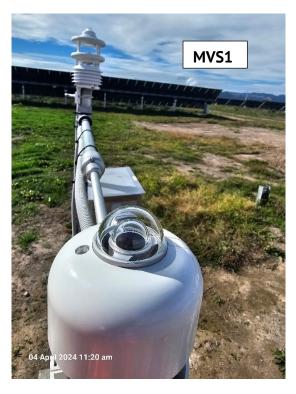
As Infratec was not going to clean the solar modules and the irradiance sensors for the performance test, the irradiance sensor cleanliness was checked to ensure that irradiance sensors were not more soiled than the modules. Images of the irradiance sensors taken before the start of the performance test can be seen in Figure 2 and Figure 3 below.

Figure 2: Uncleaned Global Horizontal Irradiance Sensor 1

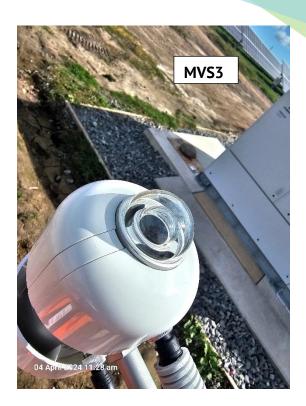
Figure 3: Uncleaned Global Horizontal Irradiance Sensor 2

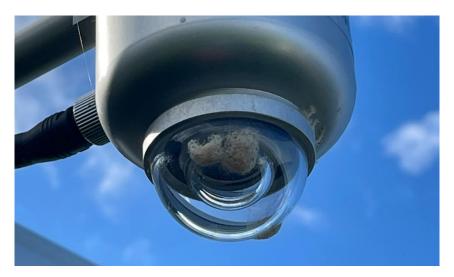
During the performance test, Lodestone informed Infratec one of the POA irradiance down sensors was deemed unacceptably dirty and instructed Infratec site personnel to clean this sensor (see Figure 6 below). Lodestone also requested that all other irradiance sensors be checked at the same time.

Figure 6: Dirty POA down sensor on near MVS 1

Despite Infratec's intention to not clean the irradiance sensors during the performance test, based on the discussion noted above, all POA sensors were cleaned. The sensors were cleaned on 15th May 2024, which was 6 days into the performance test.

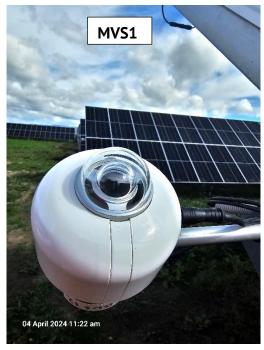
Figure 7: Uncleaned POA Irradiance up Sensor 1

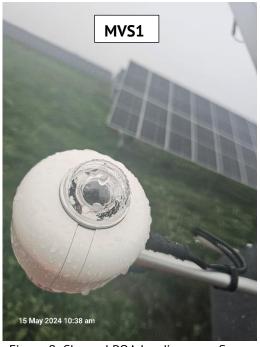
Figure 9: Cleaned POA Irradiance up Sensor 1

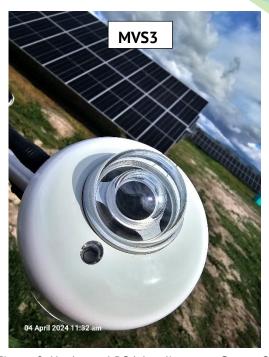
Figure 8: Uncleaned POA Irradiance up Sensor 2

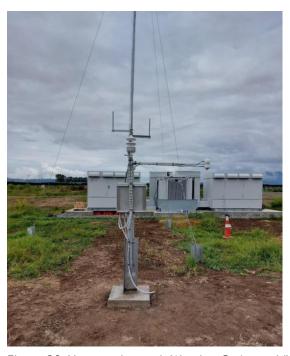
The actual albedo was not as built in the PVSyst model due to the location of the up and down irradiance sensors being in areas where the grass / ground was more reflective due to the construction activities, as seen below in Figure 20, Figure 21, Figure 22 and Figure 23. As was done for Kaitaia, the view factor assumed in PVSyst was used to correct the actual rear irradiance in the actual bifacial performance ratio calculation.

Figure 20: No grass beneath Weather Sation at MVS1

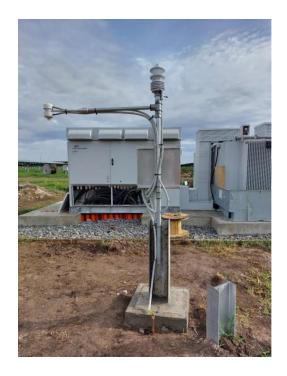
Figure 21: Ground beneath Weather Station at MVS3

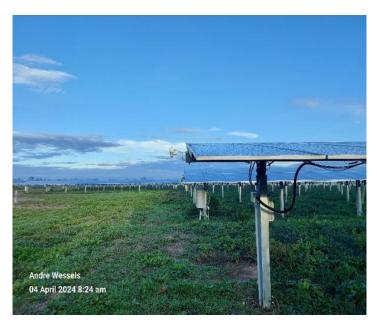
Figure 22: Ground conditions beneath POA down sensor - MVS1

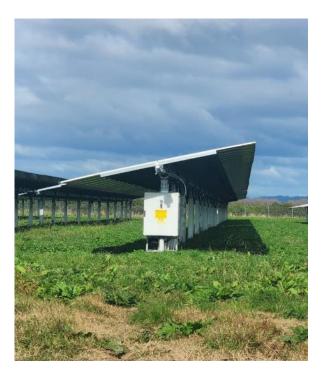
Figure 23: Ground conditions beneath POA down sensor - MVS3
