sfp

Sheet: 1/1

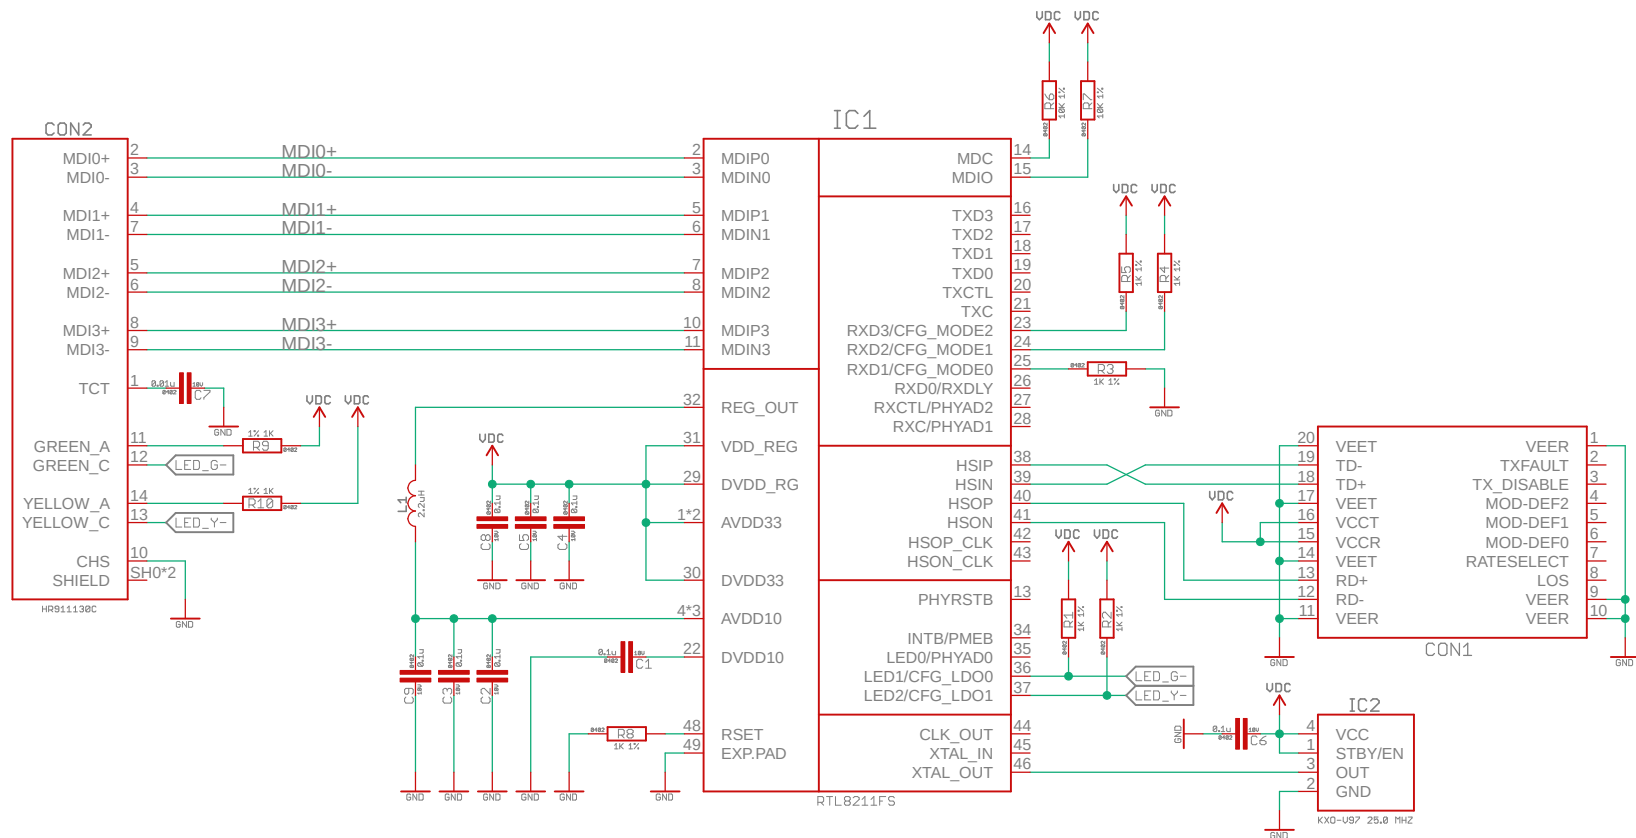
[https://en.trxcom.net/Products\\_details/386.html](https://en.trxcom.net/Products_details/386.html)  
Here is says there are NO MAGNETICS inside TRJE101AGNL

- 1) Poorly draun Schematic.
- 2) TXD+/TXD- on SFP connector side must be swapped
- 3) Ethernet connector has no embedded magnetics. Need another connector
