Appendix A - Issues

1.0 GFE Integration

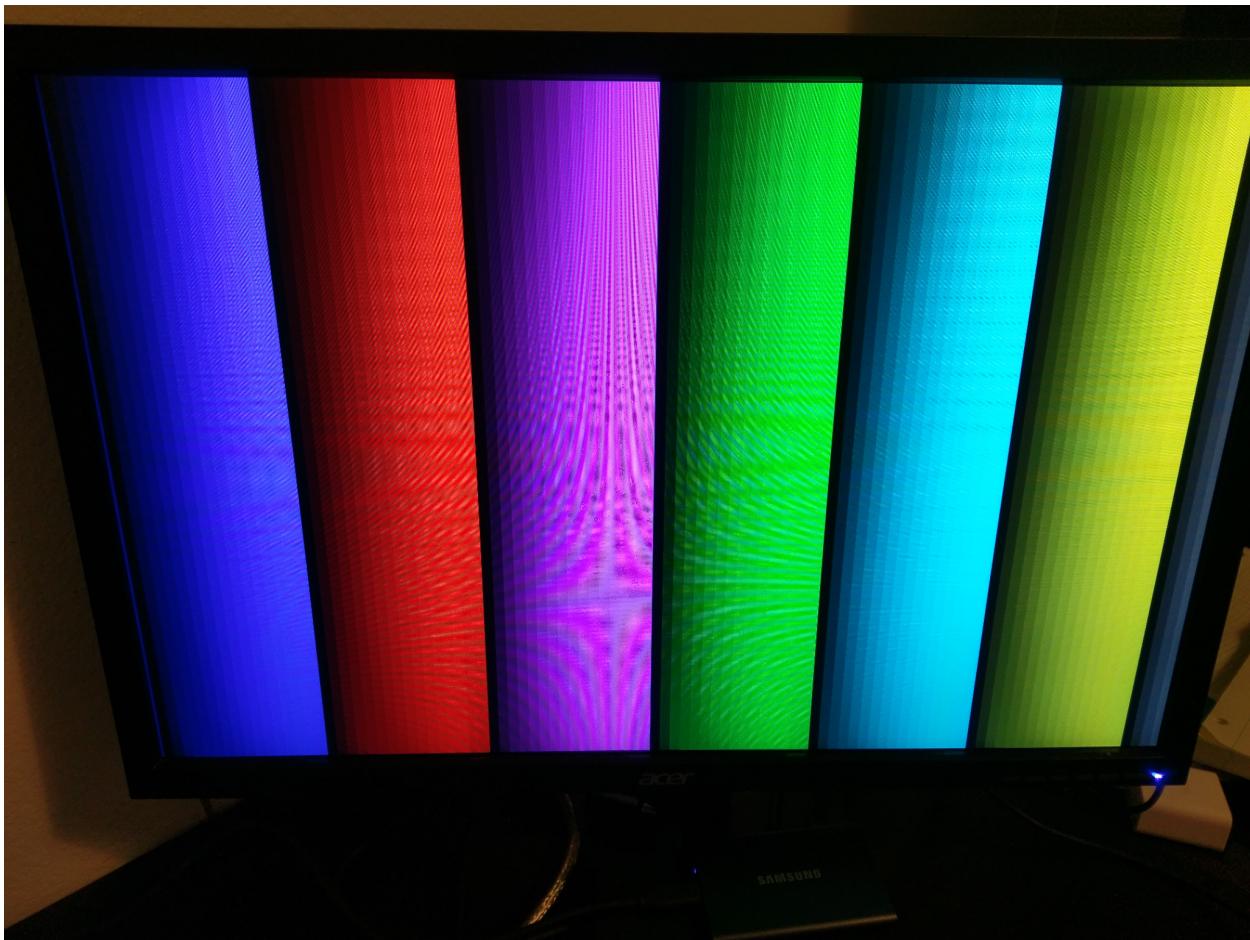
Color palette test pattern from example Vivado project

When a bitstream for this project was generated and uploaded onto the VCU118, nothing appeared on the monitor outside of a notification which implied no valid signal was found. After some debugging and documentation, we discovered that this issue is due to an older version of

the PMOD specification that the VCU118 was designed on⁴. This specification requires pullup resistors to 3.3V to be on the daughter card instead of on the VCU118.

The solution to this problem, as was also described in the forum post, would be to add pull ups as part of the PMOD expansion board. After inquiring, we noticed this was done before on a schematic about a microSD card reader over PMOD interface and developed into a PCB⁵.

Due to limited time for this project, our fix would be to enable video output on the VCU118 would be to hand solder pull ups via a PMOD 12-pin Test Point Header board, deliver it to the remote machine, and plug in the test point headers in between the jumper cables attached to the VCU118 and the PMOD DVI board.

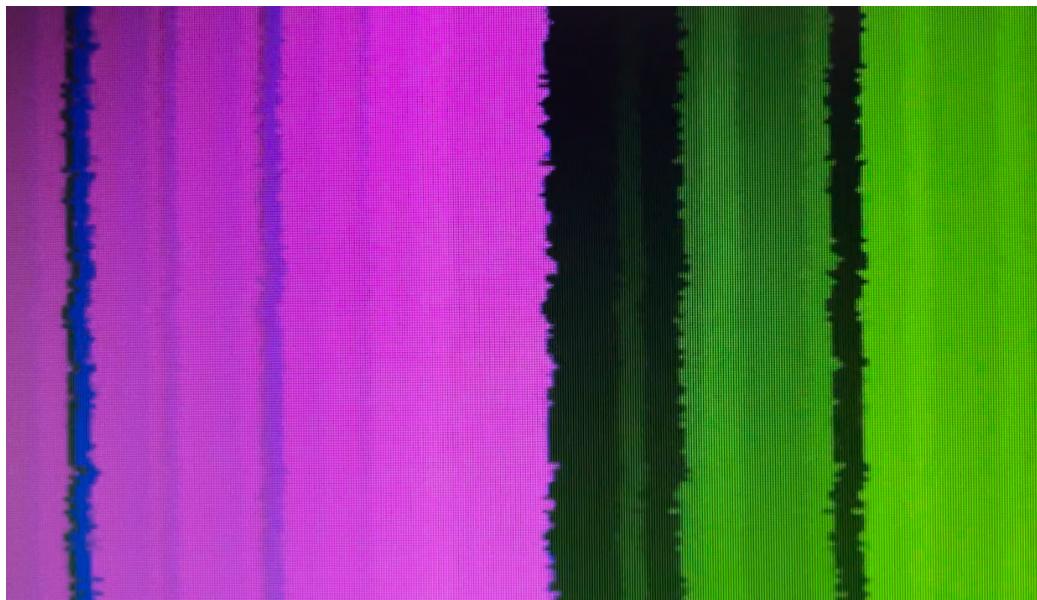
After enabling video output via a simple test, the VCU118 showed some fuzziness on the screen which was not evident on our local tests. While we're not sure what the root cause of this error is due to the lack of time for investigation, we suspect it's one of the following issues.

- Increased inductance due to jumper cables and/or the soldered PMOD pullups. This could be fixed by adding bypass capacitors in between 3.3V and GND.
- Timing control of this display test was done using a clocking wizard. Perhaps the clock is not clean.
- This was developed using an RTL mode. This may not be an issue with the AXI4-Stream to Video Out IP

Fuzziness on screen from display test on the monitor connected to the VCU118
