## SNAGGING REPORT - SNAG ACTION LIST

# Maple Row Handover

18 Maple Row, Bristol

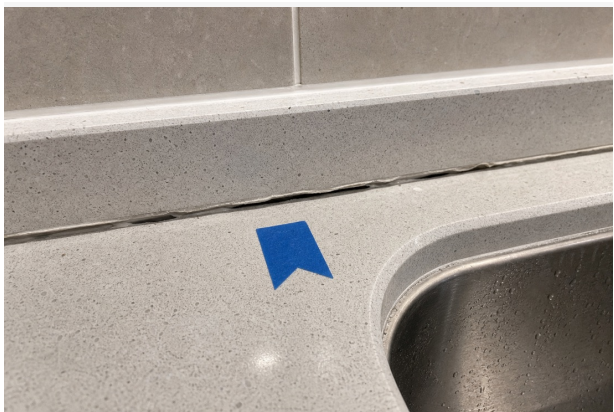
# KIT-001 Silicone gap at sink upstand

Kitchen   Finishes   Severity: Moderate   Owner: Developer   Due: Jul 17, 2026

Visible gap behind the sink upstand. Sealant should be completed before handover sign-off.

**Gap visible behind sink upstand before sealant.**  
Captured 2026-07-10 12:30 - SHA-256 159279d98a7adfa2 (verified)

Developer to correct this snag by Jul 17, 2026 and provide completion evidence.

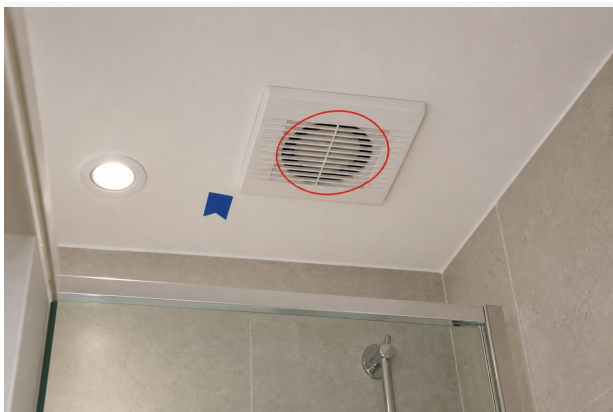
BAT-003    **Extractor fan not operating**

Bathroom    Electrical    Severity: Critical    Owner: Electrical subcontractor    Due: Jul 12, 2026

Fan does not start when the light circuit is activated. Confirm power and replace if needed.

**Extractor fan did not operate during the check.**  
Captured 2026-07-10 12:00 - SHA-256 2136a76d2077bad4 (verified)

Electrical subcontractor to correct this snag by Jul 12, 2026 and provide completion evidence.
