## PUNCH LIST

# Cedar Ridge Apartment Turnover

100 Example Way, Austin, TX 78701

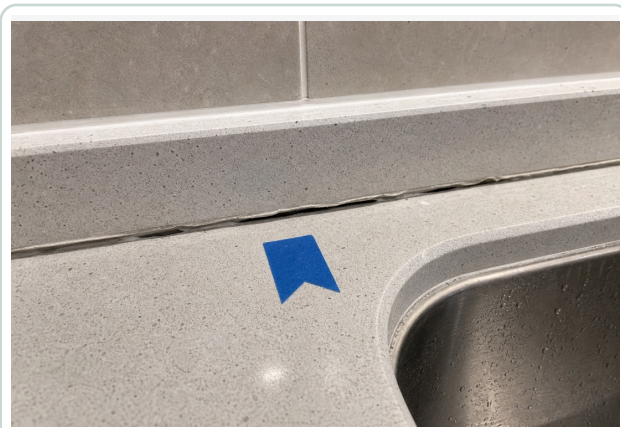
# KIT-001 Open sealant joint at backsplash

Kitchen Finishes Severity: Moderate Owner: General contractor Due: Jul 11, 2026

Open joint recorded during the turnover walk.

Complete the sealant joint before owner turnover.

General contractor to correct this punch item by Jul 11, 2026.

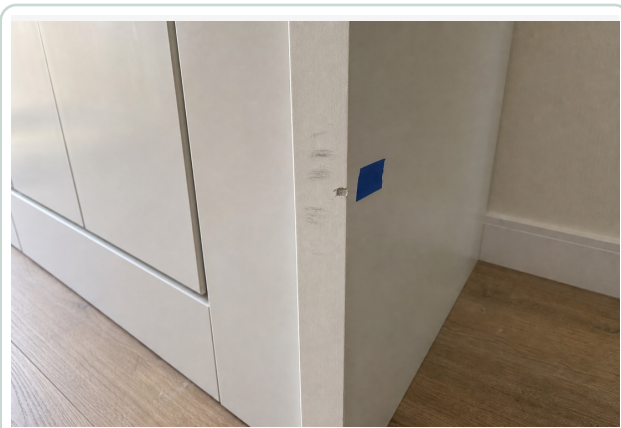
# BED-002 Paint scuff at closet return

Primary bedroom    Painting    Severity: Minor    Owner: Painting trade    Due: Jul 12, 2026

Scuff visible under normal room lighting.  
Captured Jul 10, 2026 17:00 - SHA-256 6aa458e81f19bc3e (verified)

Prepare and touch up the marked surface.

Painting trade to complete this punch item and provide closeout evidence.

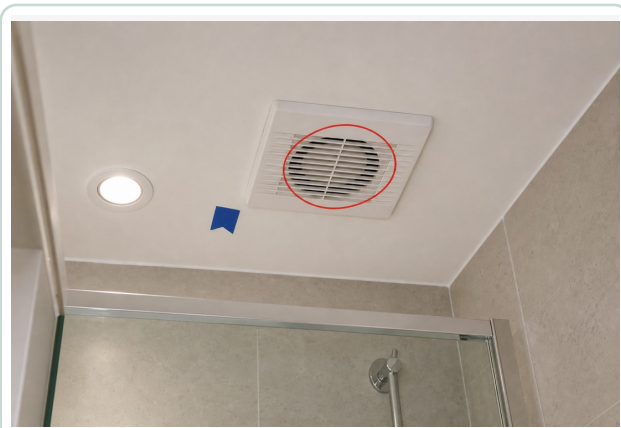
# BAT-003 Exhaust fan does not start

Bathroom   Electrical   Severity: Critical   Owner: Electrical trade   Due: Jul 13, 2026

Fan did not operate during functional testing.  
Captured Jul 11, 2026 17:00 - SHA-256 2136a76d2077bad4 (verified)

Confirm power and replace the fan if required.

Electrical trade to correct this punch item by Jul 13, 2026.

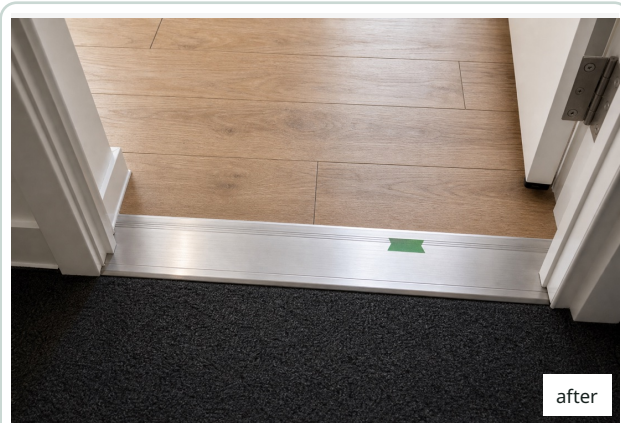
# HAL-004 Entry threshold finish repaired

Repair was reviewed during the closeout walk.

Finished threshold accepted at reinspection.

Repair complete and accepted.
