Listening Archive

The aim of the Listening Archive is to employ a scenario that will not only be a means to indulge with the everyday life of the existing resettled population, but also influence the ecologies of future resettlement initiatives in Mumbai. The built environment of the resettlement initiatives has implicit relation with the socio-cultural and economic norms of its inhabitants.

With the support and guidance of SPARC, India Alexander Valencia and Shibani Jadhav, conducted extensive research in June and July 2015, to critically document the design details of the existing resettlement initiatives in order to articulate the needs of the inhabitants for a desirable environment. The aim of the research was to document the existing relations reflected by the socio-spatial, cultural and economic conditions of the resettlement initiatives in Mumbai. Research was conducted in Lallubhai Compound, Natvar Parikh Compound, Vashi Naka [three of the biggest resettlement initiatives as of July 2015] and Milan Nagar in Mumbai and Yerwada [rehabilitation] and Warje in Pune.

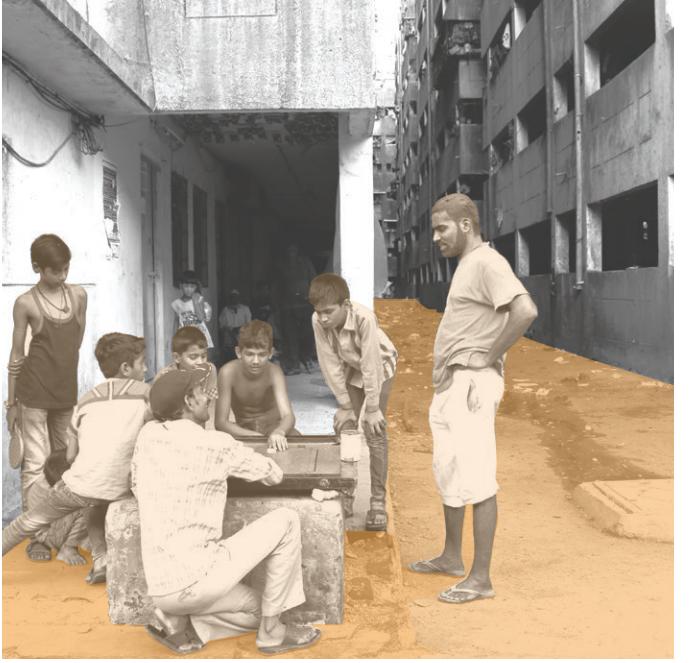
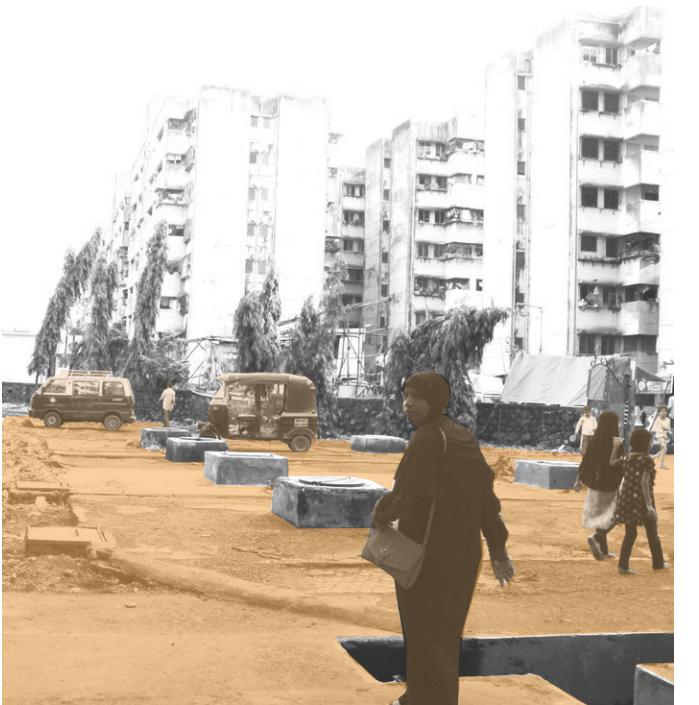
The **narrow alleys**, formed as a result of closely spaced structures, not only obstructs the flow of wind, but also blocks the sun rays from penetrating to the ground at any given time of the day. The residents on the ground and first floor of Lallubhai compound are deprived of natural light and ventilation and have to rely on artificial means, which in turn increases their monthly expenses.

While most of the narrow dark alleys, in both Lallubhai and Natvar Parekh Compound have been transformed into dumping grounds by households residing on upper floors, the alleys used by the residents to commute in and out of the compounds are observed to be clean and maintained [image page 7]. With insufficient dustbins and irregular collection, for compounds of approximately 70,000 residents, garbage disposal continues to be one of the major issues within different compound. It's the duty of BMC [Brihanmumbai Municipal Corporation] to ensure collection and disposal of garbage on regular

basis for settlements of this dimension. The poor quality of natural light and ventilation along with stagnant and continuous garbage disposal in the narrow alleys has given rise to health issues among both, kids and adults in the compounds. Such unhygienic conditions is one of the many reasons for rise in respiratory diseases like Asthma in the recent past. Although a more reliable and frequent system of garbage collection and disposal can help address this issue to a certain extent, the activation of these unused alleys can enforce a sense of responsibility and belonging among the residents, in order to curb the disposal of garbage in these narrow alleys. It is vital to avoid leftover spaces while designing the settlements as such spaces belong to everyone and to no one, thus easily abused and neglected.

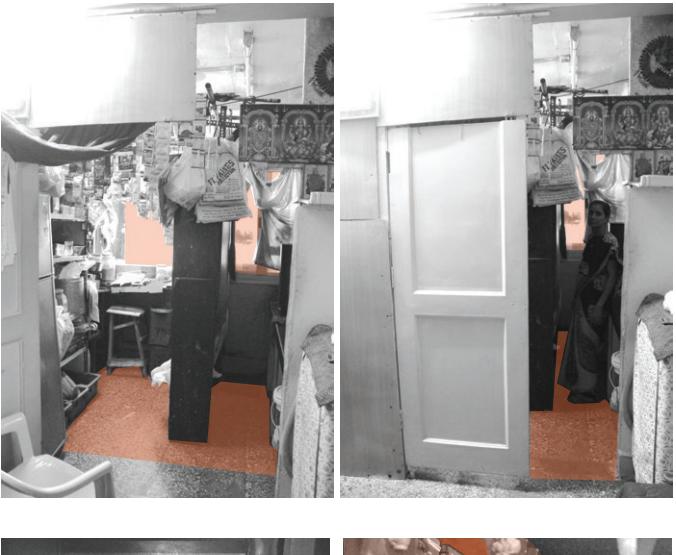
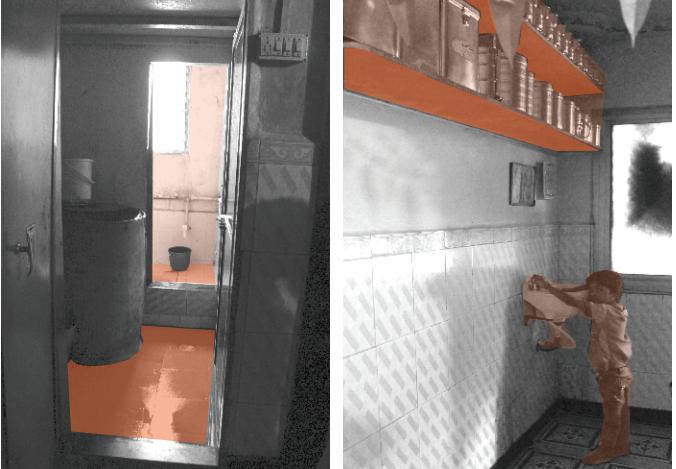
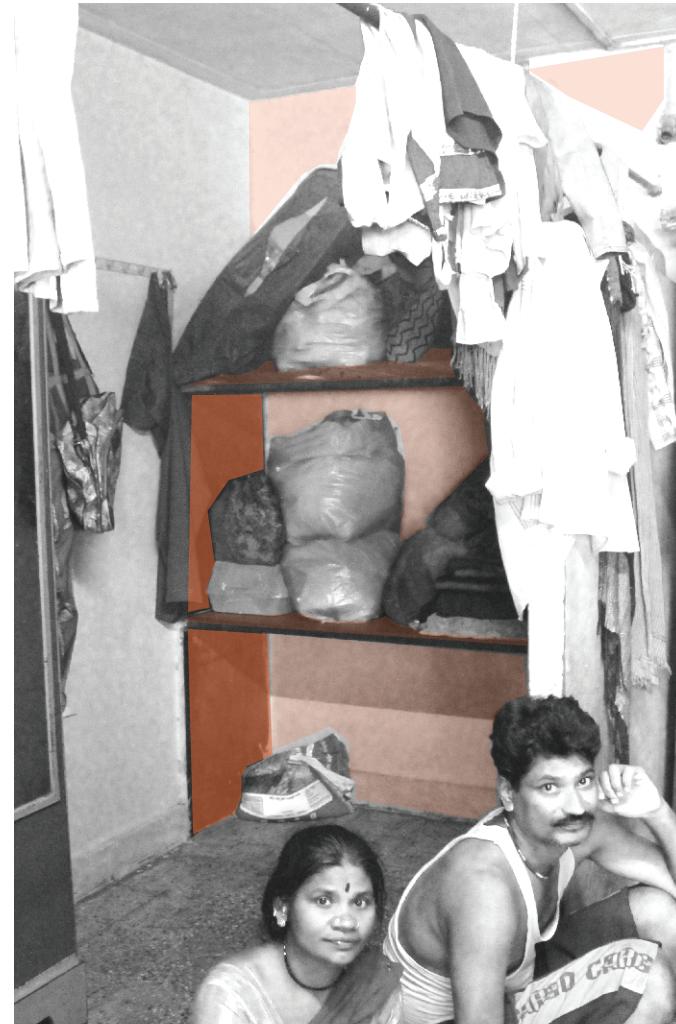
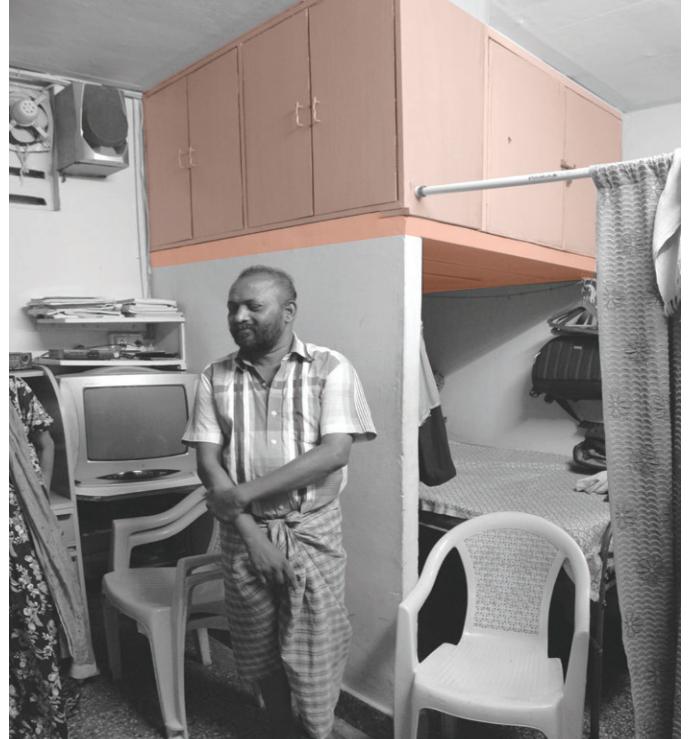
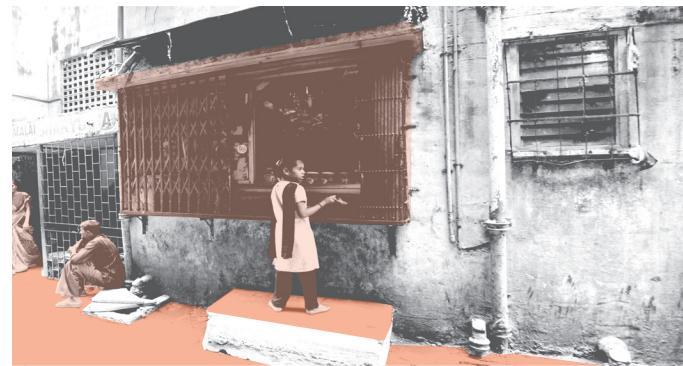
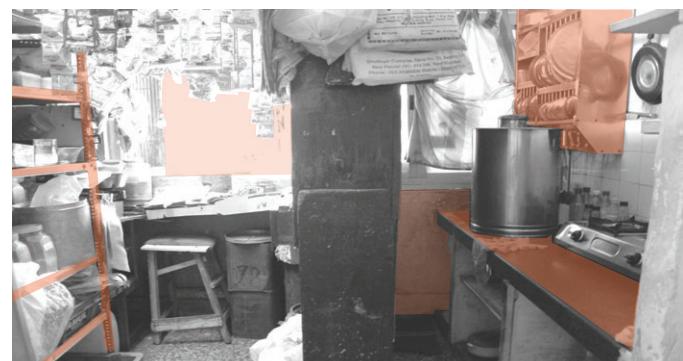
Some residents living on the ground floor have improvised their kitchen to incorporate a space for economical activity, such as store, ironing, stitching, four grinding and so on. The window thus becomes a point of interaction with the customers and highlights the importance of a space for economical activities for the residents to indulge in [page 18: left and top right]

Opening the door of the bath in the bed room affects the privacy of the only private space in the unit. More importantly, residents have sealed the opening of the toilet that opened in the kitchen to not only, avoid unhygienic conditions in the kitchen, but also use the length of the wall for storage of goods and utensils. [Page 18: bottom middle]

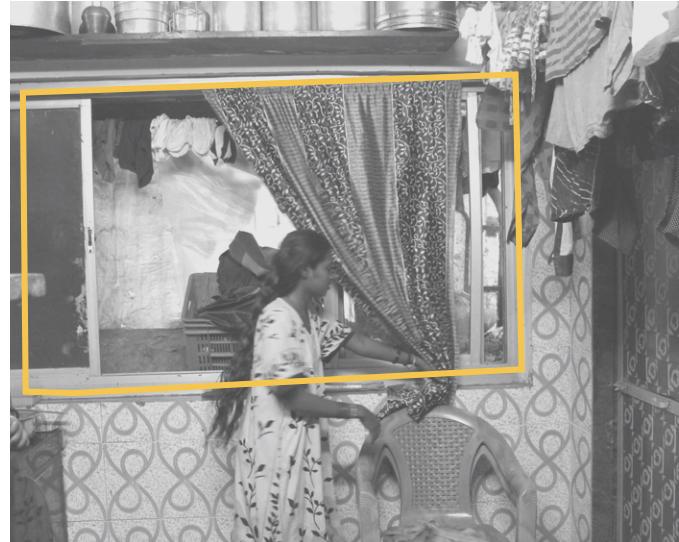
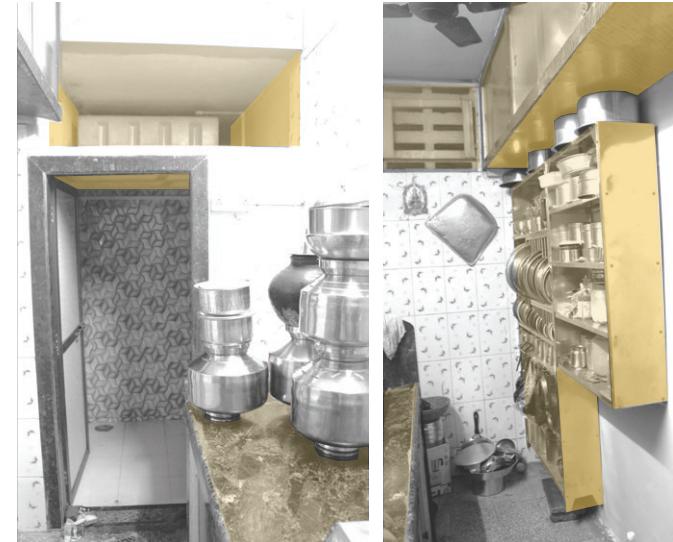
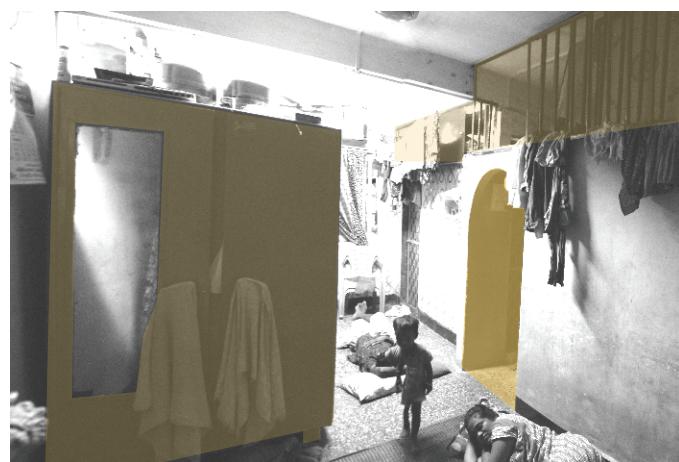
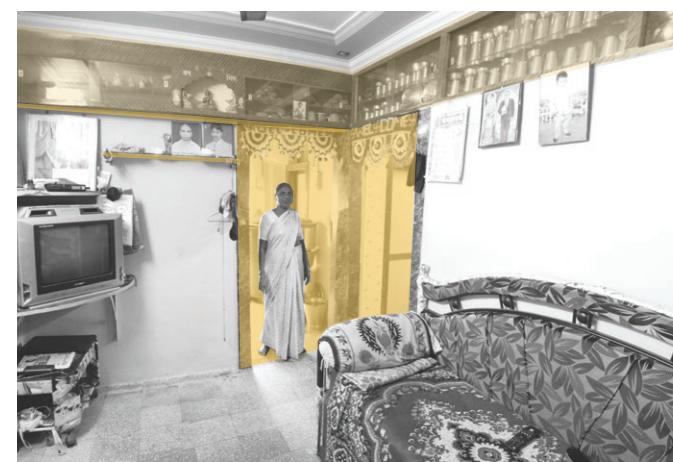
Depending on the nature and size of the family residing in the unit, different ways and means for storage we observed as illustrated in the drawings and images. While many used the space above the bath and toilet as a mezzanine storage space [page 21: top left], some have additionally built a storage over the bed room [page 19:bottom right, page 20:bottom]. Local *Kadappa* stone and wooden planks have been used by residents to build over head shelves. [Page 18: bottom right, page 19: bottom left]
