**1972 Hatteras 42 Convertible**

***"LONGSHANKS"***

## **Report of Marine Survey**

8/21/2024

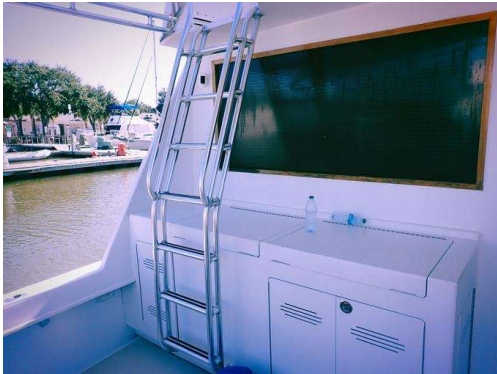
**Access to flybridge**

**FITTINGS AND HARDWARE:** Various stainless handles mounted in strategic places. A large 8 step ladder allows access to the flybridge from the cockpit. Serviceable.

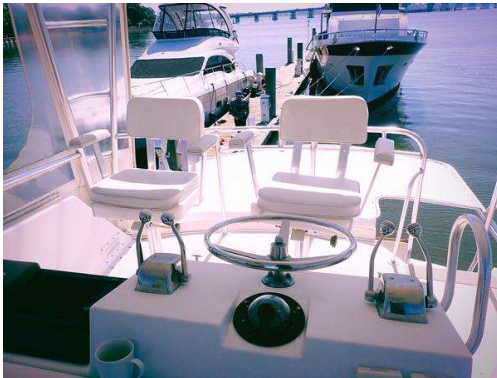
Helm seating

**SEATS:** Pedestal mounted swivel chairs are provided for the helmsman and mate. Good condition.

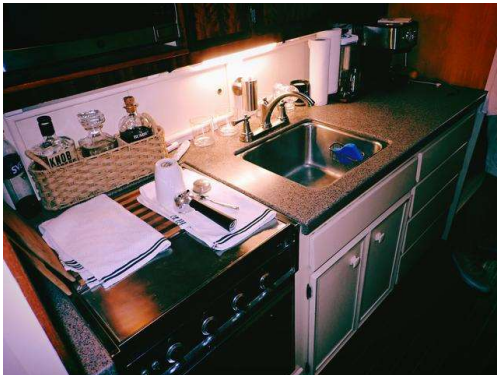
**LOCATION:** Galley is on the starboard side of the lower cabin, with storage and built in microwave, refrigerator and stove.

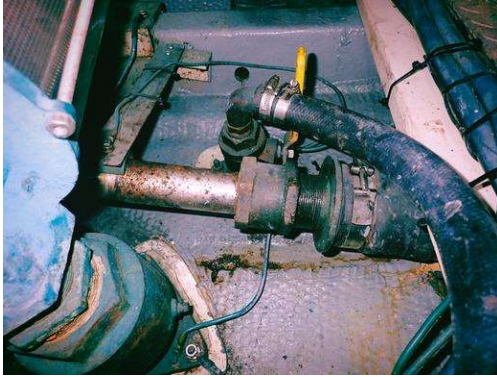
Shaft seal stbd

**STUFFING BOX:** Stuffing boxes and packing glands, are bronze single hex type, boots are well clamped and serviceable.  
Monitor Frequently for leakage and proper adjustment.

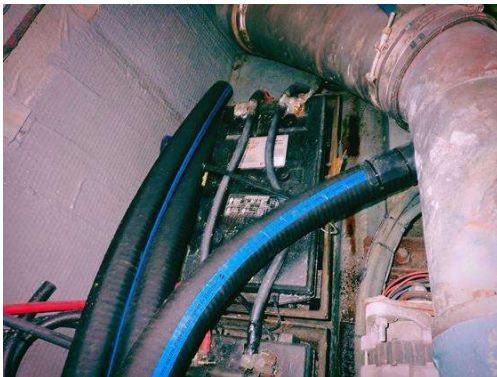
Battery bank port side

- \* **BATTERIES: [A3]** Four (4), 8D wet cell batteries, two wired in parallel as a starting bank for each diesel engine. Also a Group 27 12V wet cell battery for generator starting. None of the batteries are well secured in their boxes, their positive terminals are not protected against accidental shorting, and a "wing nut" is used on the generator start battery.

| FINDINGS | RECOMMENDATIONS |
|---|---|
| <b>None of the batteries are well secured in their boxes, their positive terminals are not protected against accidental shorting, and a "wing nut" is used on the generator start battery.</b> | <i>Replace wing nut with a hex nut, secure batteries and install protective covers over positive terminals. CFR 183.420, CFR 183.445, NFPA 302 7-43.</i> |

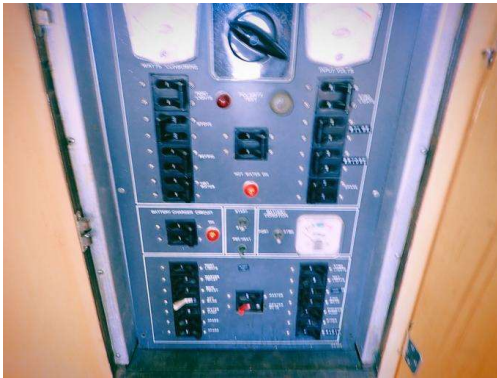
Main electrical panel

**BREAKERS/FUSES:** 12V breakers for various well labeled circuits, plus two (2) spares, values of breakers unknown. Serviceable

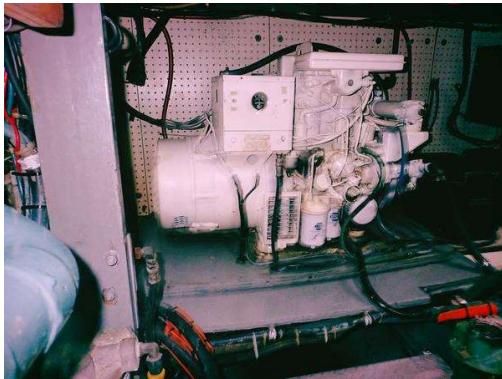
**Diesel generator**

**TYPE:** Onan diesel generator, 120V/240V, Model MDJE, Ser. No. 06711308283. Serviceable.

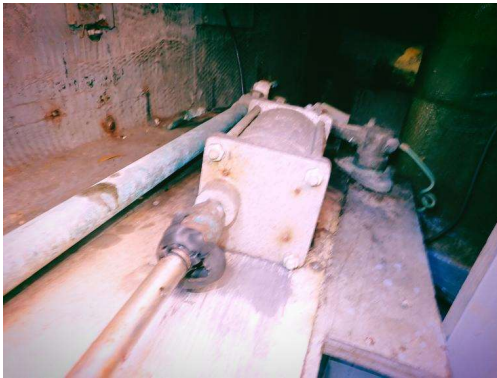
Steering cylinder

- \* **TYPE: [C1]** Hydraulic, by Hynautic, where sighted appeared serviceable. Number of Stations: one (1), on flybridge. Lines and fittings: Copper and reinforced flexible hose, with metallic fittings. Appears serviceable (no leaks or wet areas observed). Mounting: Cylinder and ram actuator are well secured under lazarette. Gauge on the steering hydraulic reservoir is reading 23 psi, recommended pressure is 30 psi.

| <b>Gauge on the steering hydraulic reservoir is reading 23 psi, recommended pressure is 30 psi.</b> | <i>Investigate further and pump up air pressure as necessary and monitor.</i> |

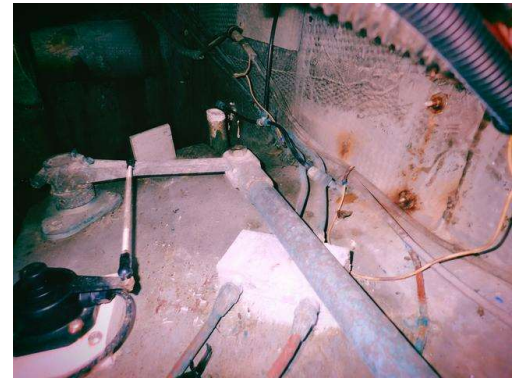
Steering stbd

**MOUNTING:** Cylinder and ram actuator are well secured.

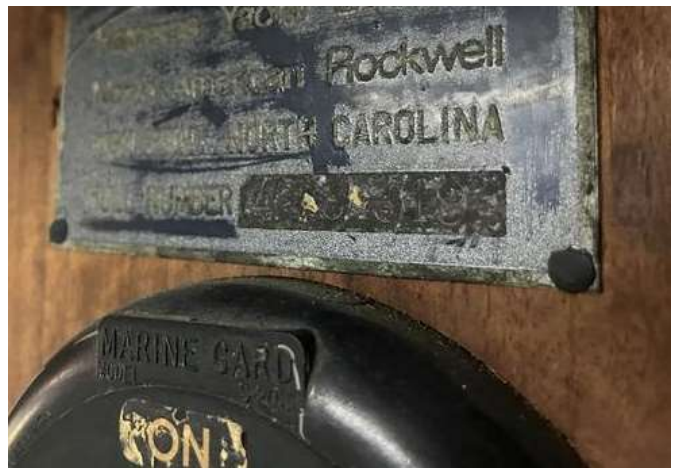
Hull No. 319 (barely visible)
