Shoreline Situation Report
CITY OF VIRGINIA BEACH

Special Report In Applied Marine Science and Ocean Engineering Number 163 of the

VIRGINIA INSTITUTE OF MARINE SCIENCE
Gloucester Point, Virginia 23062

1978

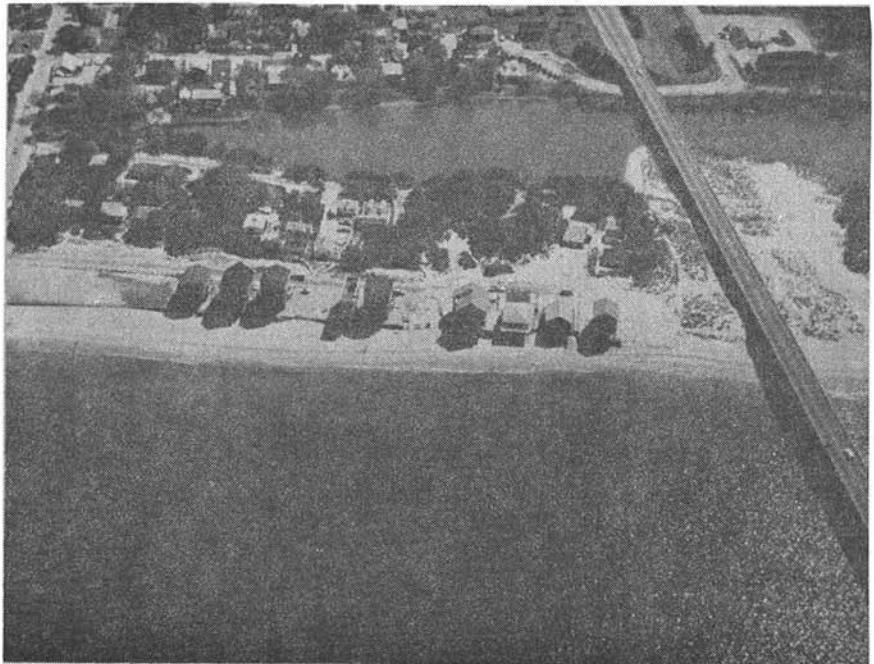
FIGURE 3

FIGURE 3: Chesapeake Bay Bridge Tunnel, Segment 2. These houses have been built very near the tidal zone. Abnormally high water would damage or destroy these structures.

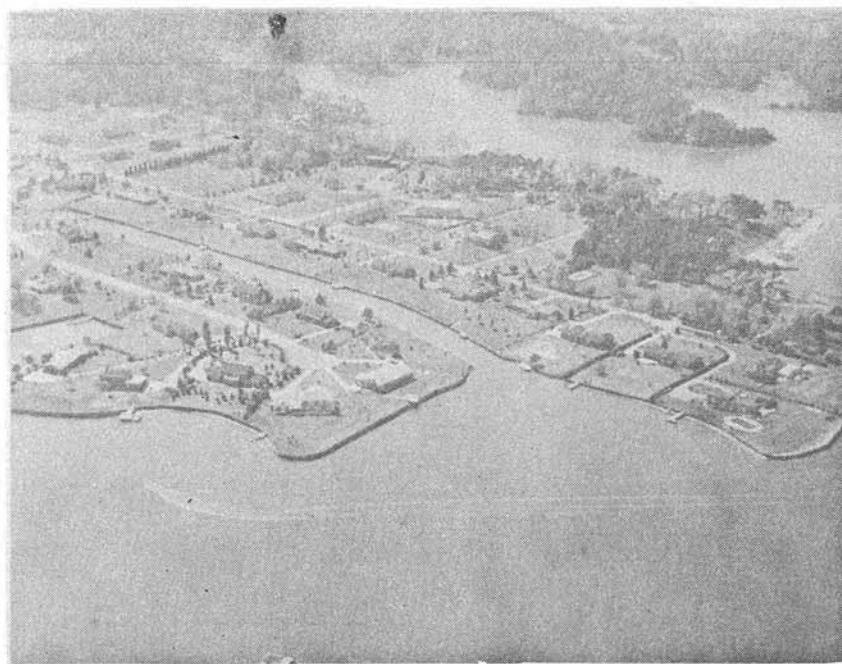
FIGURE 5

FIGURE 5: Witch Duck Point, Subsegment 3B. This is a typical residential development in the Lynnhaven River.

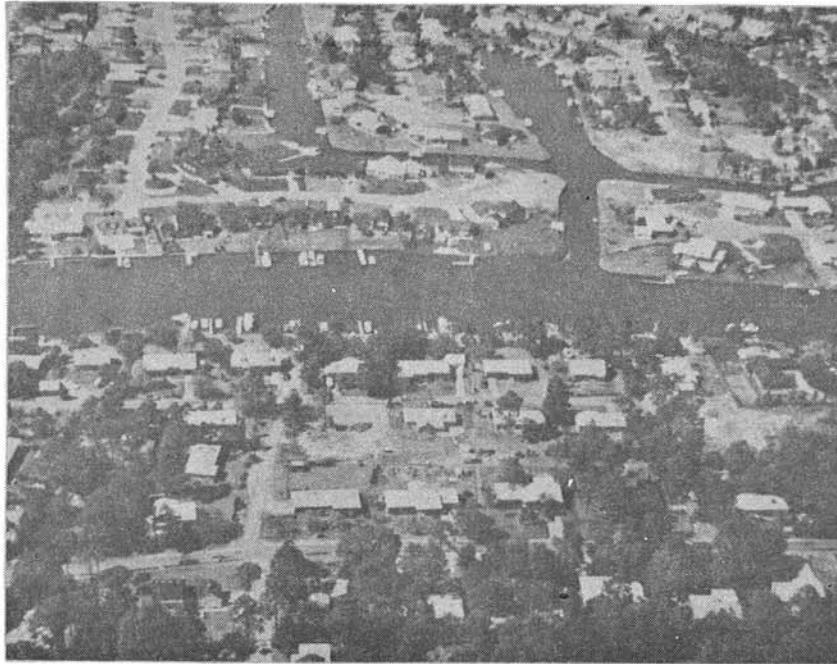
FIGURE 7

FIGURE 7: Cape Story by the Sea, Subsegment 3H. Canals have been dredged here to create waterfront property in this new residential area. This practice has been fairly common in Virginia Beach.

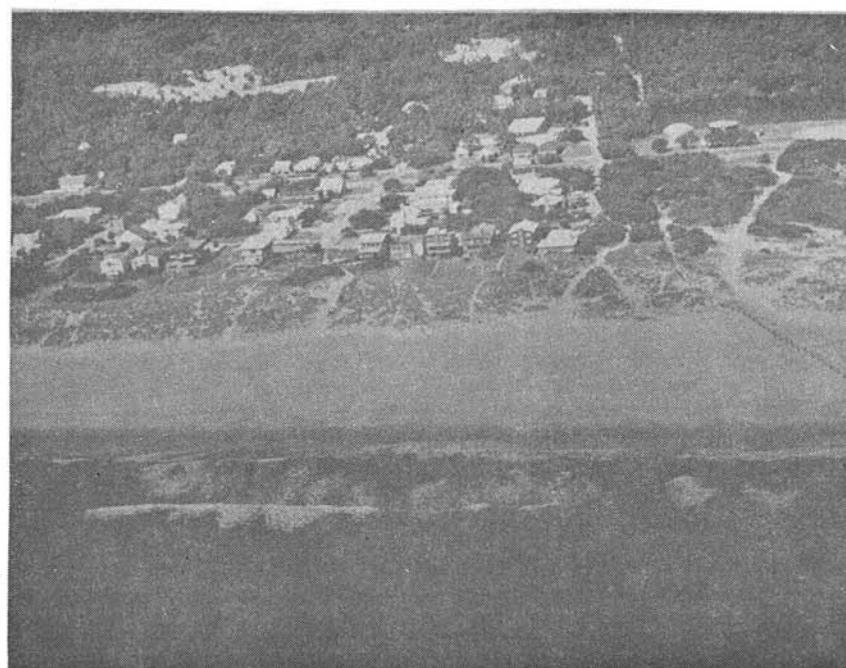
FIGURE 10

FIGURE 10: North Virginia Beach, Segment 6. The wide beach is backed by an area of low vegetated dunes, which serves to protect the residential area.
